HISTORIC AND DESIGN REVIEW COMMISSION

August 15, 2018

HDRC CASE NO: 2018-318
ADDRESS: 2620 N MAIN AVE
LEGAL DESCRIPTION: NCB 1704 BLK 12 LOT N 62.5 FT OF 1, 2 & 3 ARB A1
ZONING: O-2 H
CITY COUNCIL DIST.: 1
DISTRICT: Monte Vista Historic District
APPLICANT: Cristina Maria Rohrs
OWNER: Cristina Maria Rohrs
TYPE OF WORK: Installation of a low stone perimeter wall
APPLICATION RECEIVED: July 27, 2018
60-DAY REVIEW: September 25, 2018
REQUEST:

The applicant is requesting a Certificate of Appropriateness for approval to construct a low perimeter wall in the front and side yard of the property. The wall will be constructed of stone and measure approximately 2 feet in height with 3 foot tall posts.

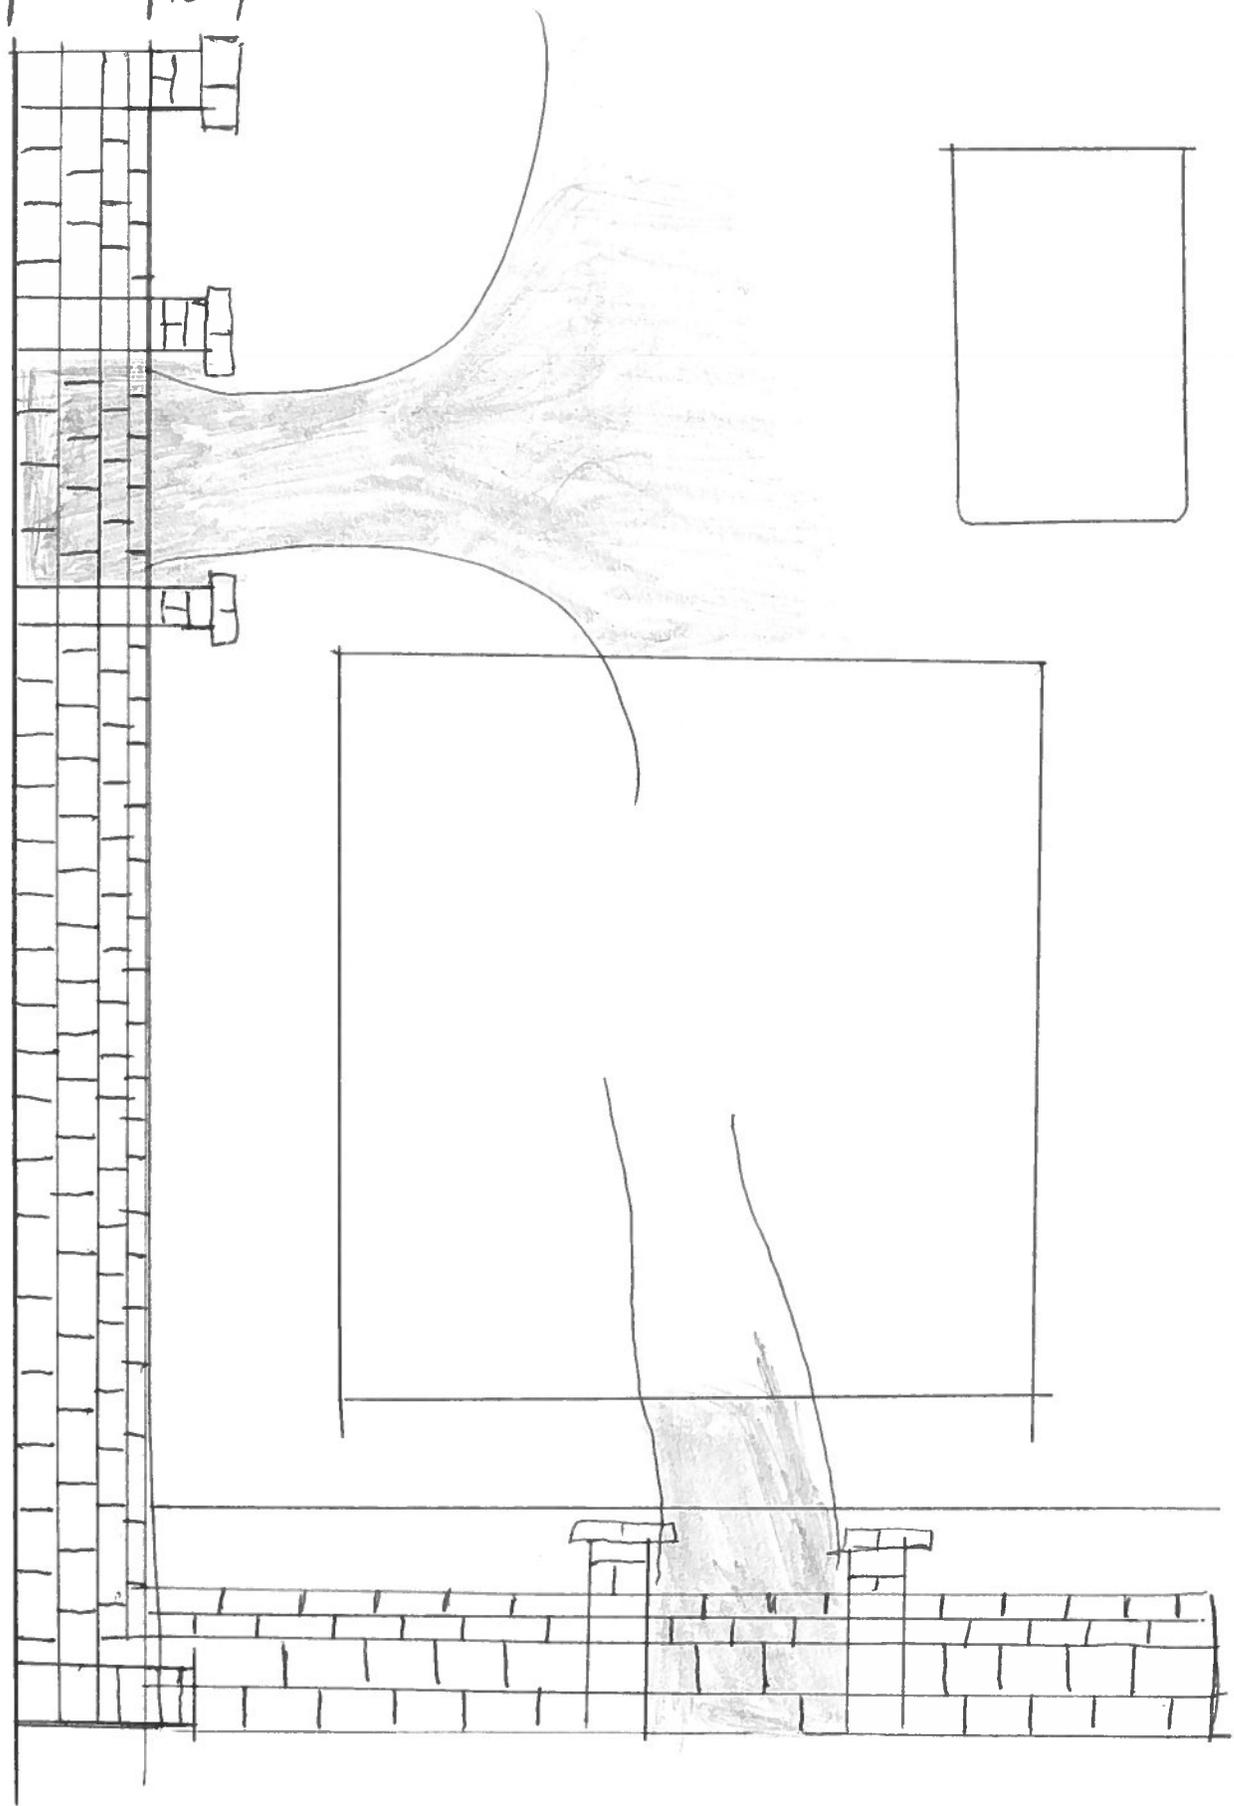
24" 10" 2

- b. **NEW WALL: HEIGHT AND LOCATION** - The applicant has proposed to install a low perimeter wall constructed of brick masonry. The wall will measure approximately 24” in height with 34” tall decorative posts. The wall will front the existing sidewalk fronting N Main Ave and E Magnolia Ave and terminate at the rear and south property line. The wall is requested for aesthetic reasons and will not function as a retaining wall for a slope or grade change. According to the Historic Design Guidelines for Site Elements, new fences and walls should appear similar to those used historically within the district in terms of their scale and location. In the blocks surrounding the property, there are no properties with low, non-retaining perimeter walls on E Magnolia or N Main. A low perimeter wall in the front yard of a property on E Magnolia and at the intersection of N Main and E Huisache both retain ground elements. Staff does not find low perimeter walls to be historically common or characteristic of the district. Staff does not find the height and location consistent with the Guidelines.

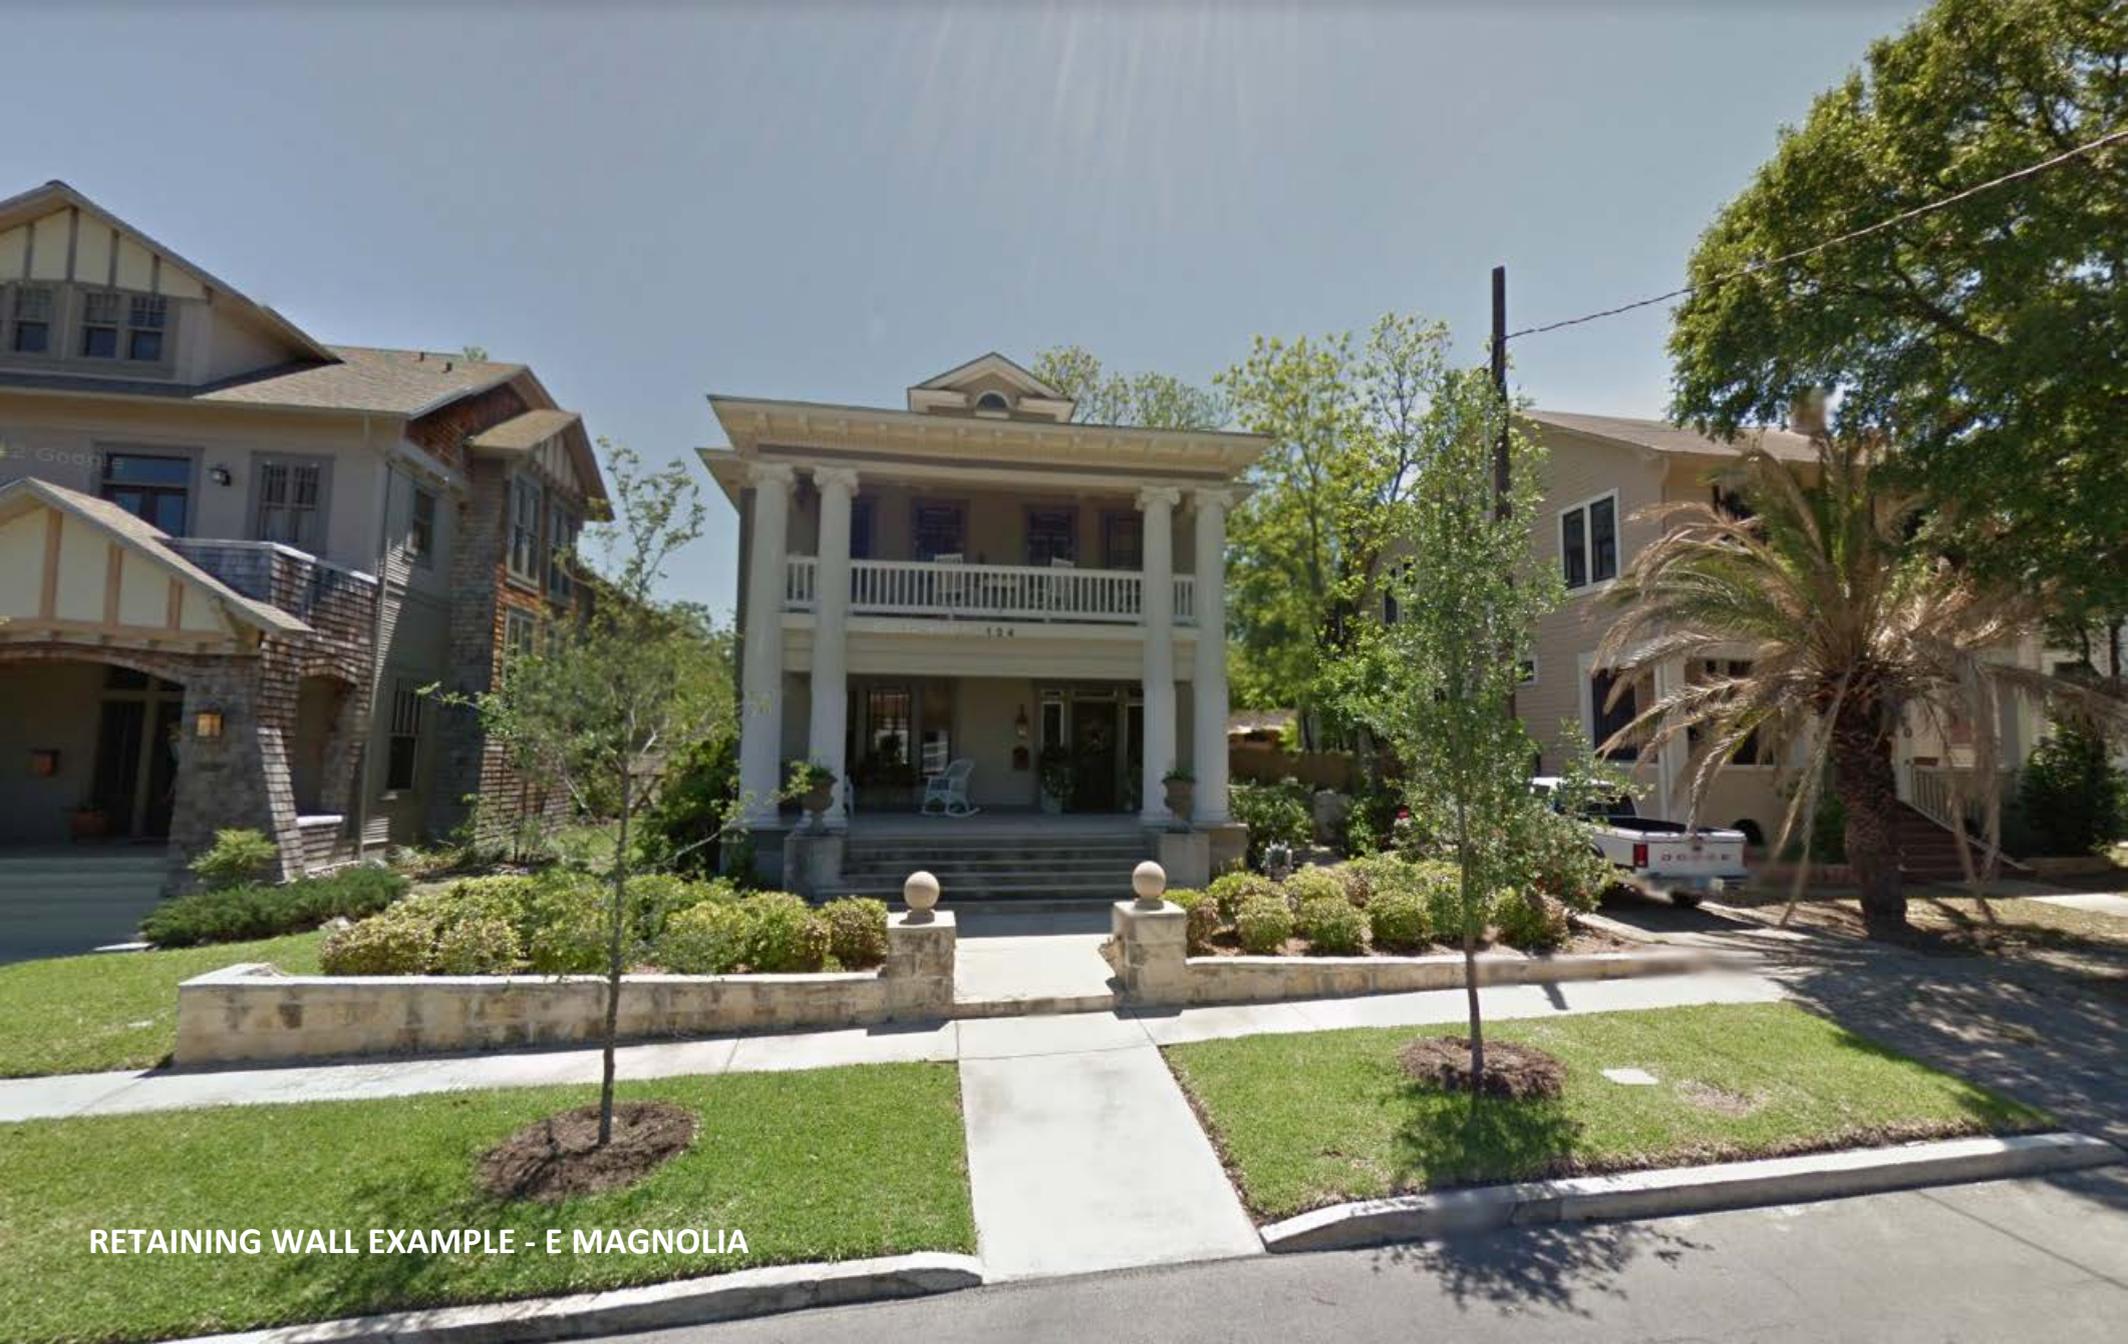
RETAINING WALL EXAMPLE - E MAGNOLIA

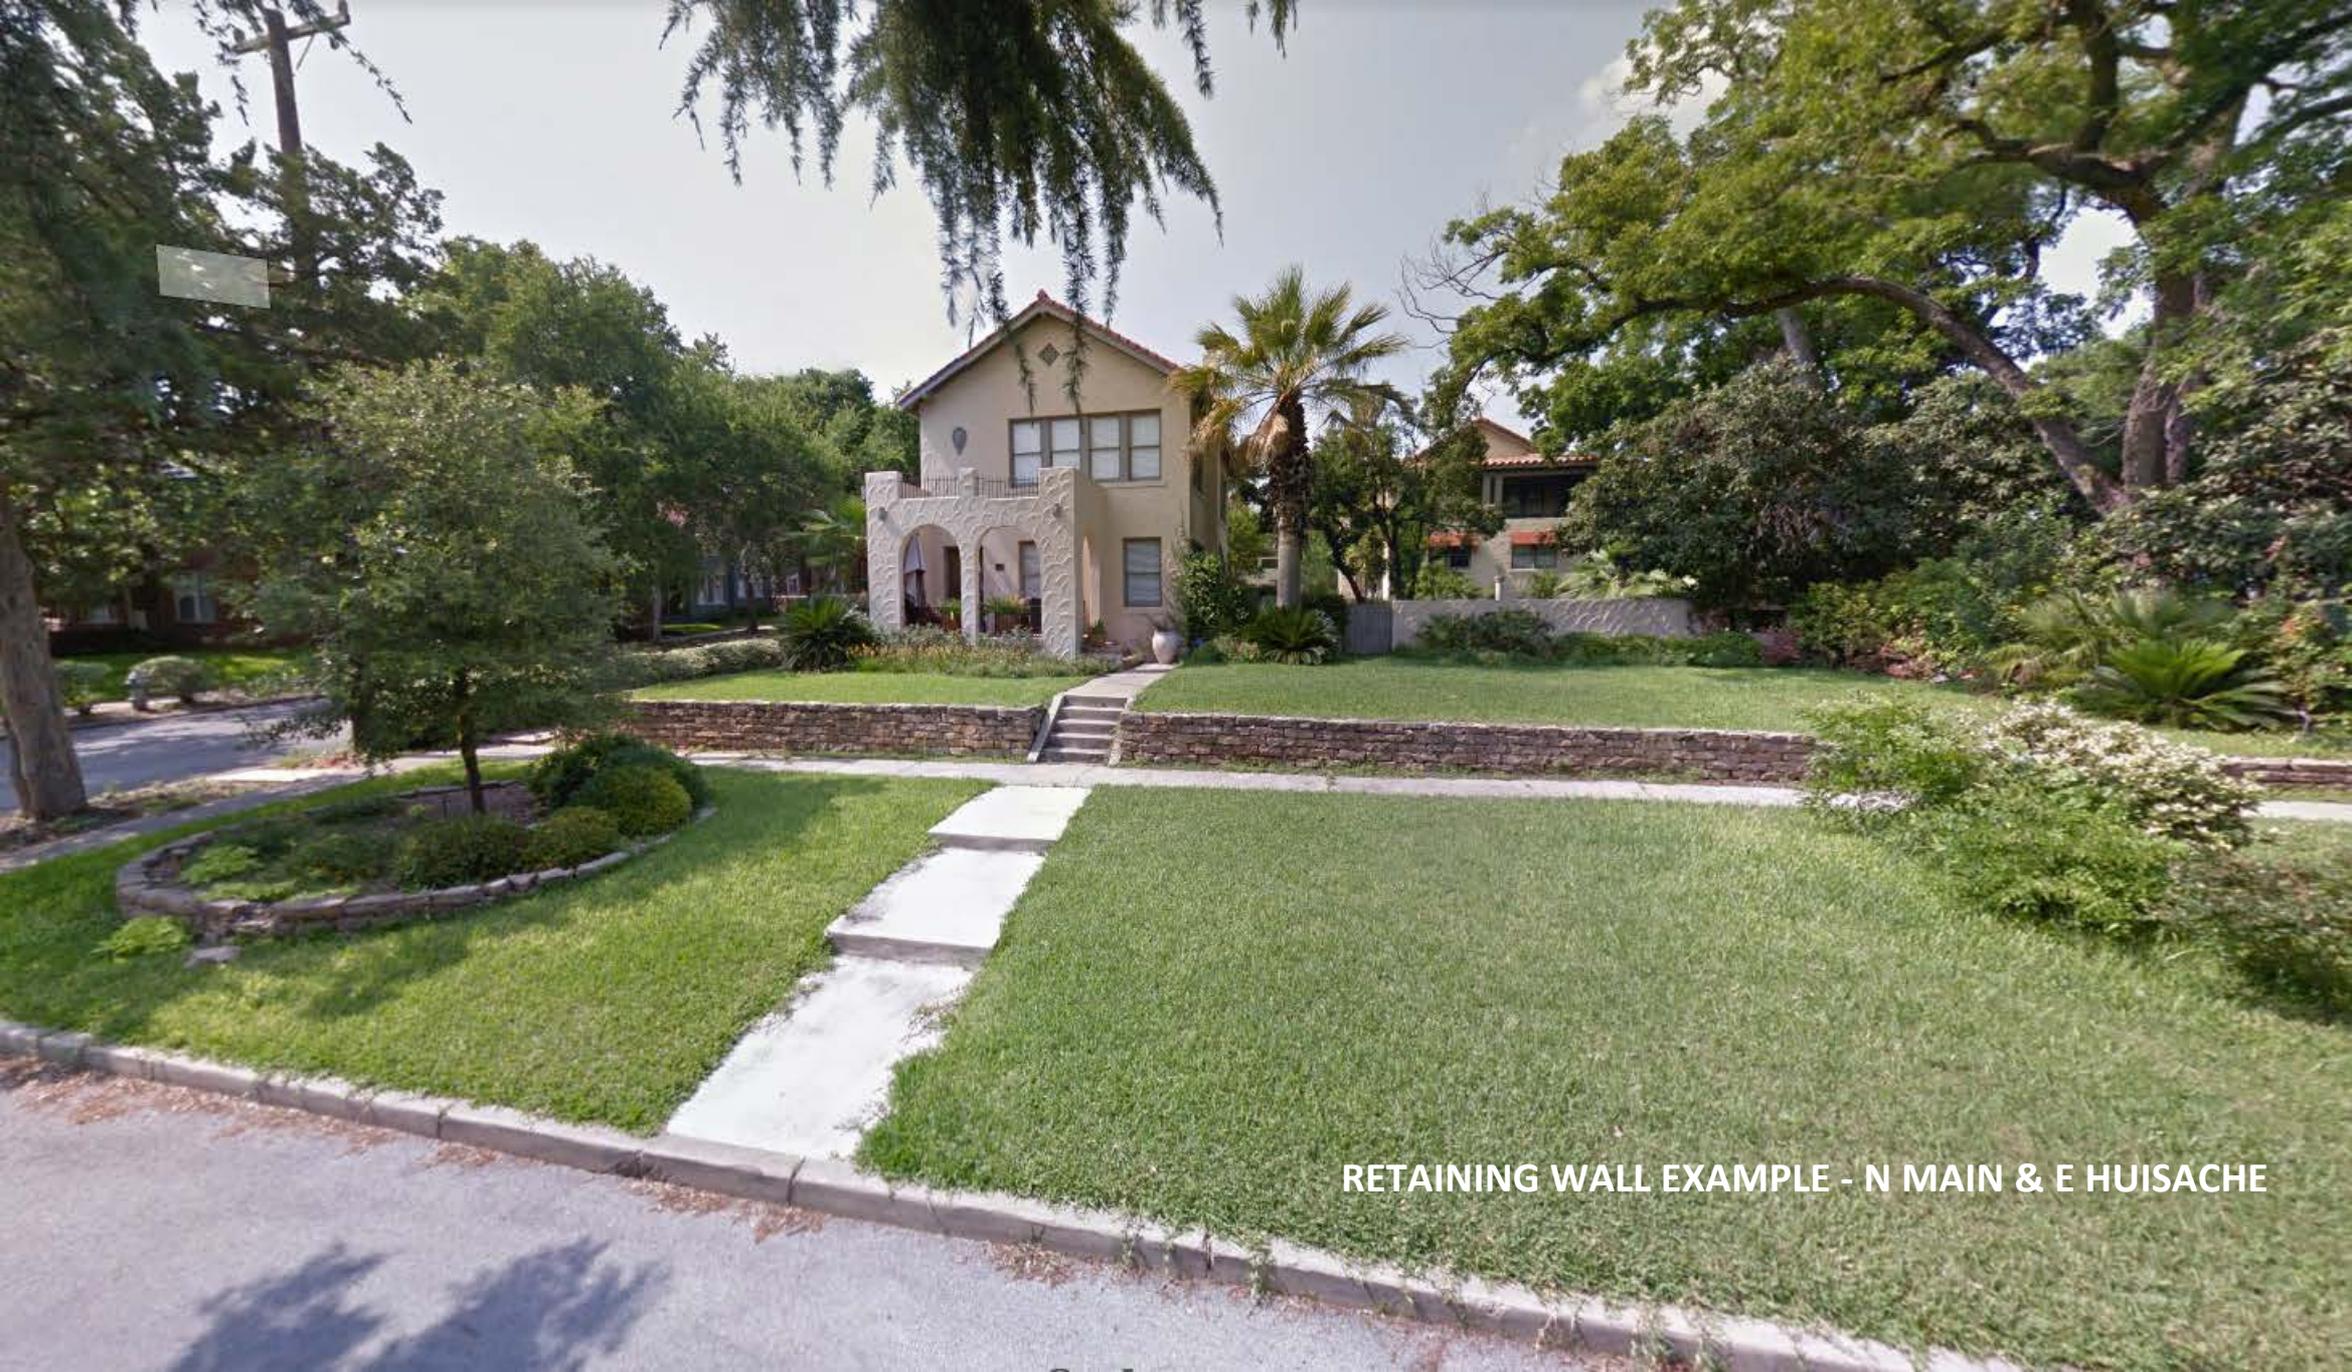
RETAINING WALL EXAMPLE - N MAIN & E HUISACHE
