**SERVICE FIRST
CROSS DEVELOPMENT**

SITE EXHIBIT 007
AUSTIN HWY, SAN ANTONIO, TX

EXH007

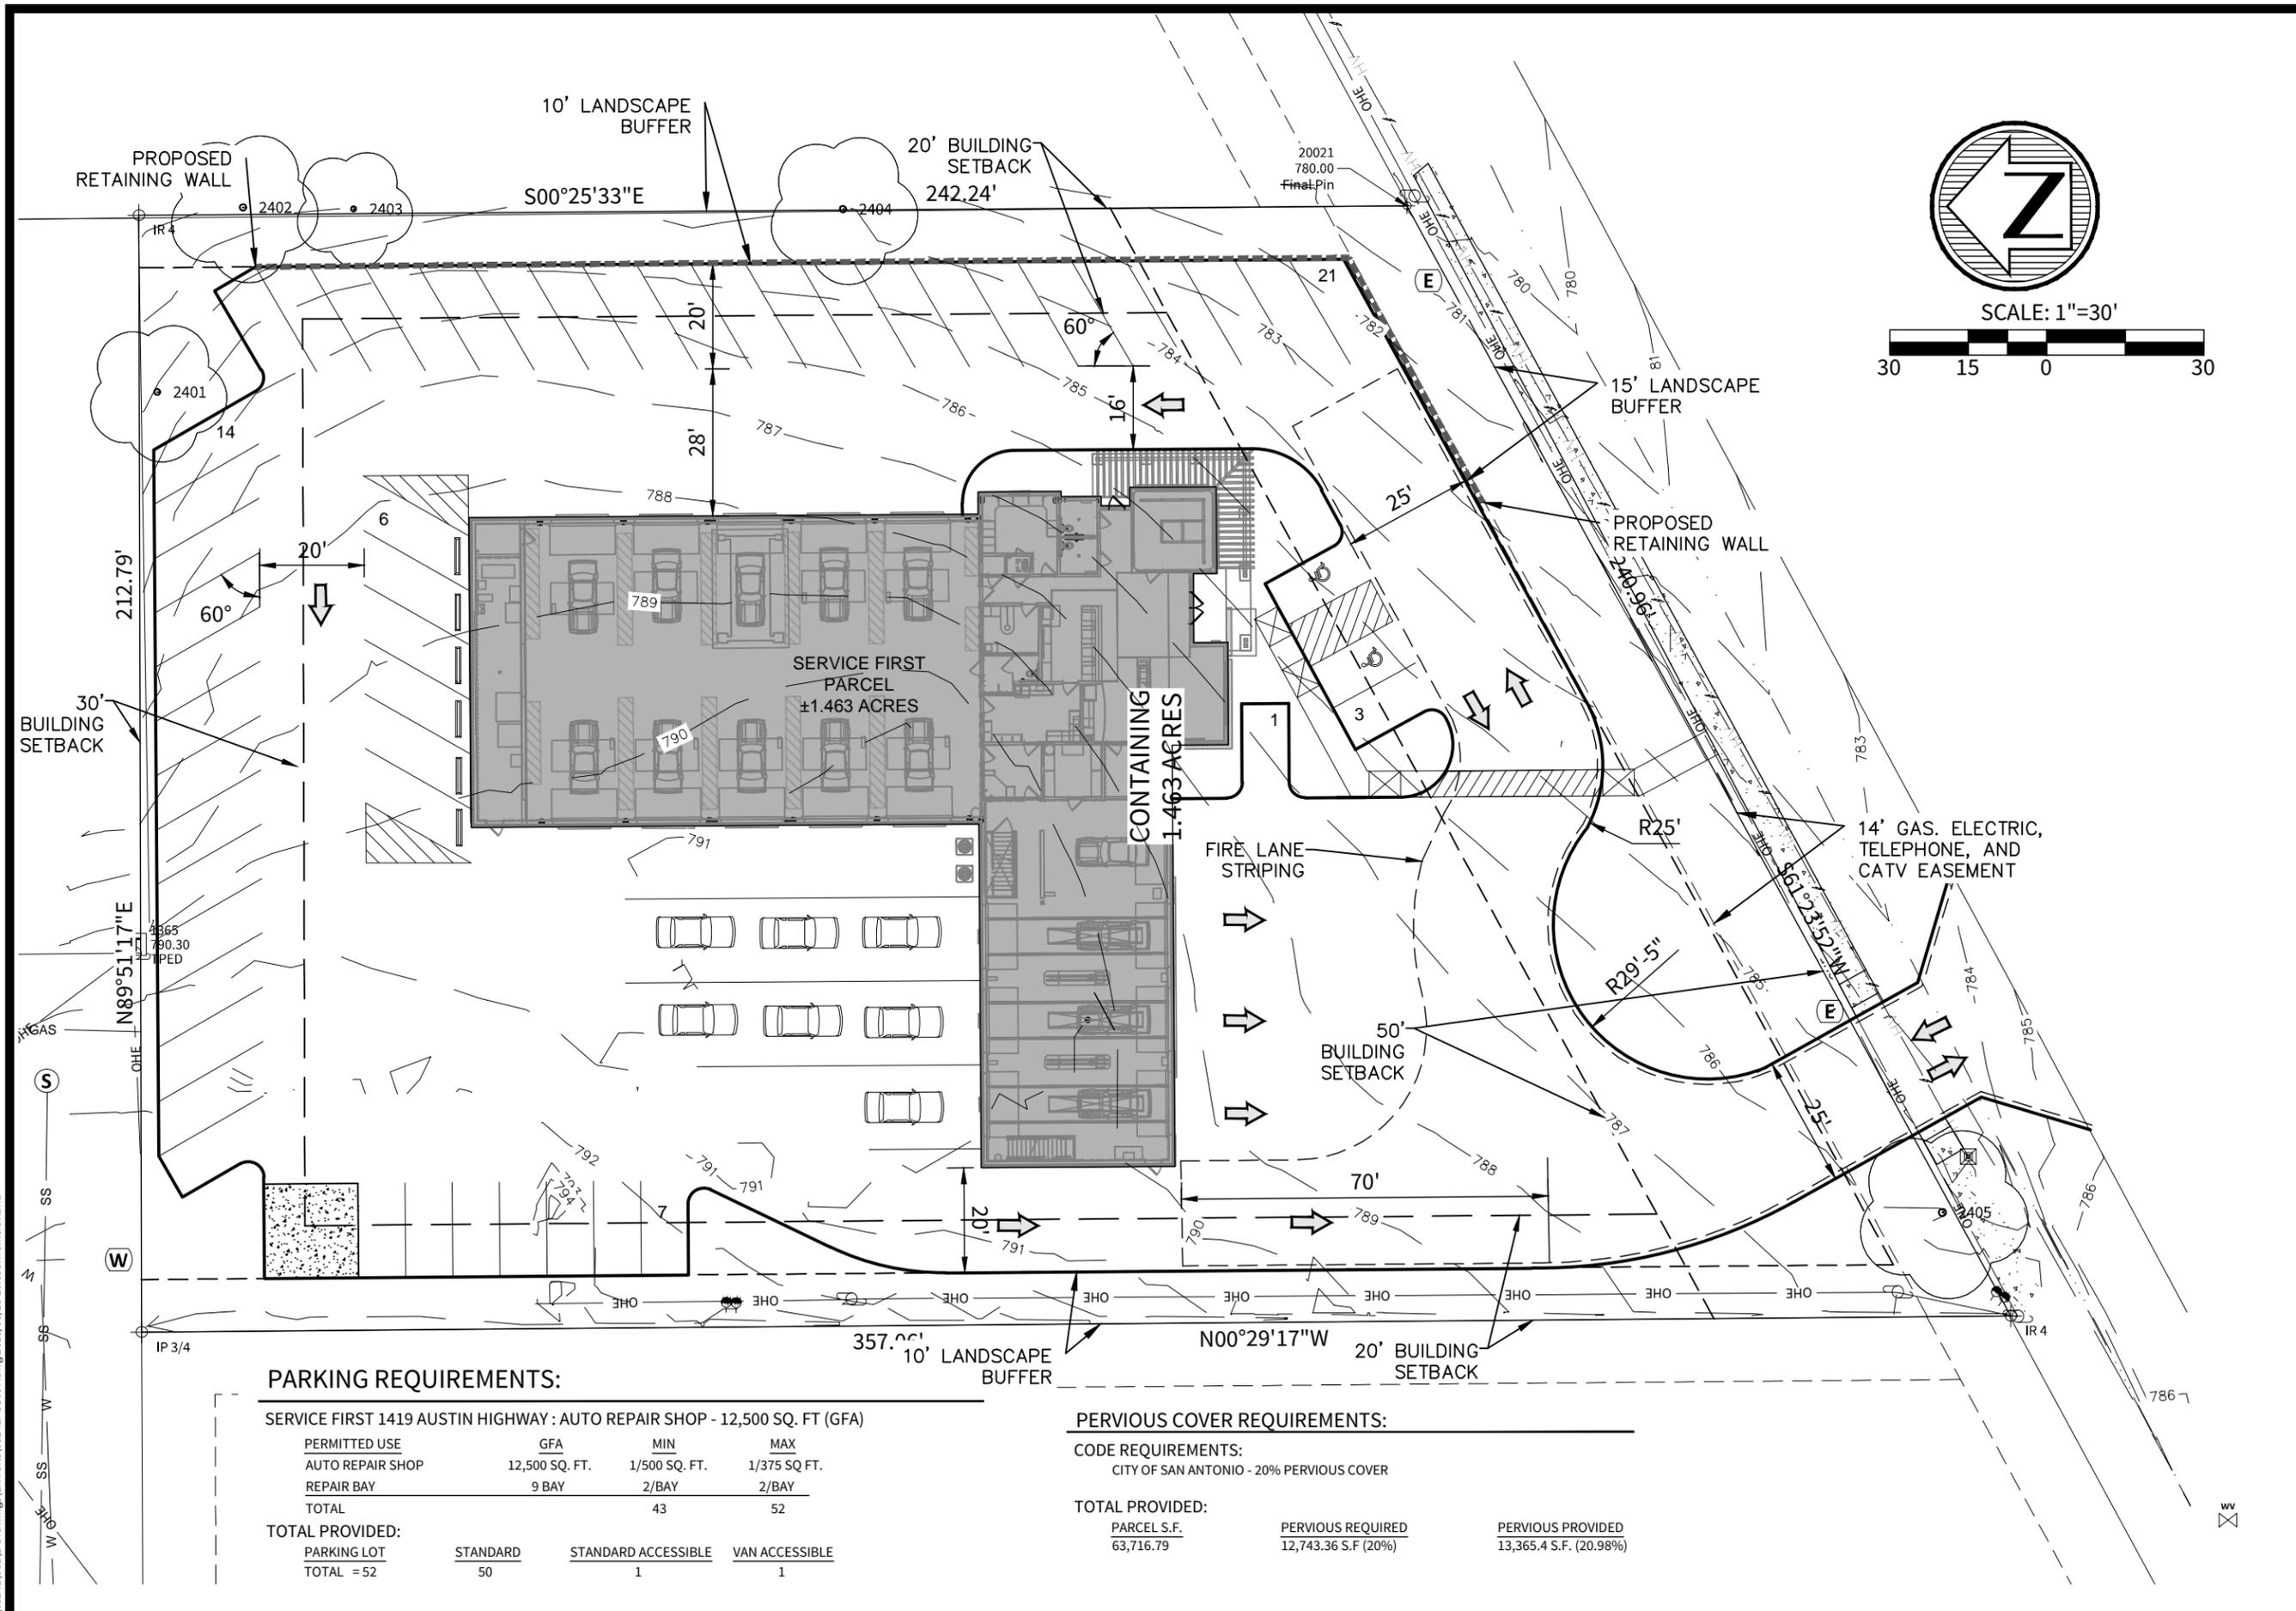
SERVICE FIRST 1419 AUSTIN HIGHWAY : AUTO REPAIR SHOP - 12,500 SQ. FT (GFA)

PERMITTED USE	GFA	MIN	MAX
AUTO REPAIR SHOP	12,500 SQ. FT.	1/500 SQ. FT.	1/375 SQ. FT.
REPAIR BAY	9 BAY	2/BAY	2/BAY
TOTAL		43	52

TOTAL PROVIDED:	STANDARD	STANDARD ACCESSIBLE	VAN ACCESSIBLE
PARKING LOT			
TOTAL = 52	50	1	1

CODE REQUIREMENTS:
CITY OF SAN ANTONIO - 20% PERVIOUS COVER

TOTAL PROVIDED:	PERVIOUS REQUIRED	PERVIOUS PROVIDED
PARCEL S.F. 63,716.79	12,743.36 S.F (20%)	13,365.4 S.F. (20.98%)
