HISTORIC AND DESIGN REVIEW COMMISSION

HDRC CASE NO: 2016-150
ADDRESS: 334 W ELSMERE PLACE
LEGAL DESCRIPTION: NCB 3967 BLK 2 LOT E 25 FT OF 3 & W 25FT OF 4
ZONING: R5 H
CITY COUNCIL DIST.: 1
DISTRICT: Monte Vista Historic District
APPLICANT: David McKay/Painting N More
OWNER: Peter Krulevitch
TYPE OF WORK: Reroofing and roof form change
REQUEST:

1. Remove larger gable roof line and leave existing rounded gable over porch.
2. Replace an asbestos shingle roof with a 24 gauge galvalume standing seam metal roof with 18 inch panels.

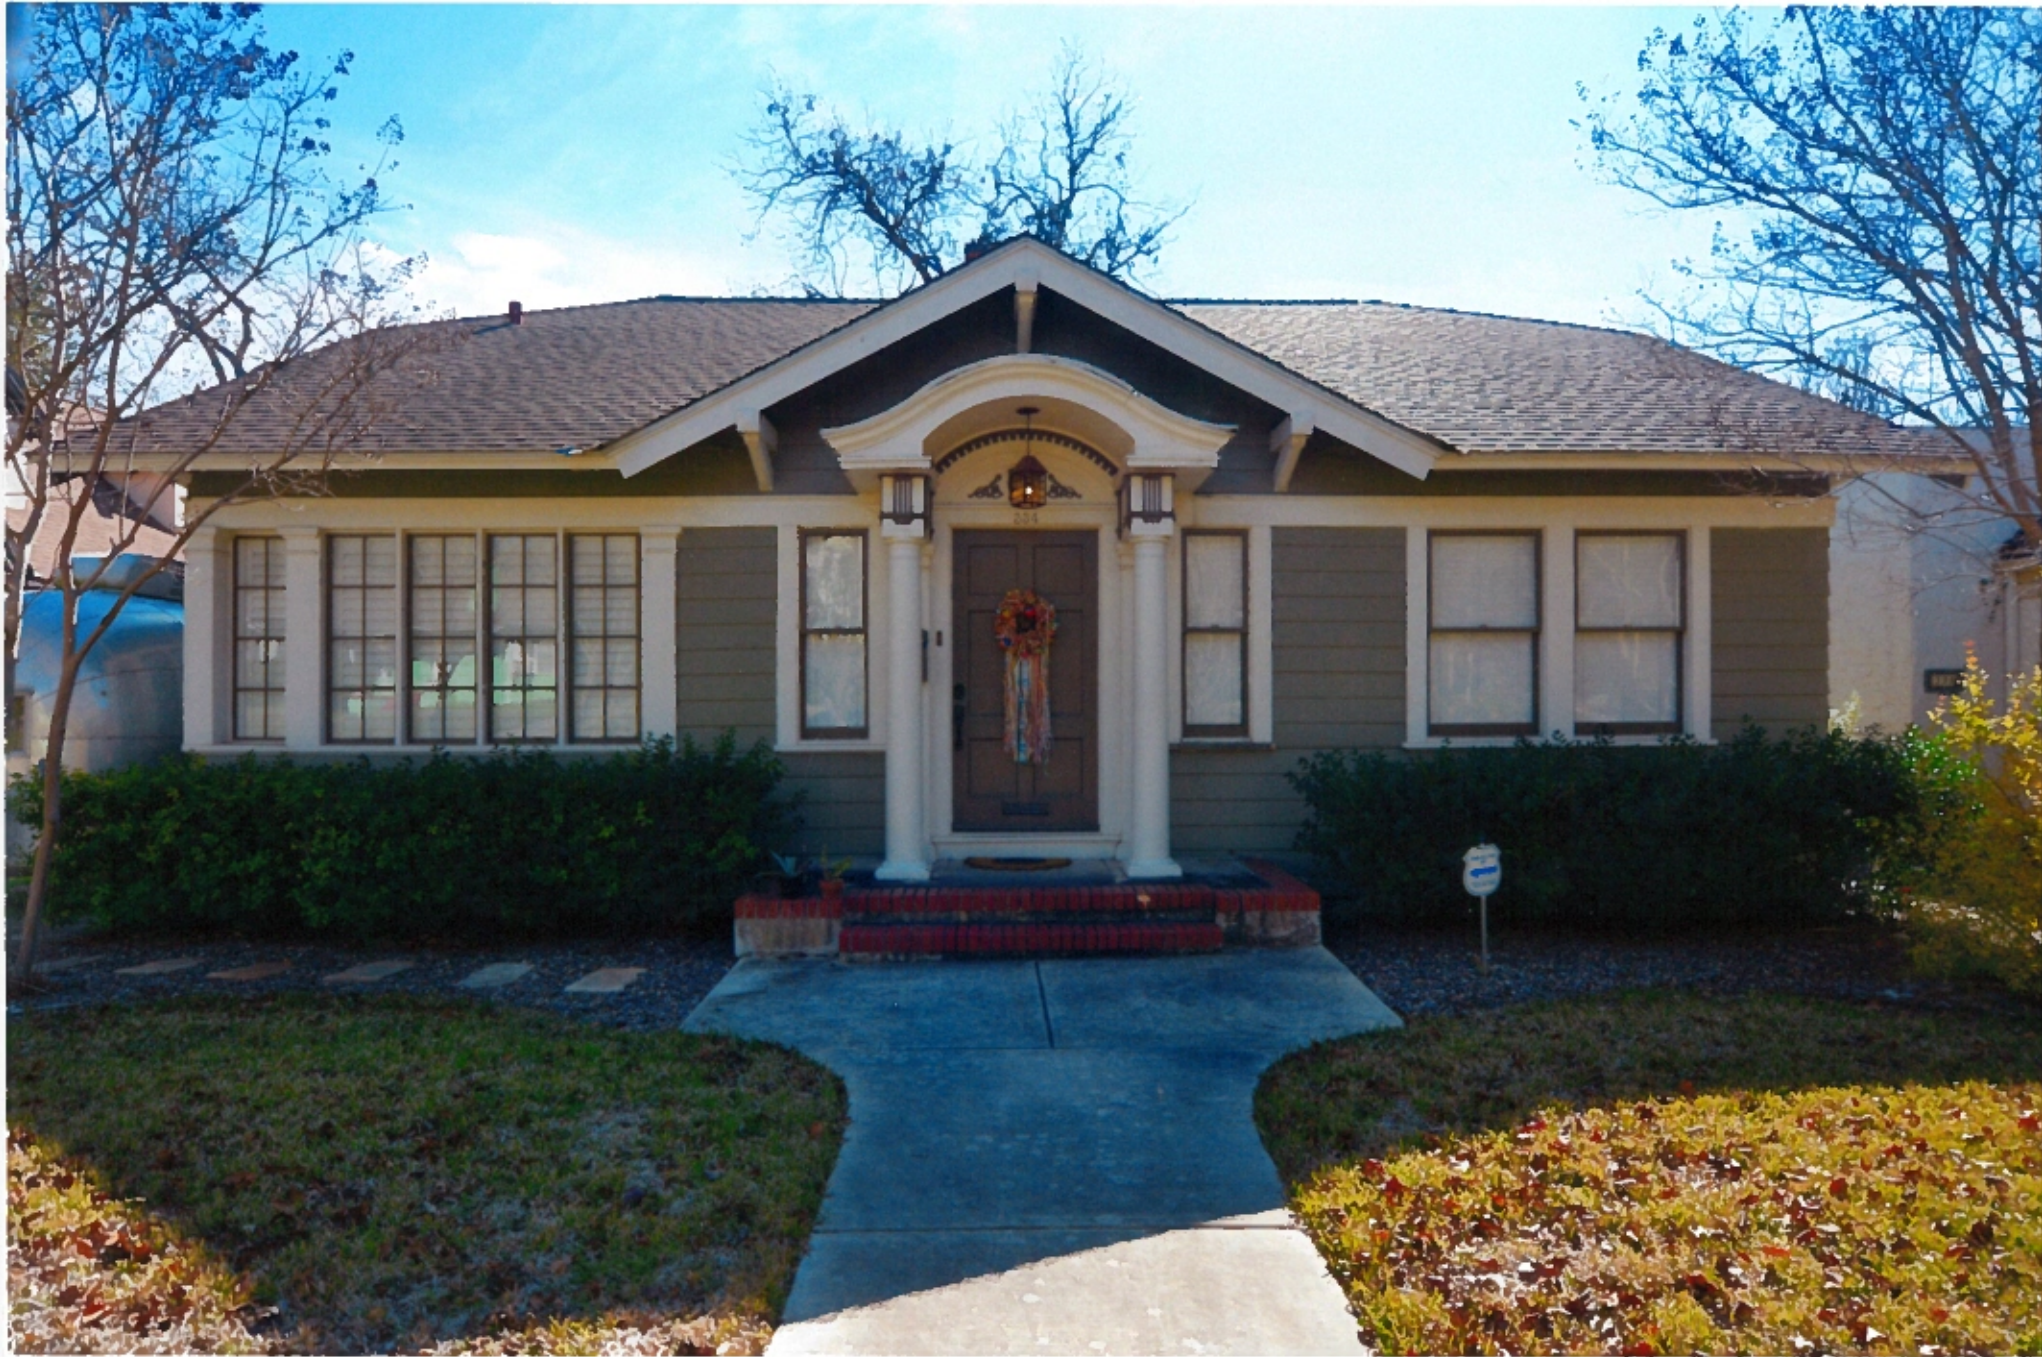
334 W Elsmere Pl - existing

- a. The structure at 334 W Elsmere Place is craftsman style one story home, with an asphalt shingle roof. The configuration at the entrance includes a gable over a brow arch supported by columns.

- b. The applicant is proposing to remove the gable and continue existing roof slope to meet the bow. According to the Guidelines for Exterior Maintenance and Alterations 3.B.ii., historic roof forms should be preserved. Staff made a site visit on April 12, 2016, and found that roof form change would be appropriate for the craftsman architecture style of the home, and that there are other homes on the block with similar roof forms. Staff finds the applicant's proposal appropriate and consistent with the Guidelines.

Staff recommends approval of item #1 based on findings a and b. Staff does not recommend approval of item #2 based on finding c. If the HDRC approves the request to install a standing seam metal roof, staff recommends that it's approved with stipulations that the applicant ensure seams are one to two inches, use a a crimped ridge seam, and use a low-profile ridge cap with no ridge cap vent or end cap.

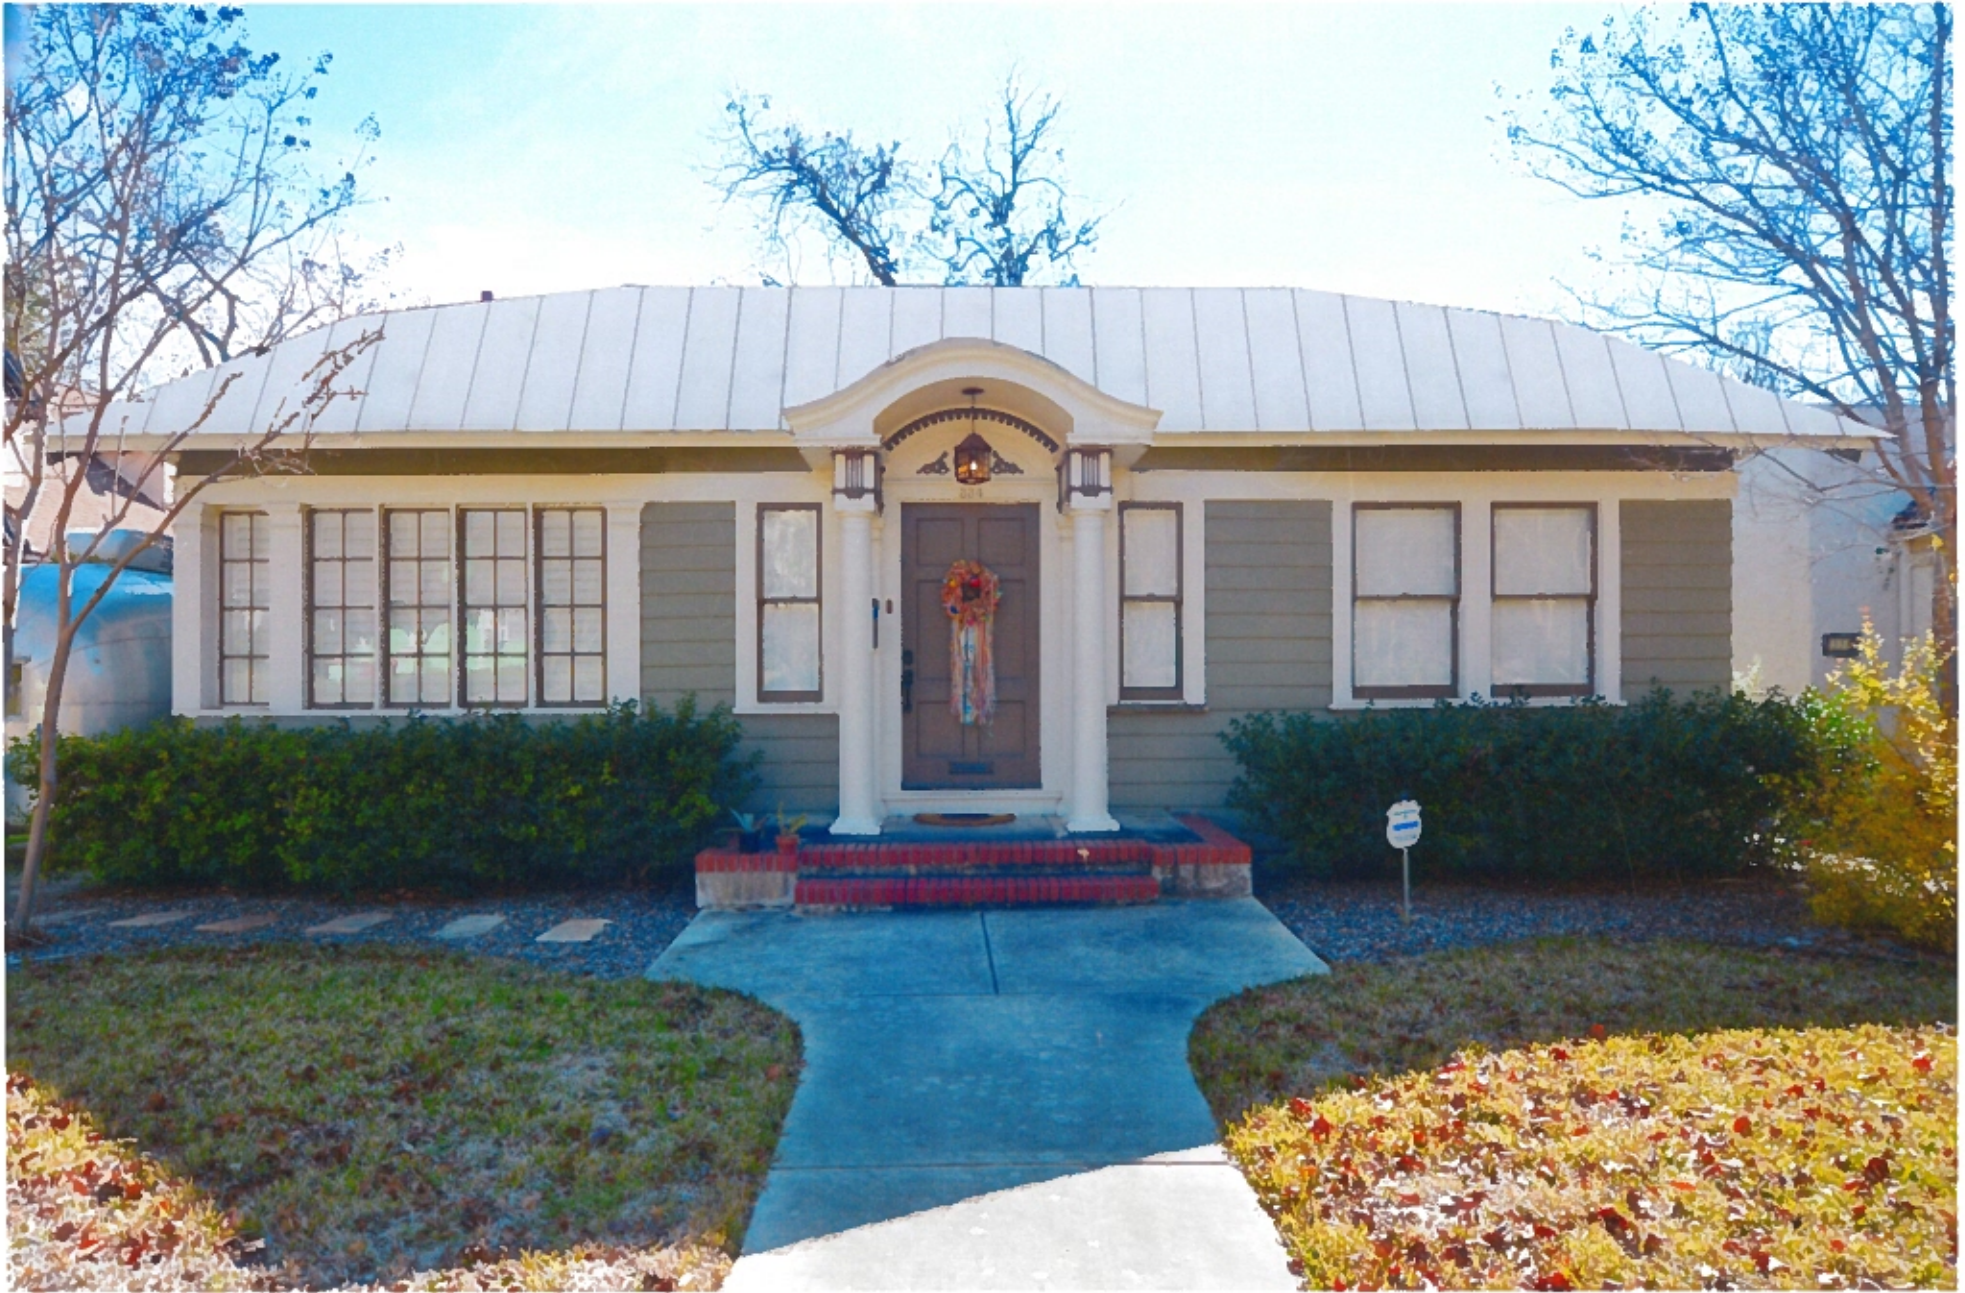
334 W Elsmere - proposed

- d. The applicant is proposing to install a standing seam metal roof on the main structure at 334 W Elsmere Place to feature the standard galvalume color and 18 inch panels. According to the Guidelines for Exterior Maintenance

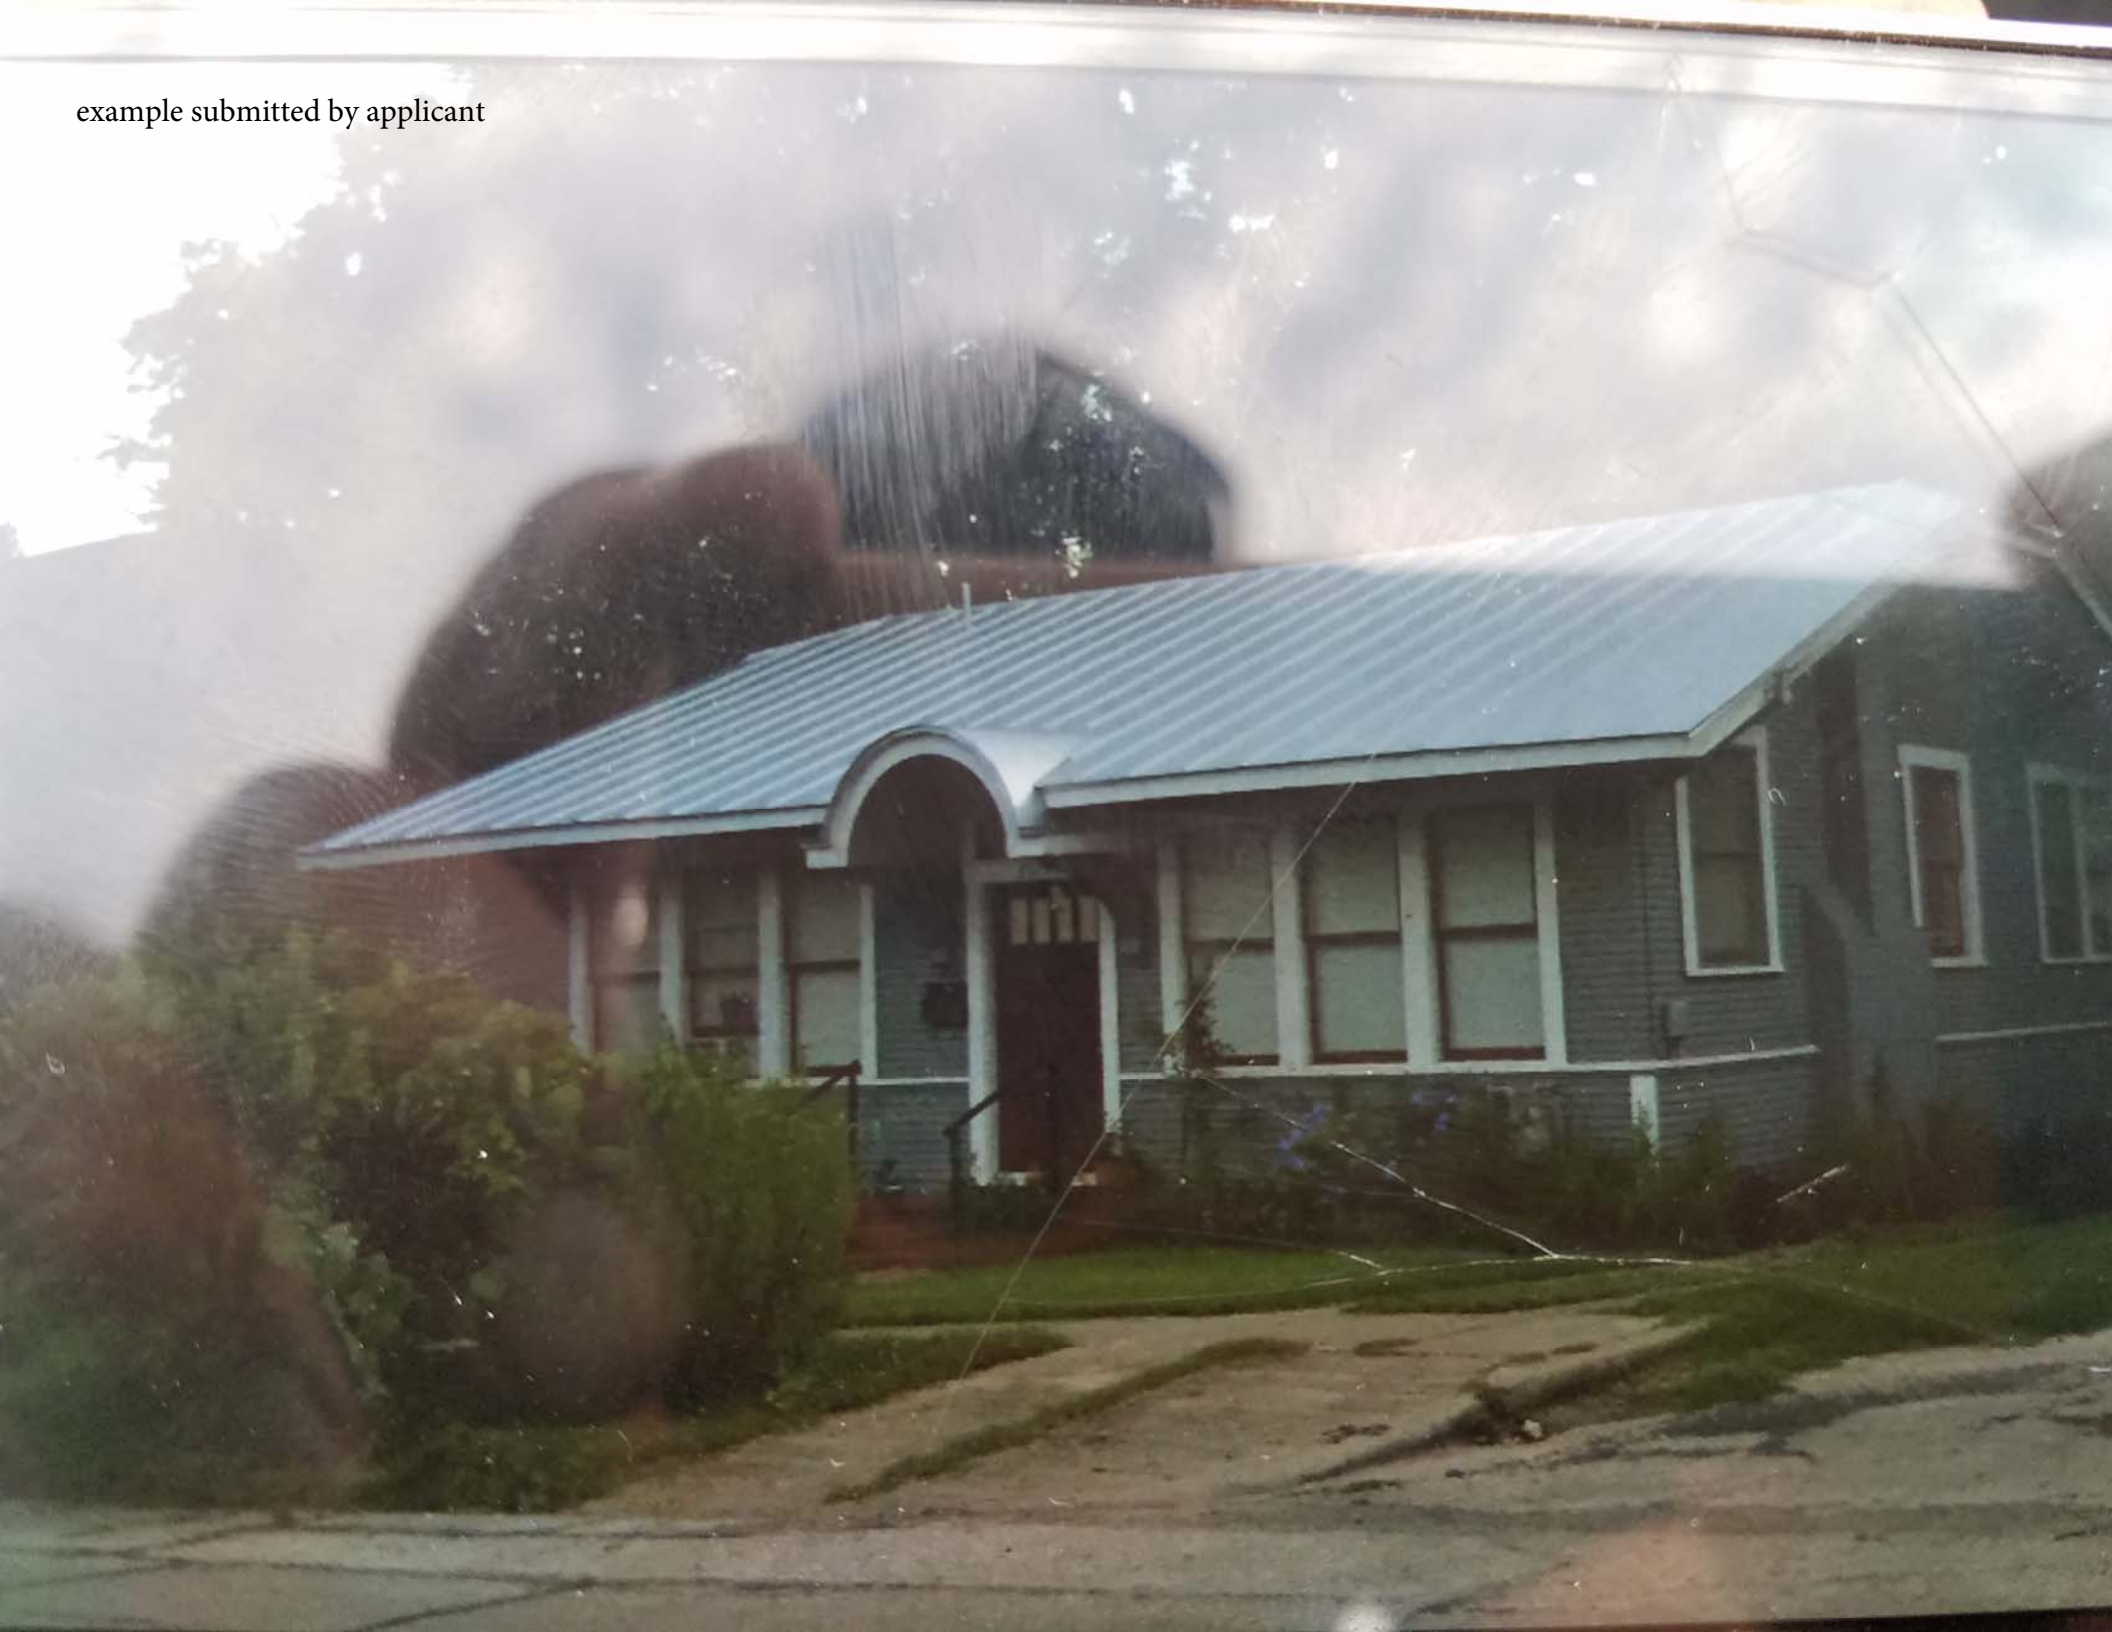
example submitted by applicant

and Alterations, metal roofs are to be used on structures that historically had metal roofs or where a metal roof is appropriate for the style or construction period. During the site visit, staff found standing seam metal roofs on craftsman style homes, but did not find the combination of this architectural style and a standing seam metal roof. The proposal is not consistent with the Guidelines.
