HISTORIC AND DESIGN REVIEW COMMISSION

HDRC CASE NO: 2016-457
ADDRESS: 721 BURLESON ST
LEGAL DESCRIPTION: NCB 1300 BLK 1 LOT 22
ZONING: R-5 CD H
CITY COUNCIL DIST.: 2
DISTRICT: Dignowity Hill Historic District
APPLICANT: Christopher Gill/CGRE Ltd Co
OWNER: Christopher Gill/CGRE Ltd Co
TYPE OF WORK: Exterior modifications, porch reconstruction, rear addition
REQUEST:

1. Rehabilitate the historic structure including the installation of a standing seam metal roof, foundation repair, siding repair and wood window repair.
2. Reconstruct the front porch.
3. Construct a rear addition.

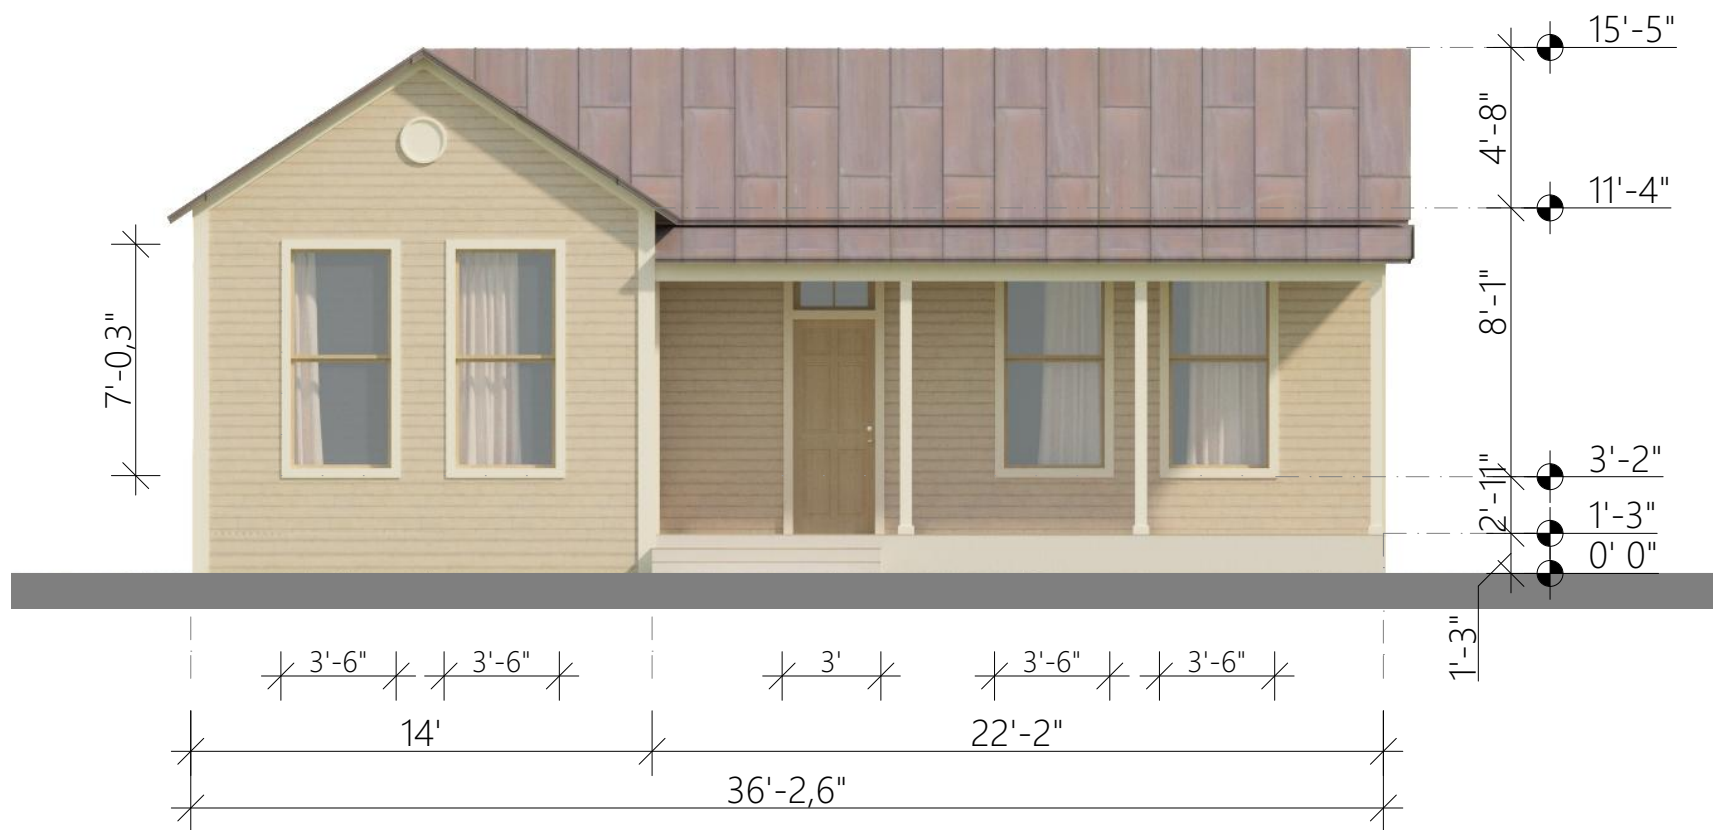
South Elevation (Front)

This house will be fully updated and rehabbed with attention being paid to historic details. The damaged front porch will be restored to it's original facade with period appropriate materials used. i.e. metal roofing, square columns, wood porch floor, etc.

The front porch will extend to the end of patio matching the original profile, size, pitch, etc.

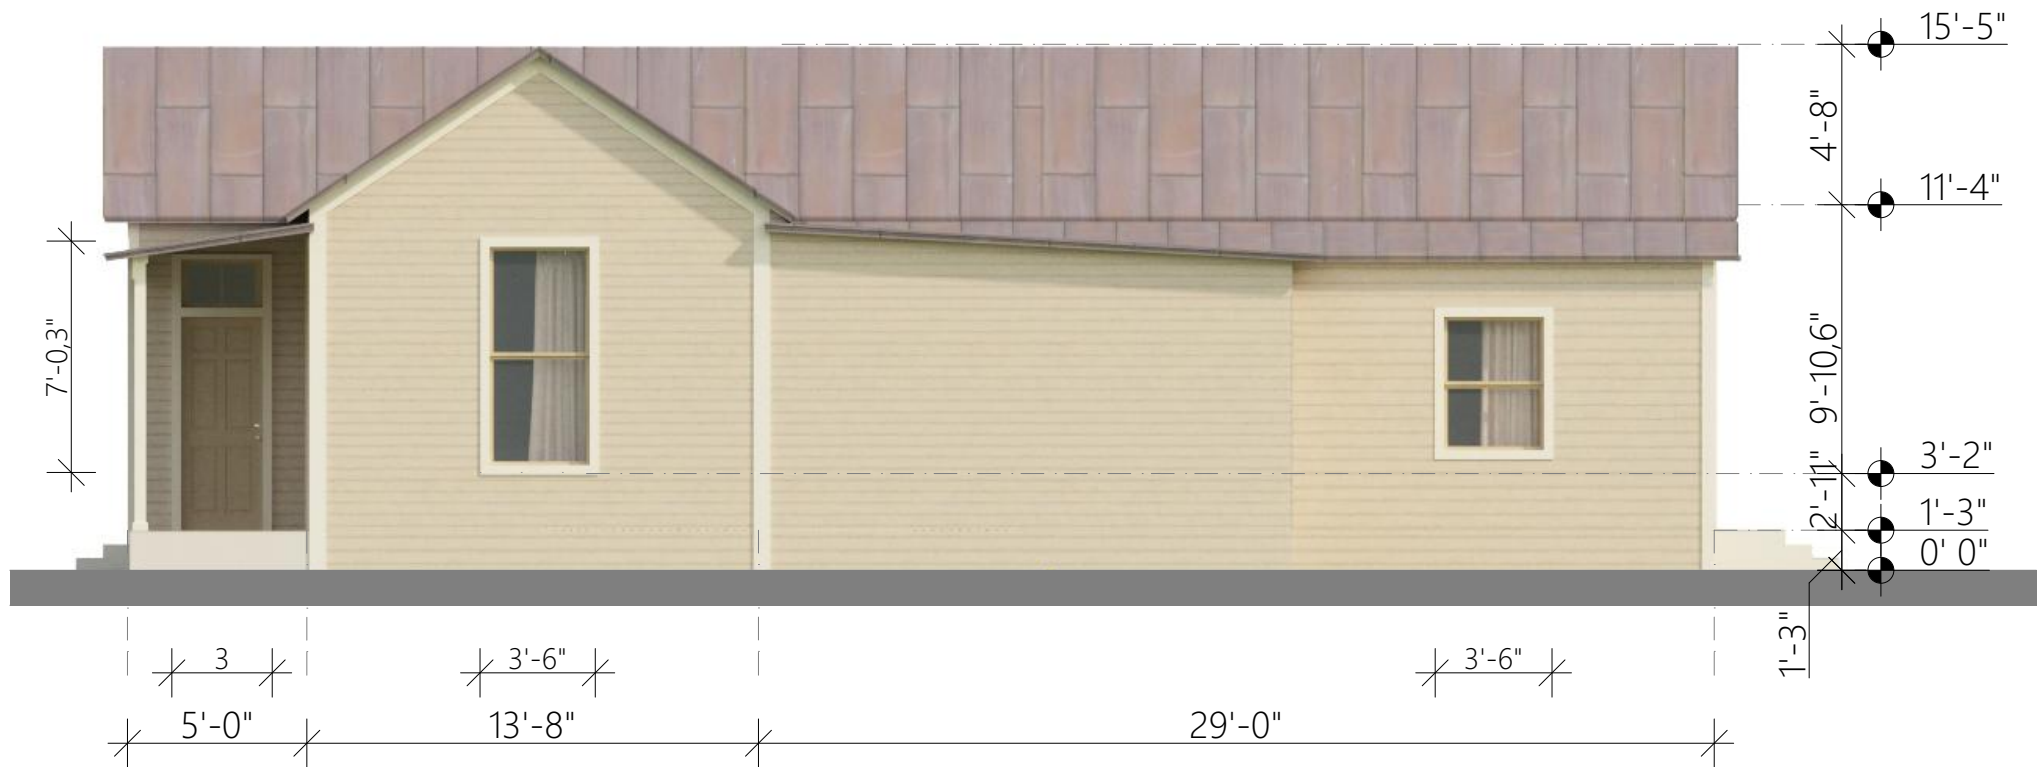
East Elevation (Right)

An addition to the back of the house will be added. The roofline will be matched and materials that are in the existing house will be used on the addition. (additional wood siding, period appropriate back door, cedar shingles under the back eave, etc.)

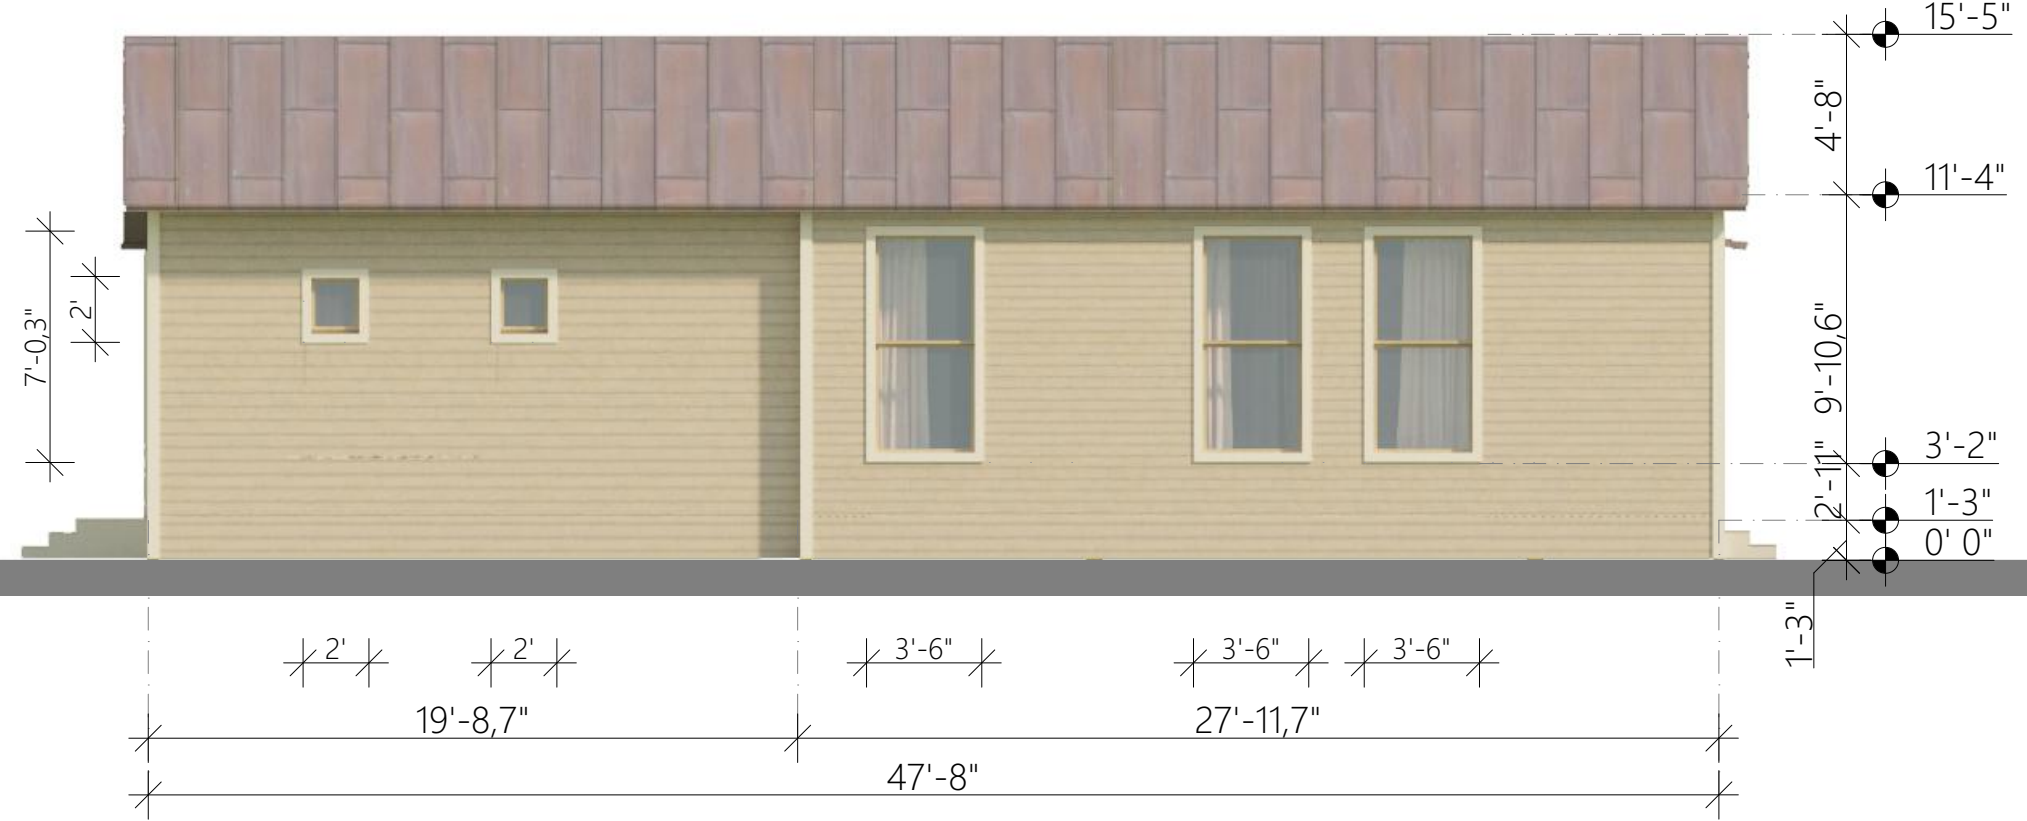
West Elevation (Left)

The original structure and addition are set back about 7' from the property line on each side of the house.

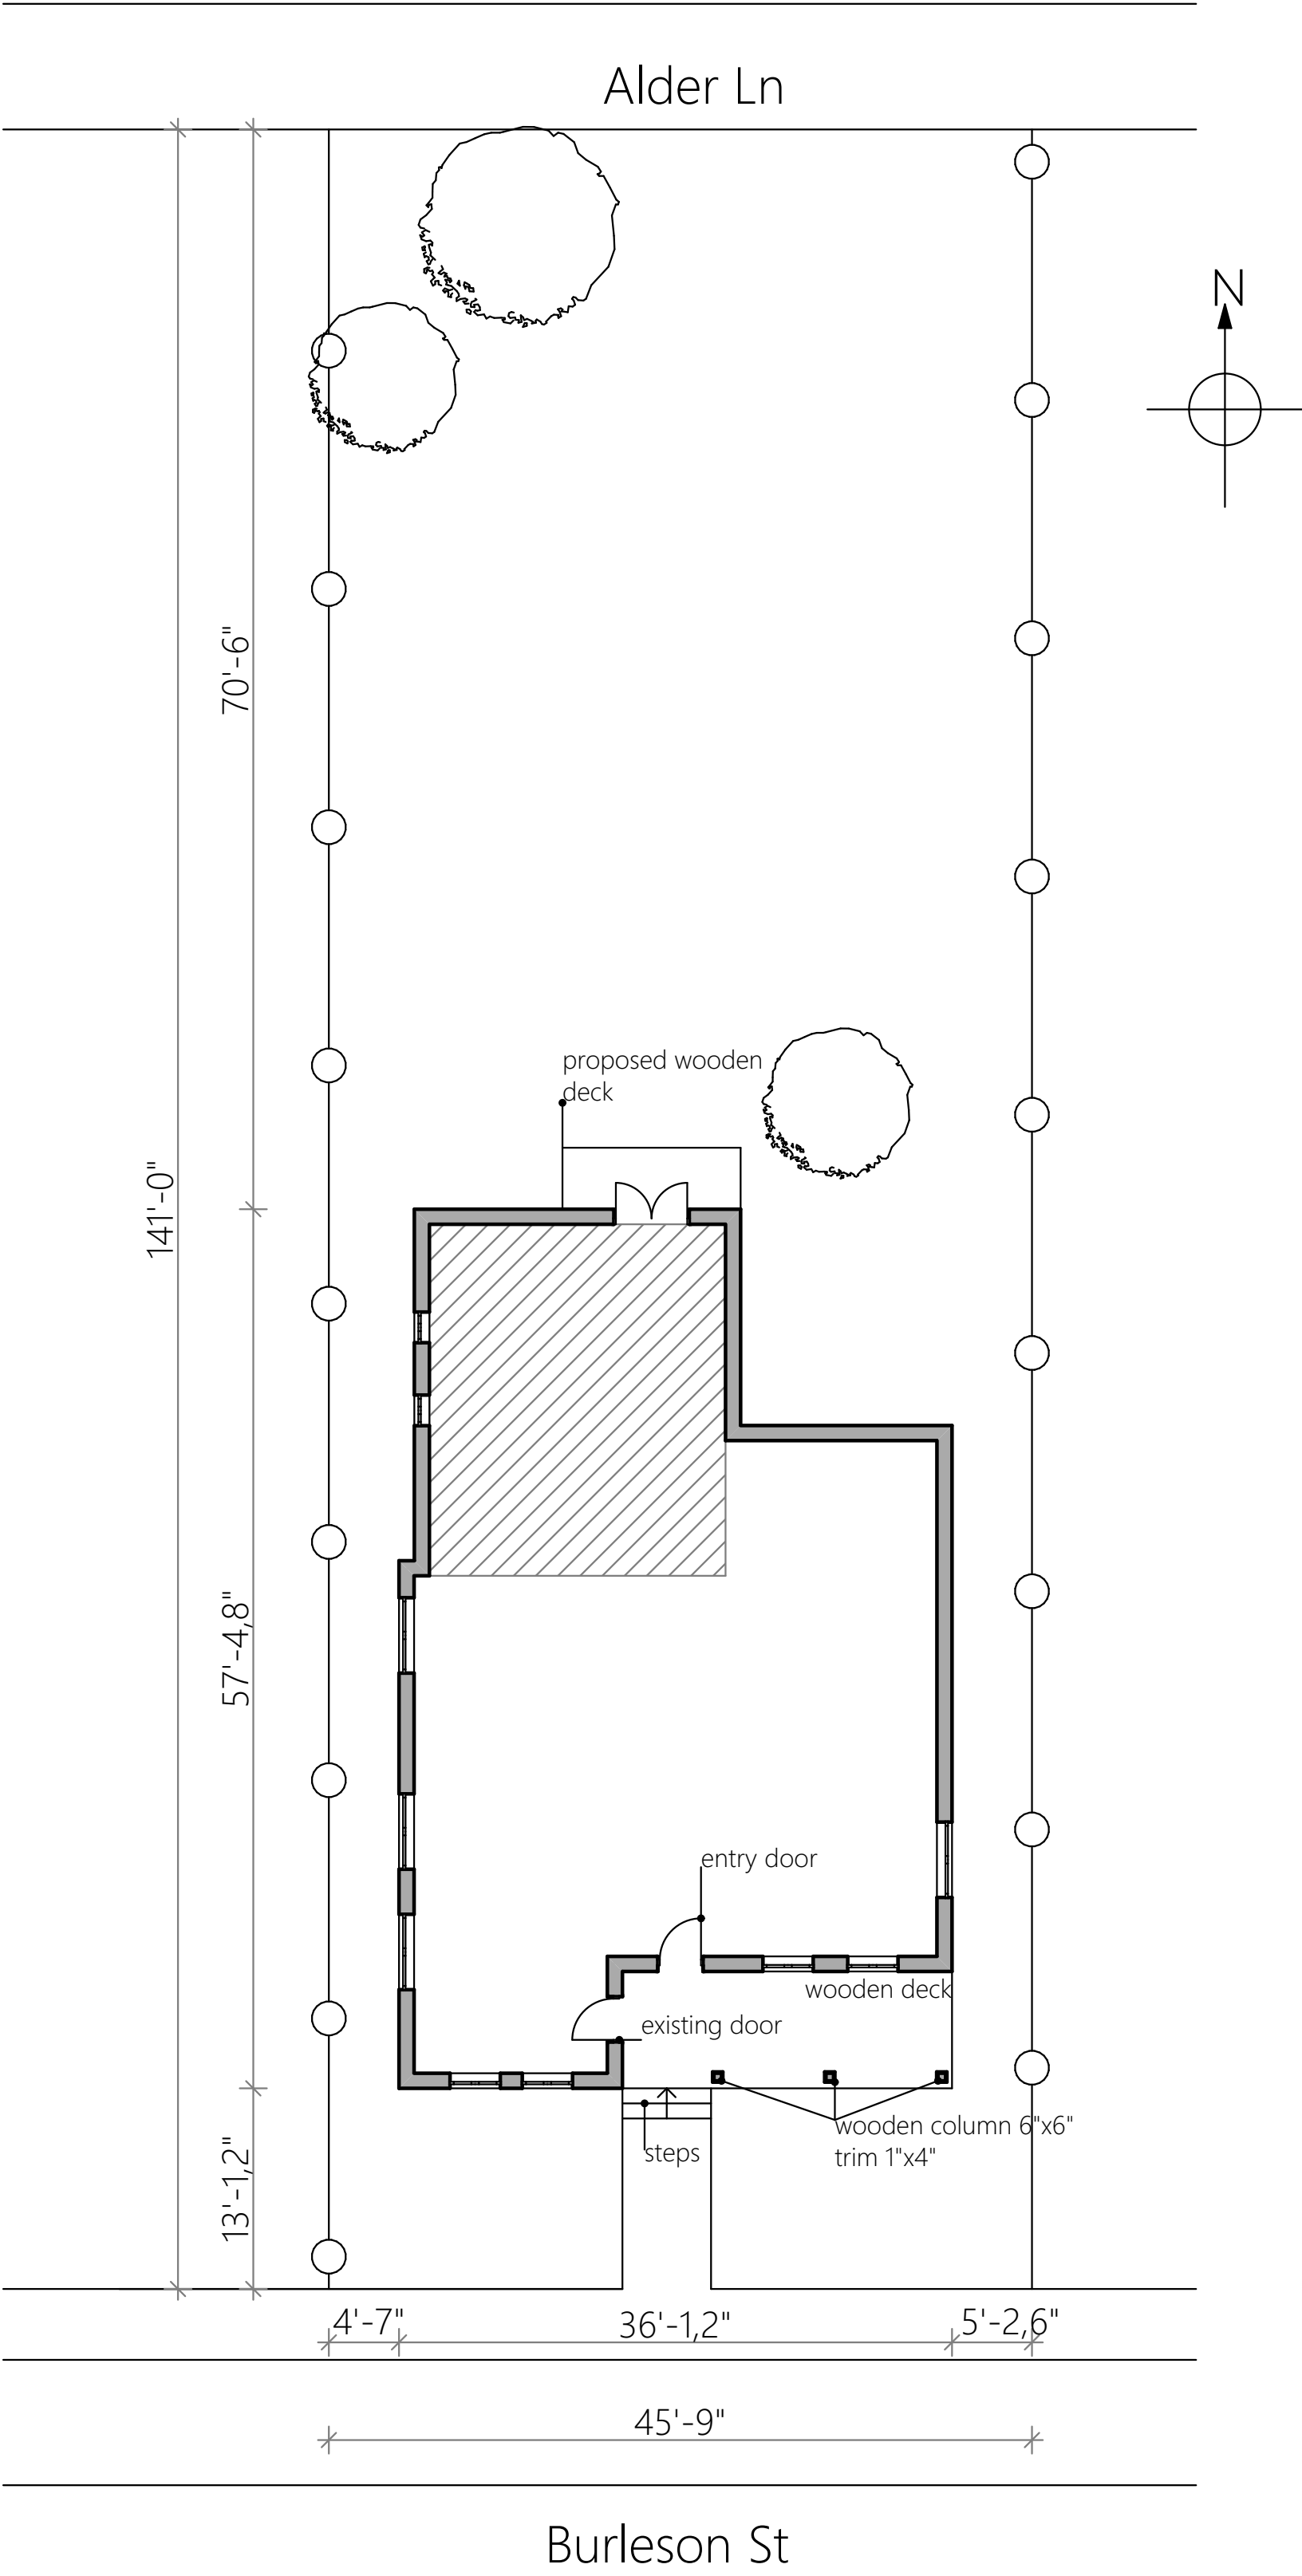
PROPOSED SITE/FLOOR PLAN
Scale 1" = 10'-0"

- i. **ADDITION** – At the rear of the primary historic structure, the applicant has proposed to construct a rear addition of approximately 480 square feet. The Guidelines for Additions 1.A. states that additions should be sited to minimize visual impact from the public right of way, should be designed to be in keeping with the historic context of the block, should utilize a similar roof form and should feature a transition between the old and the new. The applicant has proposed for the addition to include a rear gable roof and has proposed an inset and siding change for the addition. This is consistent with the Guidelines.

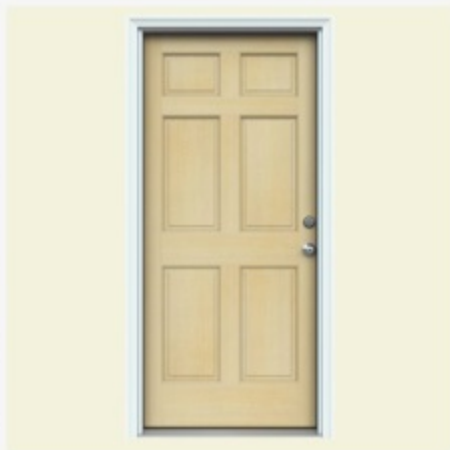
32 in. x 80 in. Authentic Wood 6-Panel
Unfinished Fir Prehung Front Door w/
Primed White AuraLast Jamb &
Brickmould

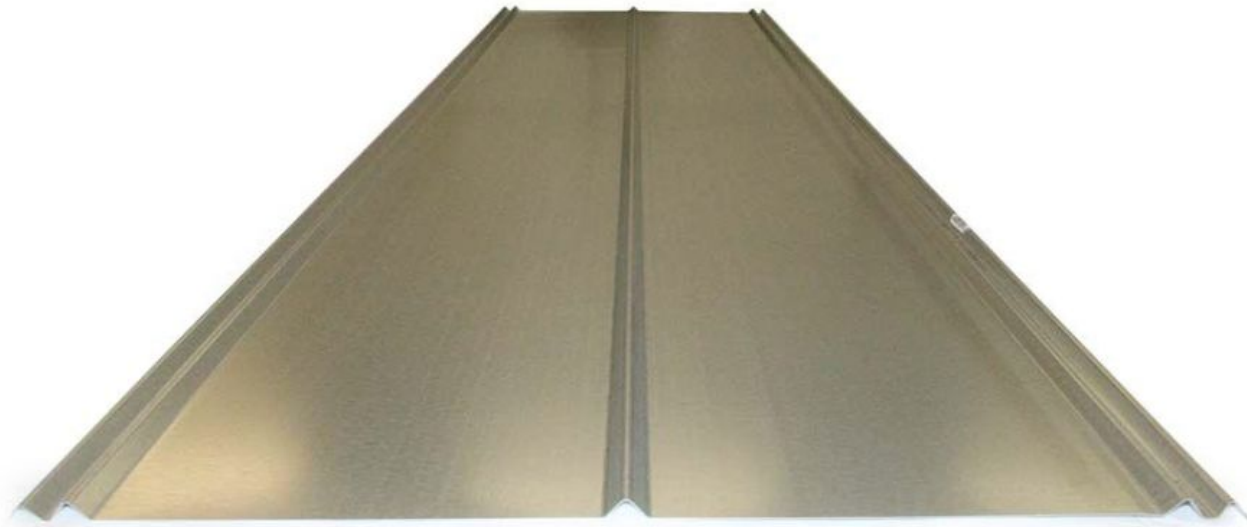
12 ft. Galvanized Steel 5V Crimp Roofing Panel

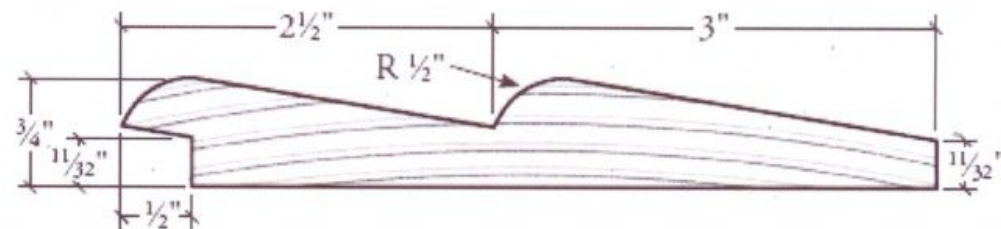
2 - LAP

PATTERN #	NOM. SIZE	NET WIDTH	NET THICK	LENGTHS
430	1x6	5 1/2"	3/4"	16' & 20'

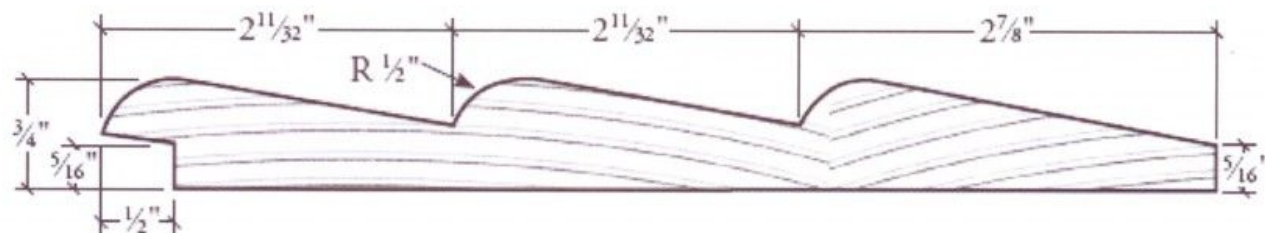
3 - LAP

PATTERN #	NOM. SIZE	NET WIDTH	NET THICK	LENGTHS
432	1x8	7 1/2"	3/4"	16' & 20'

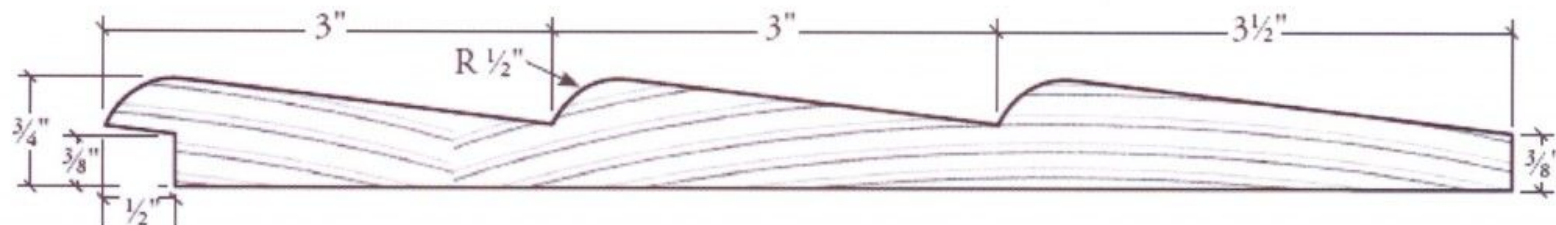
PATTERN #	NOM. SIZE	NET WIDTH	NET THICK	LENGTHS
433	1x10	9 1/2"	3/4"	16' & 20'
