HISTORIC AND DESIGN REVIEW COMMISSION September 06, 2017

HDRC CASE NO: 2017-372 ADDRESS: 609 HAYS ST

TYPE OF WORK: Historic Tax Certification

The applicant is requesting Historic Tax Certification for the property at 609 Hays.

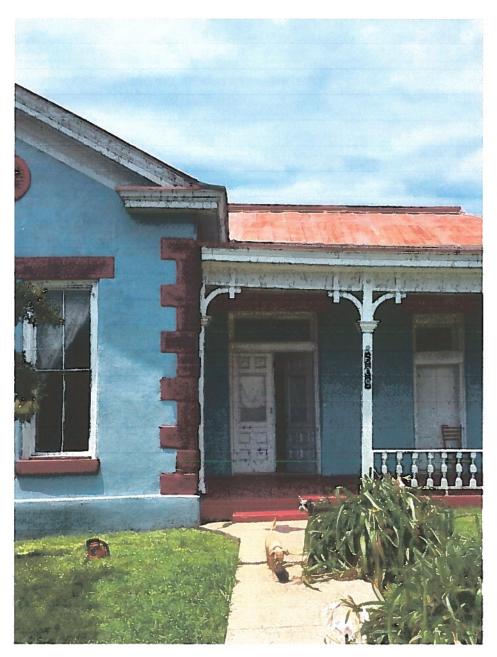
Exterior Photos

Example of existing exterior cement stucco finish (ca. 1960s) and painted stone lintels, sills, and cornerstones.

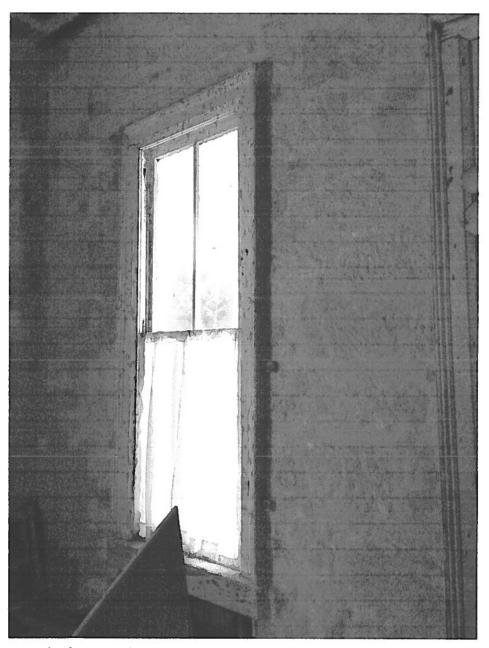
Photos - Recent Masonry Restoration

Example of structural masonry: exposed, repointed. Window re-leveled by Baltazar Espinosa, August 2016.
