## HISTORIC AND DESIGN REVIEW COMMISSION

**HDRC CASE NO:** 2017-595  
**ADDRESS:** 205 OSTROM  
**LEGAL DESCRIPTION:** NCB 6938 BLK LOT 1&2  
**ZONING:** R-4 CD, H, RIO-1  
**CITY COUNCIL DIST.:** 1  
**DISTRICT:** River Road Historic District  
**APPLICANT:** Tobias Stapleton  
**OWNER:** Tobias Stapleton  
**TYPE OF WORK:** Construction of a two story, rear accessory structure and rehabilitation of the historic structure  
**APPLICATION RECEIVED:** November 3, 2017  
**60-DAY REVIEW:** January 2, 2017  
**REQUEST:**

The applicant is requesting conceptual approval to construct a two story, rear accessory structure. The existing, one-story historic structure on the property will be retained and rehabilitation plans will be submitted at a future date.

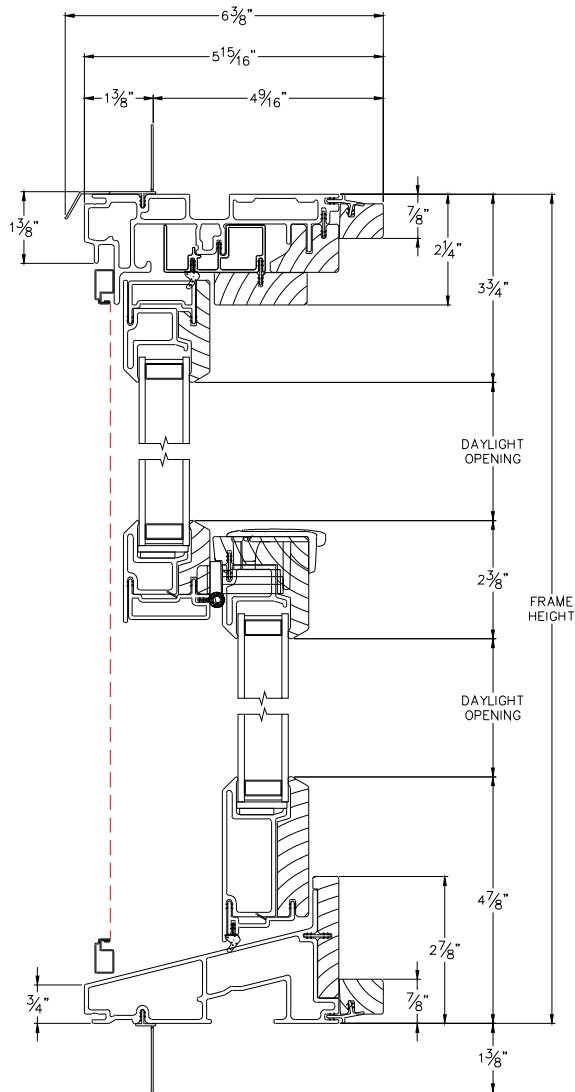
## Essence Double Hung Window 1 3/8" Fin Setback, 4 9/16" Wall Condition

# DOUBLE HUNG SERIES 9200

- i. That the applicant install wood or aluminum clad wood windows should be installed that feature meeting rails that are no taller than 1.25” and stiles no wider than 2.25”. White manufacturer’s color is not allowed, and color

selection must be presented to staff. There should be a minimum of two inches in depth between the front face of the window trim and the front face of the top window sash. This must be accomplished by recessing the window sufficiently within the opening or with the installation of additional window trim to add thickness. Window trim must feature traditional dimensions and an architecturally appropriate sill detail. Window track components must be painted to match the window trim or concealed by a wood window screen set within the opening.

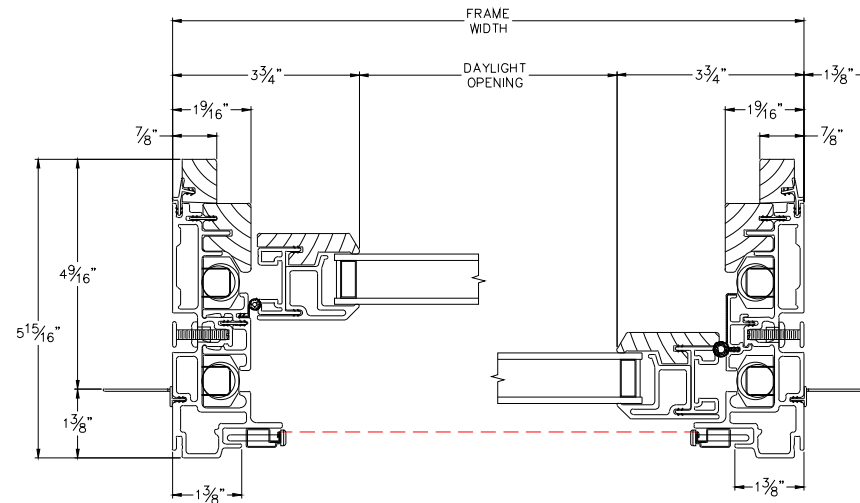
## HEAD & SILL

***We are proposing this style windows that are inline with the HDRC window guidelines for new construction, These windows have been used in the following locations within Historic Districts with no objection.***  
***Howl & Moon on the River Walk***  
***111 W Crockett St, San Antonio, Tx 78205***

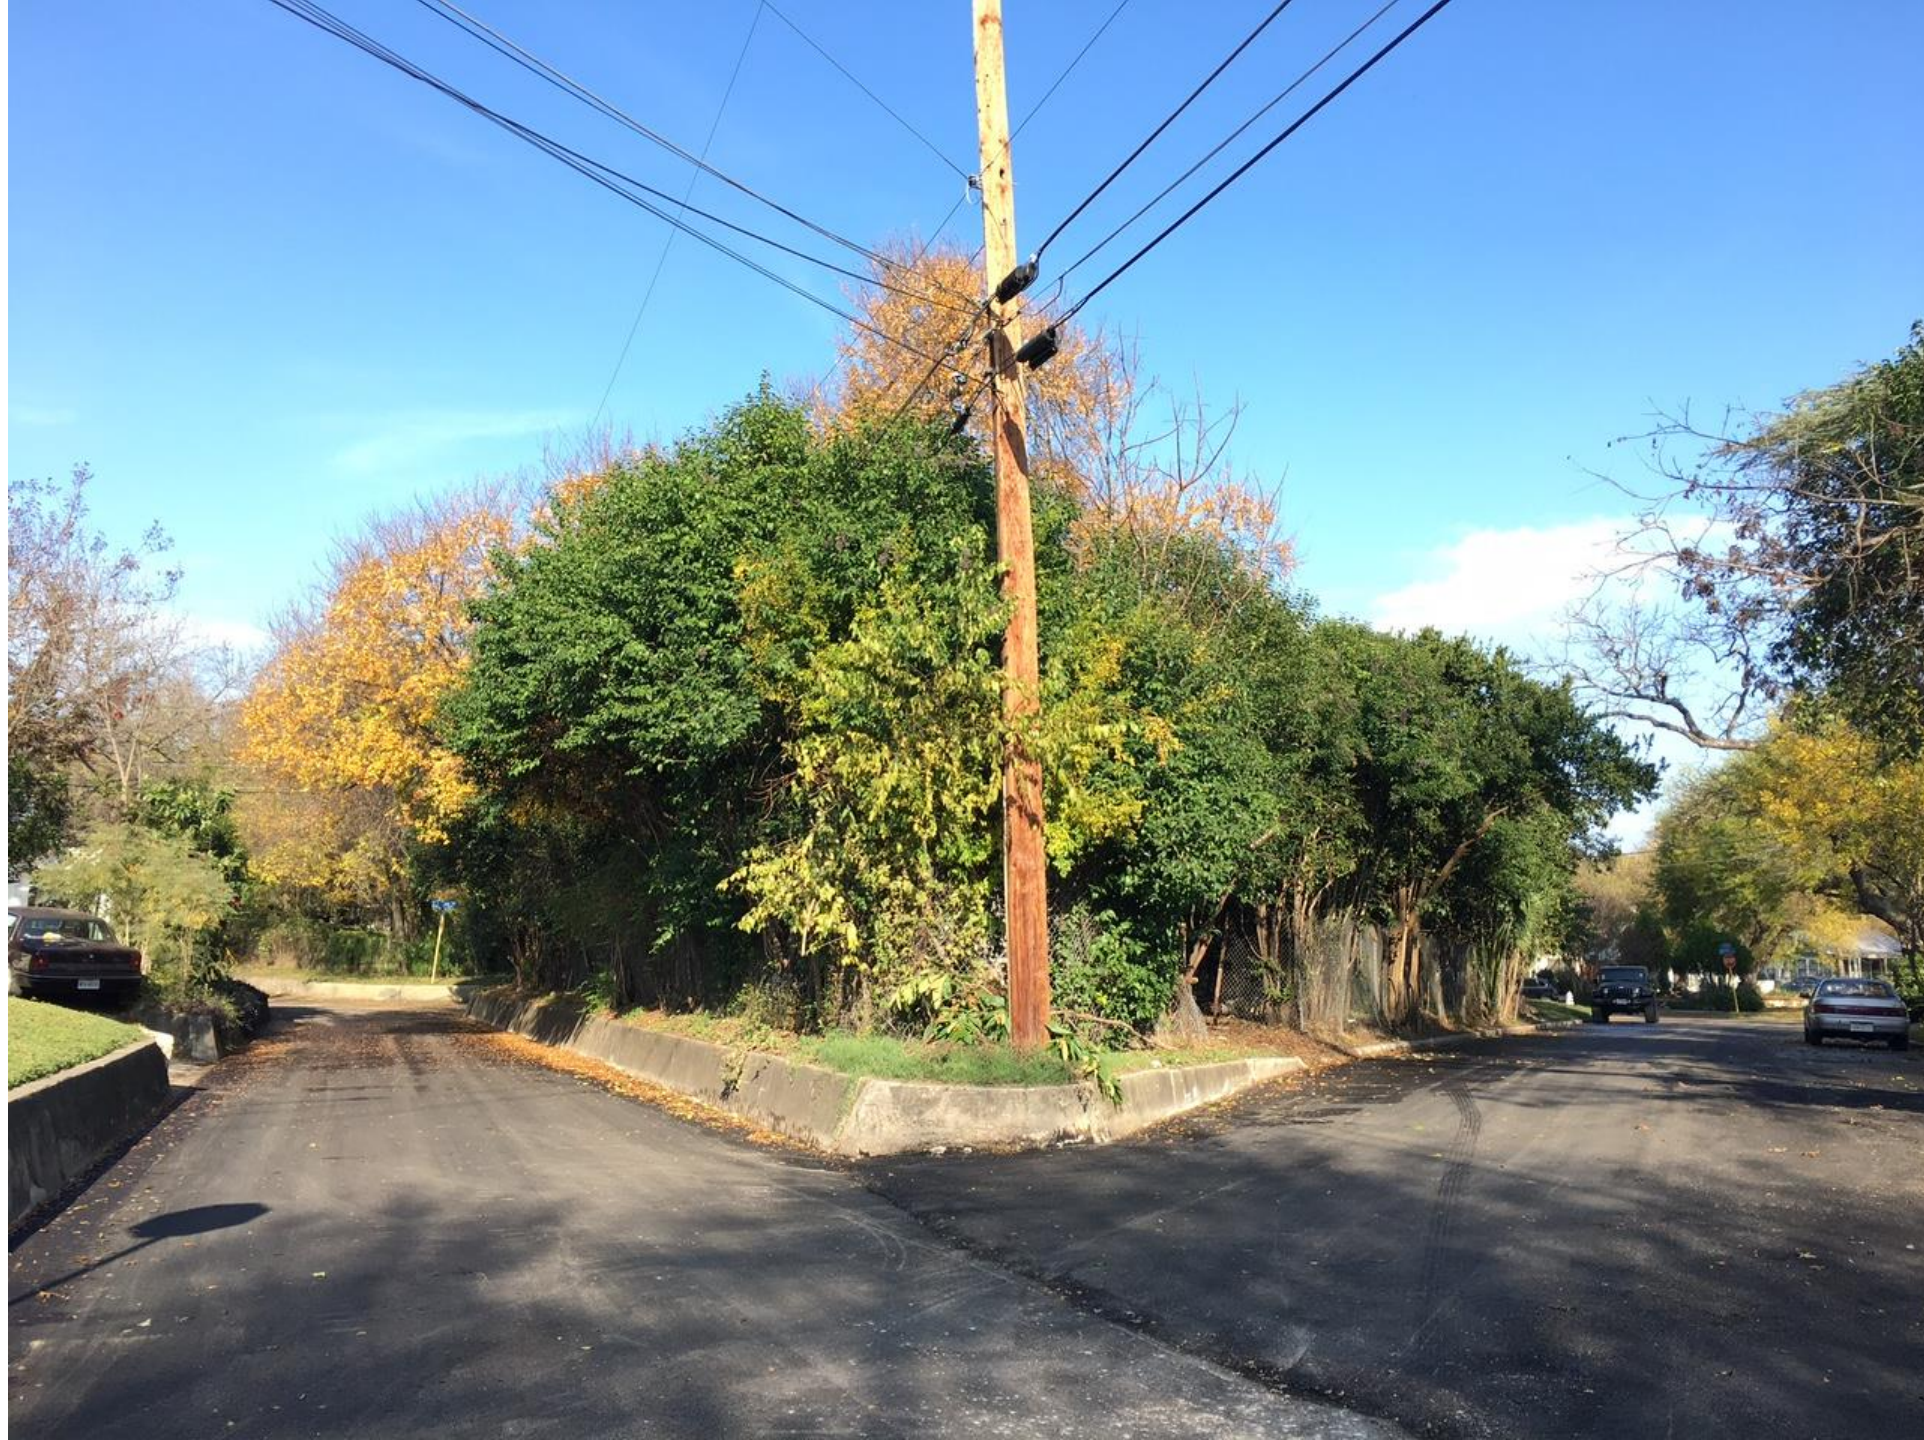
205 Ostrom Drive  
Photo from Ostrom &  
Dewberry Intersection

Accessory Building would be located  
behind this corner.

- h. **LOT LAYOUT** – The lot at 205 Ostrom features an irregular shape and layout, inconsistent with the primary development pattern found in the district. The applicant has proposed to locate the accessory structure at the western portion of the site, to the side and rear of the primary historic structure, similar to the location of accessory structures found elsewhere in the district. While the general orientation of the accessory structure is skewed, staff finds the placement appropriate.
