HISTORIC AND DESIGN REVIEW COMMISSION

April 18, 2018

HDRC CASE NO: 2018-156
ADDRESS: 504 AUSTIN ST
LEGAL DESCRIPTION: NCB 510 BLK 2 LOT A-2
ZONING: D, HS
CITY COUNCIL DIST.: 2
LANDMARK: La Fama Bakery, Alt House, Rear House
APPLICANT: Chris Gill/CGRE LTC CO
OWNER: Chris Gill/CGRE LTC CO
TYPE OF WORK: Construction of a rear addition, construction of a rooftop addition, painting and Historic Tax Certification
APPLICATION RECEIVED: April 02, 2018
60-DAY REVIEW: June 01, 2018
REQUEST:

504 AUSTIN ST

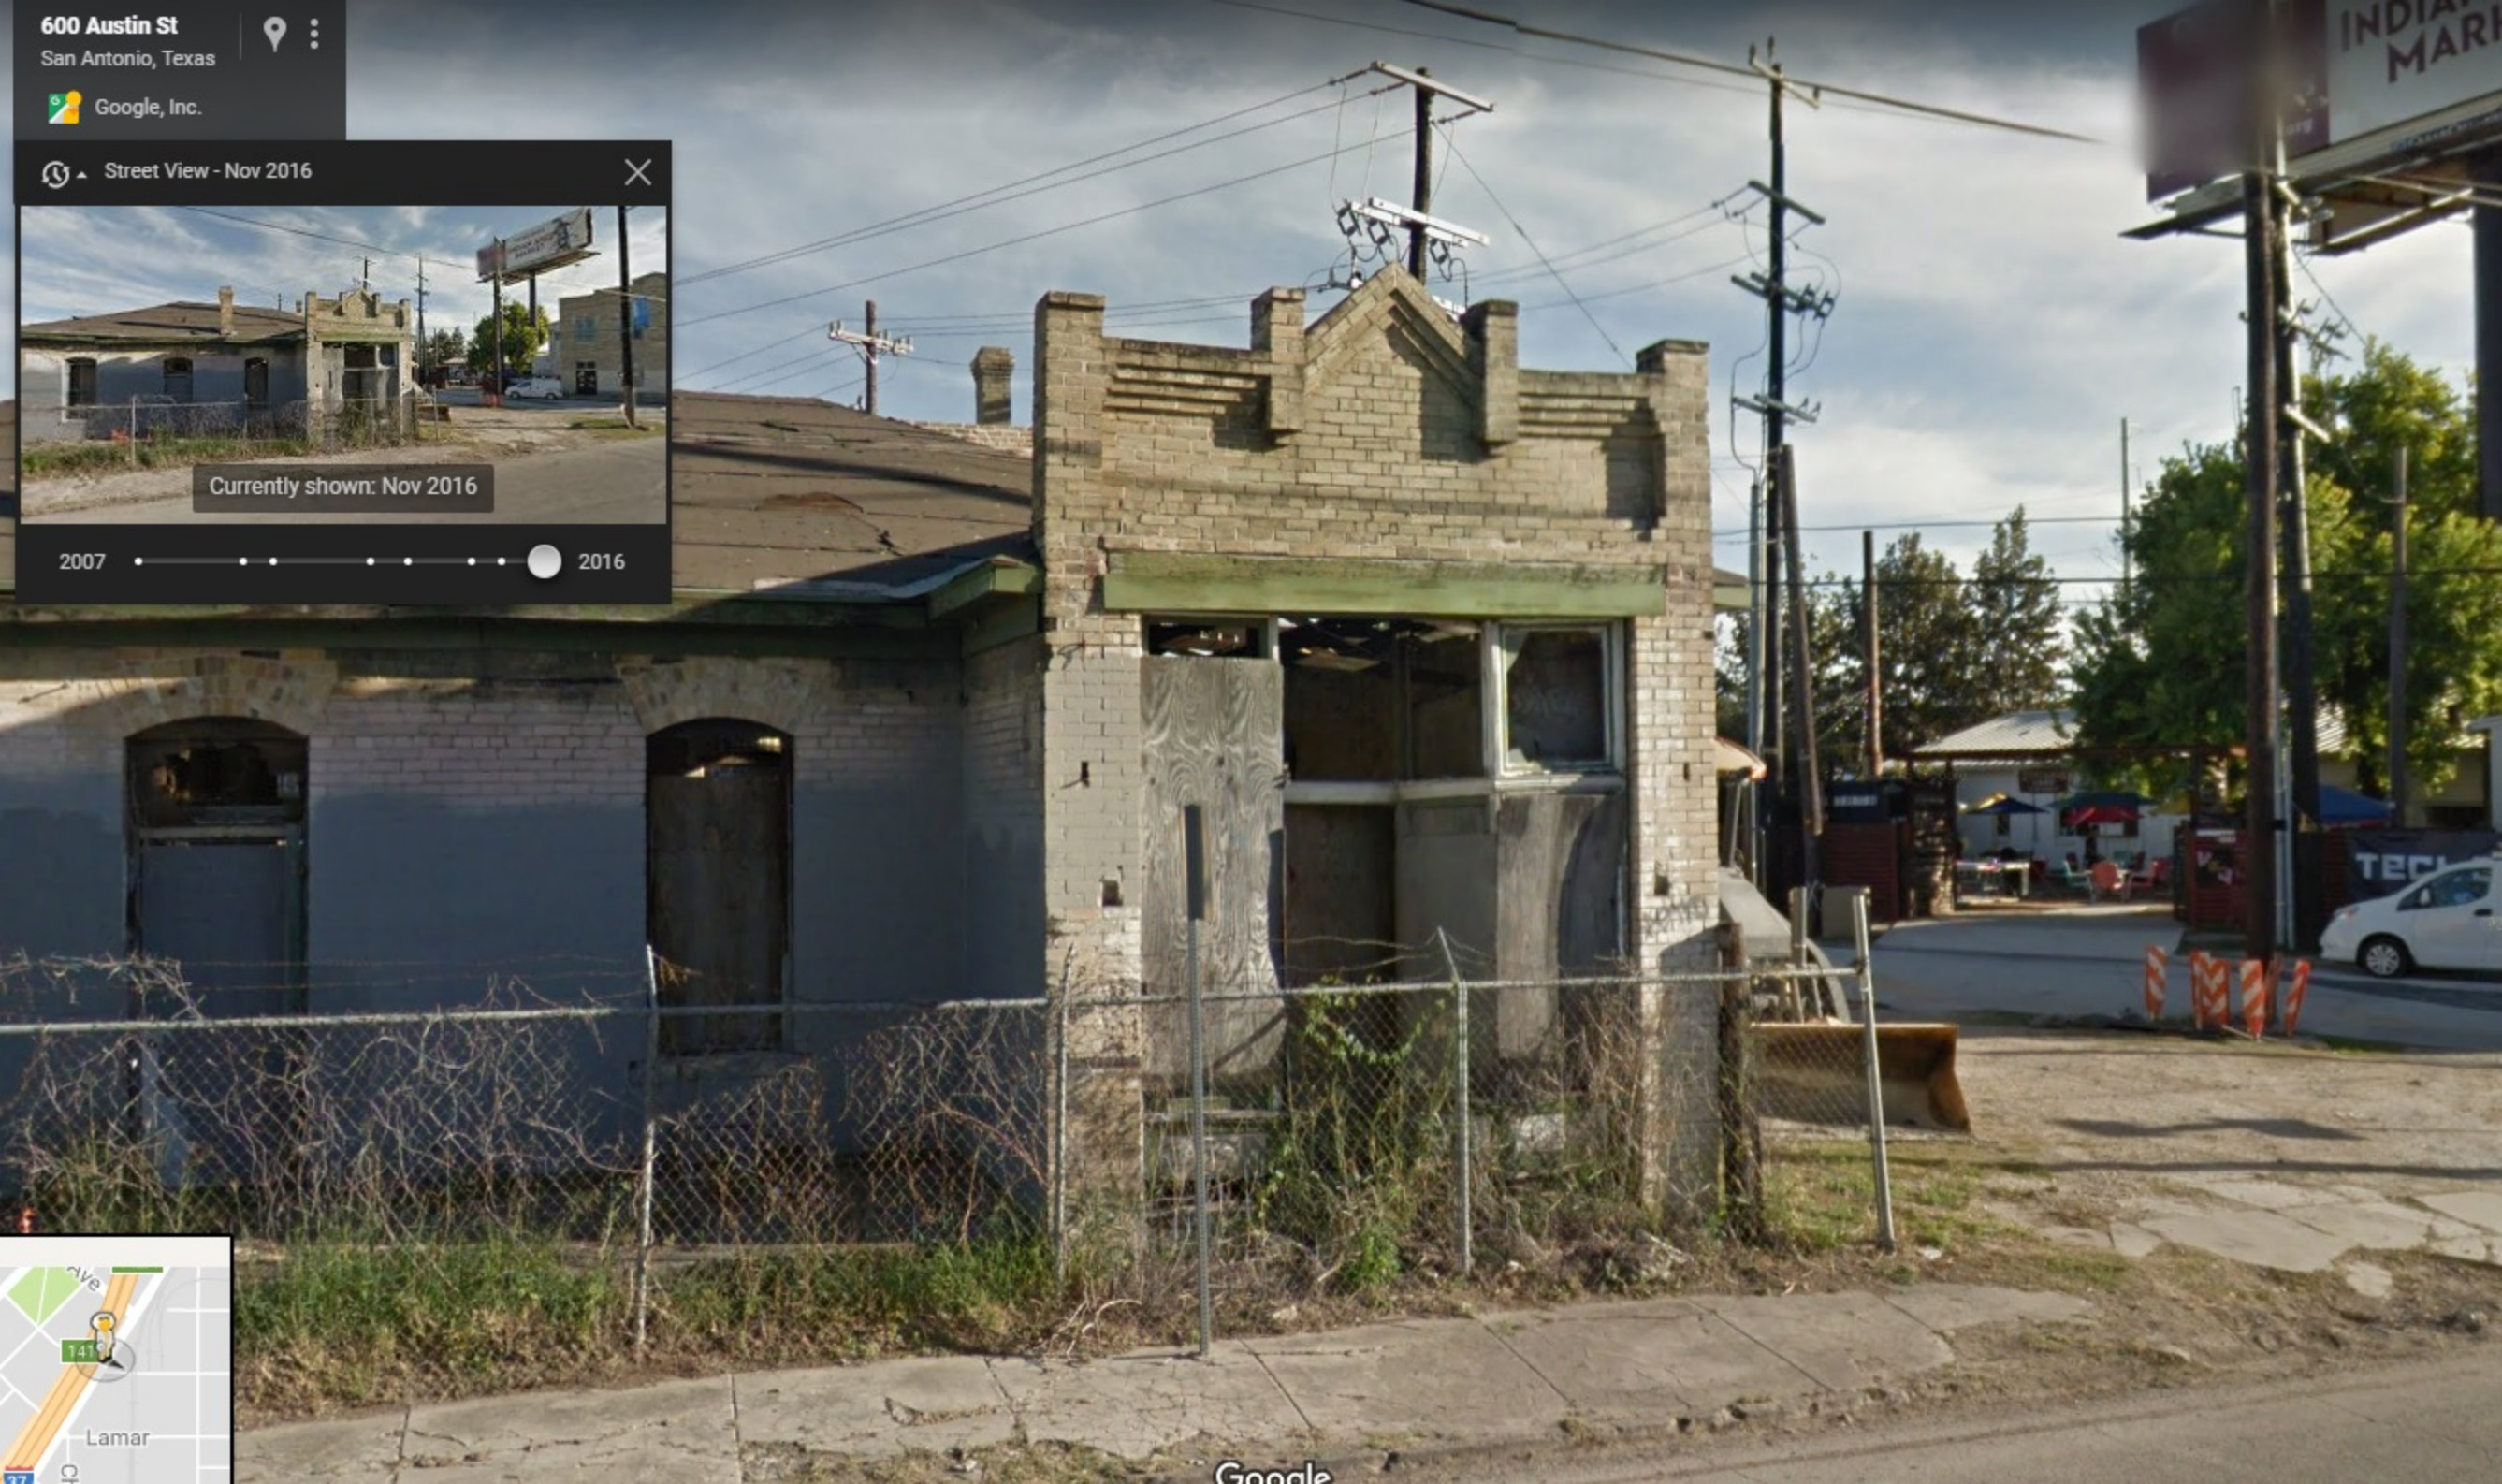
Staff performed a site visit on April 13, 2018, and found scopes of work including roofing, storefront system installation, roof decking installation and exterior modifications being performed inconsistently with previous approvals. The profile and materials of both the storefront system and roofing are inconsistent with previous approvals. Additionally, the profile of the proposed roof deck is inconsistent with previous approvals.

ROOF DECKING IS INCONSISTENT WITH CURRENT AND PREVIOUSLY APPROVED CONSTRUCTION DOCUMENTS AND STIPULATIONS THAT NOTED NO NEW ROOF STRUCTURE WAS TO BE VISIBLE FROM THE PUBLIC RIGHT OF WAY.

- v. That inconsistencies in current scopes of work related to storefront systems, roof decking, exterior modifications and roofing be corrected to match all previous approvals in regards to materials, architectural profiles and details.

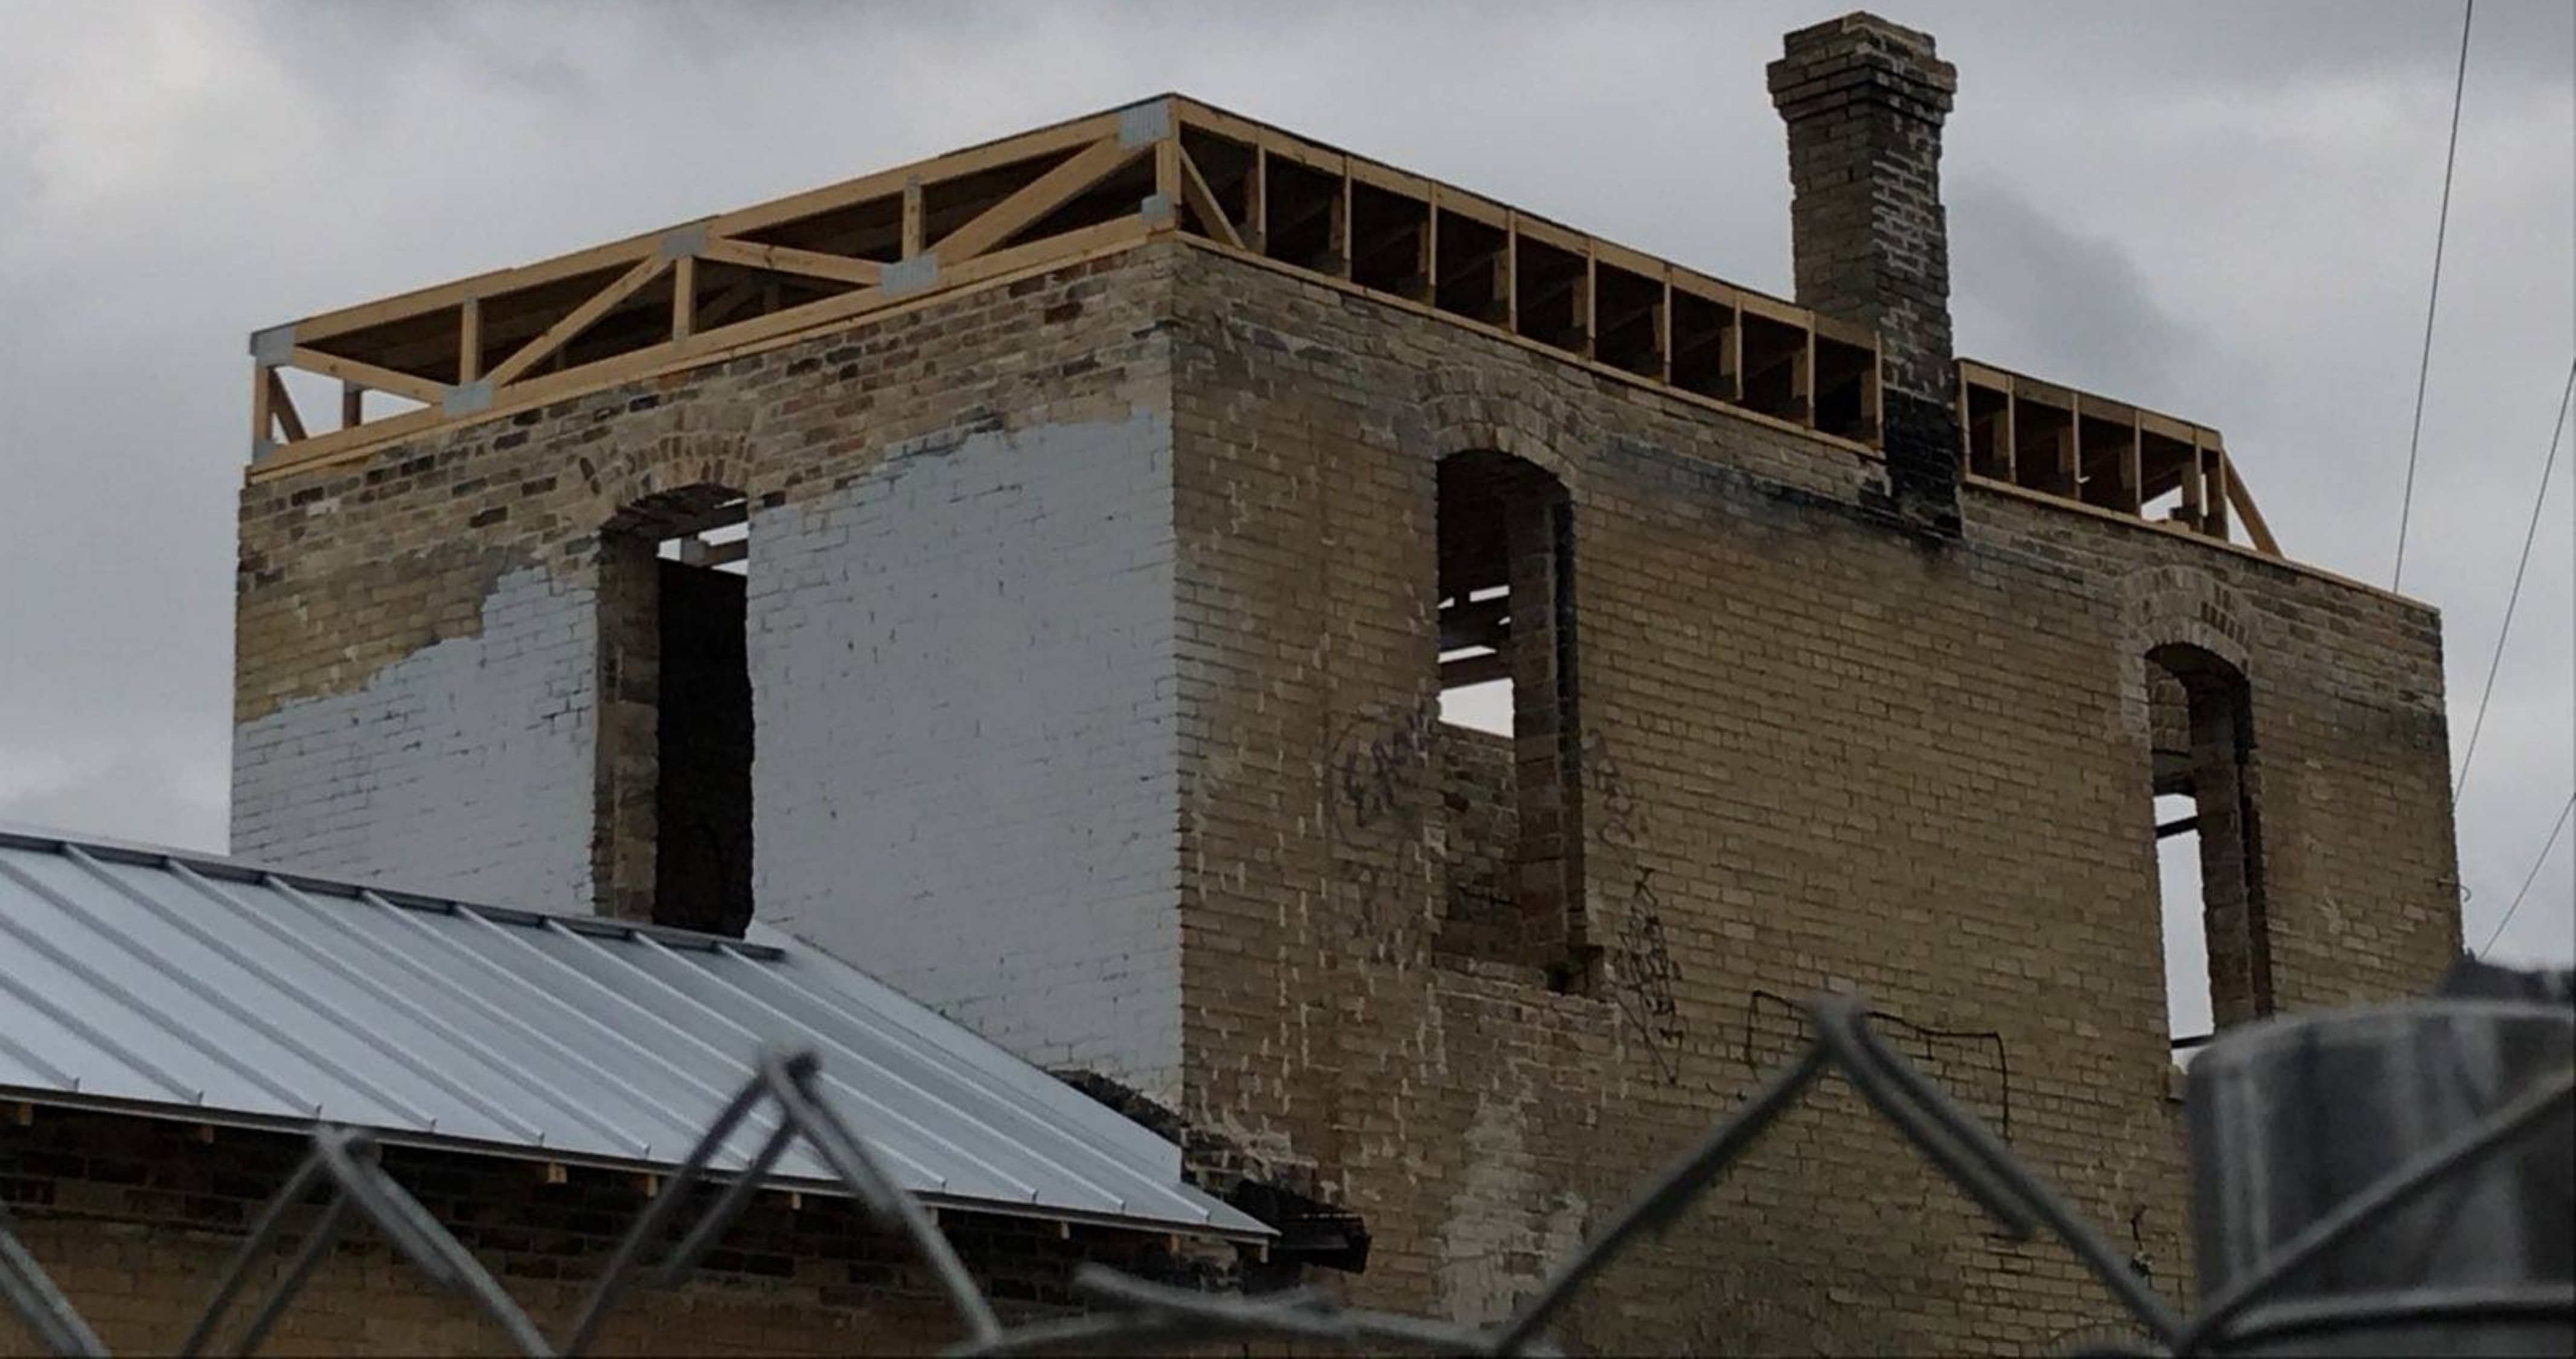
**PREVIOUSLY APPROVED ROOFING INCLUDES ONLY
SHINGLES - NO STANDING SEAM REPLACEMENT HAS
BEEN APPROVED - THE INSTALLED RIDGECAP IS
INAPPROPRIATE.**

- ii. That the roofing material be submitted to staff for review and approval prior to installation. Standing seam metal roofs should feature panels that are 18 to 21 inches wide, seams that are 1 to 2 inches in height, a crimped ridge seam and a standard galvalume finish.
