HISTORIC AND DESIGN REVIEW COMMISSION

HDRC CASE NO: 2018-318
ADDRESS: 2620 N MAIN AVE
LEGAL DESCRIPTION: NCB 1704 BLK 12 LOT N 62.5 FT OF 1, 2 & 3 ARB A1
ZONING: O-2 H
CITY COUNCIL DIST.: 1
DISTRICT: Monte Vista Historic District
APPLICANT: Cristina Maria Rohrs
OWNER: Cristina Maria Rohrs
TYPE OF WORK: Installation of a low stone perimeter wall
APPLICATION RECEIVED: June 15, 2018
60-DAY REVIEW: August 14, 2018
REQUEST:

The applicant is requesting a Certificate of Appropriateness for approval to construct a low perimeter wall in the front and side yard of the property. The wall will be constructed of stone and measure approximately 2 feet in height with 3 foot tall posts.

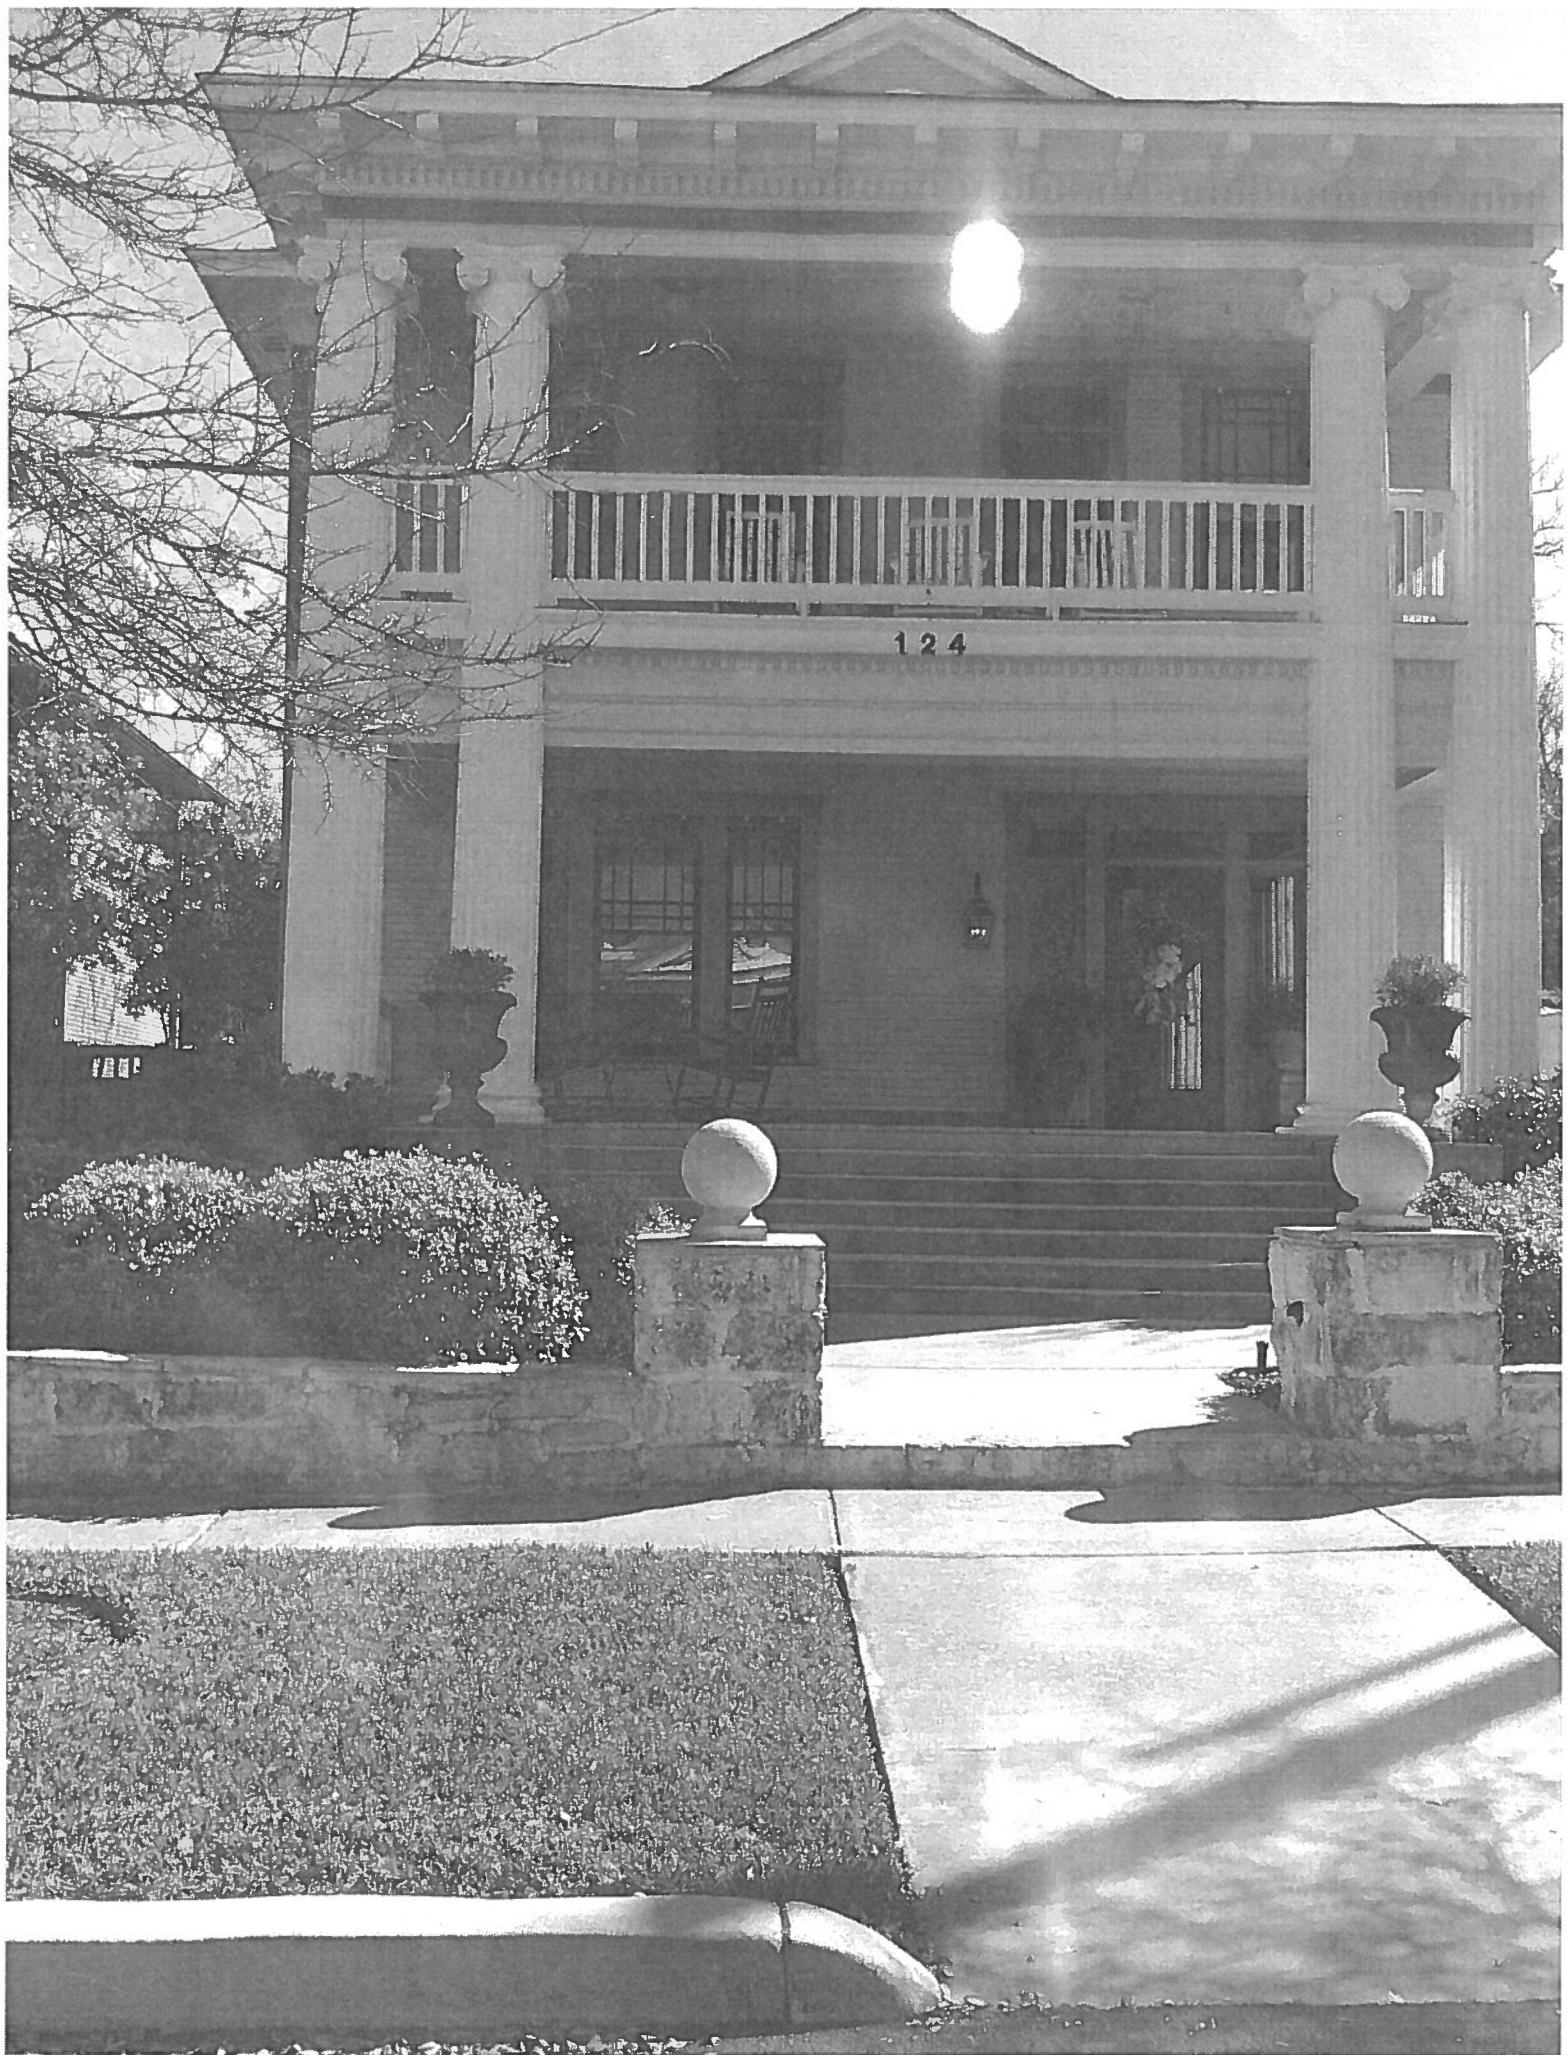
24" 10" 2

- b. NEW WALL: HEIGHT AND LOCATION - The applicant has proposed to install a low perimeter wall constructed of brick masonry. The wall will measure approximately 24” in height with 34” tall decorative posts. The wall will front the existing sidewalk fronting N Main Ave and E Magnolia Ave and terminate at the rear and south property line. The wall is requested for aesthetic reasons and will not function as a retaining wall for a slope or grade change. According to the Historic Design Guidelines for Site Elements, new fences and walls should appear similar to those used historically within the district in terms of their scale and location. In the blocks surrounding the property, there are no properties with low, non-retaining perimeter walls on E Magnolia or N Main. A low perimeter wall in the front yard of a property on E Magnolia and at the intersection of N Main and E Huisache both retain ground elements. Staff does not find low perimeter walls to be historically common or characteristic of the district. Staff does not find the height and location consistent with the Guidelines.

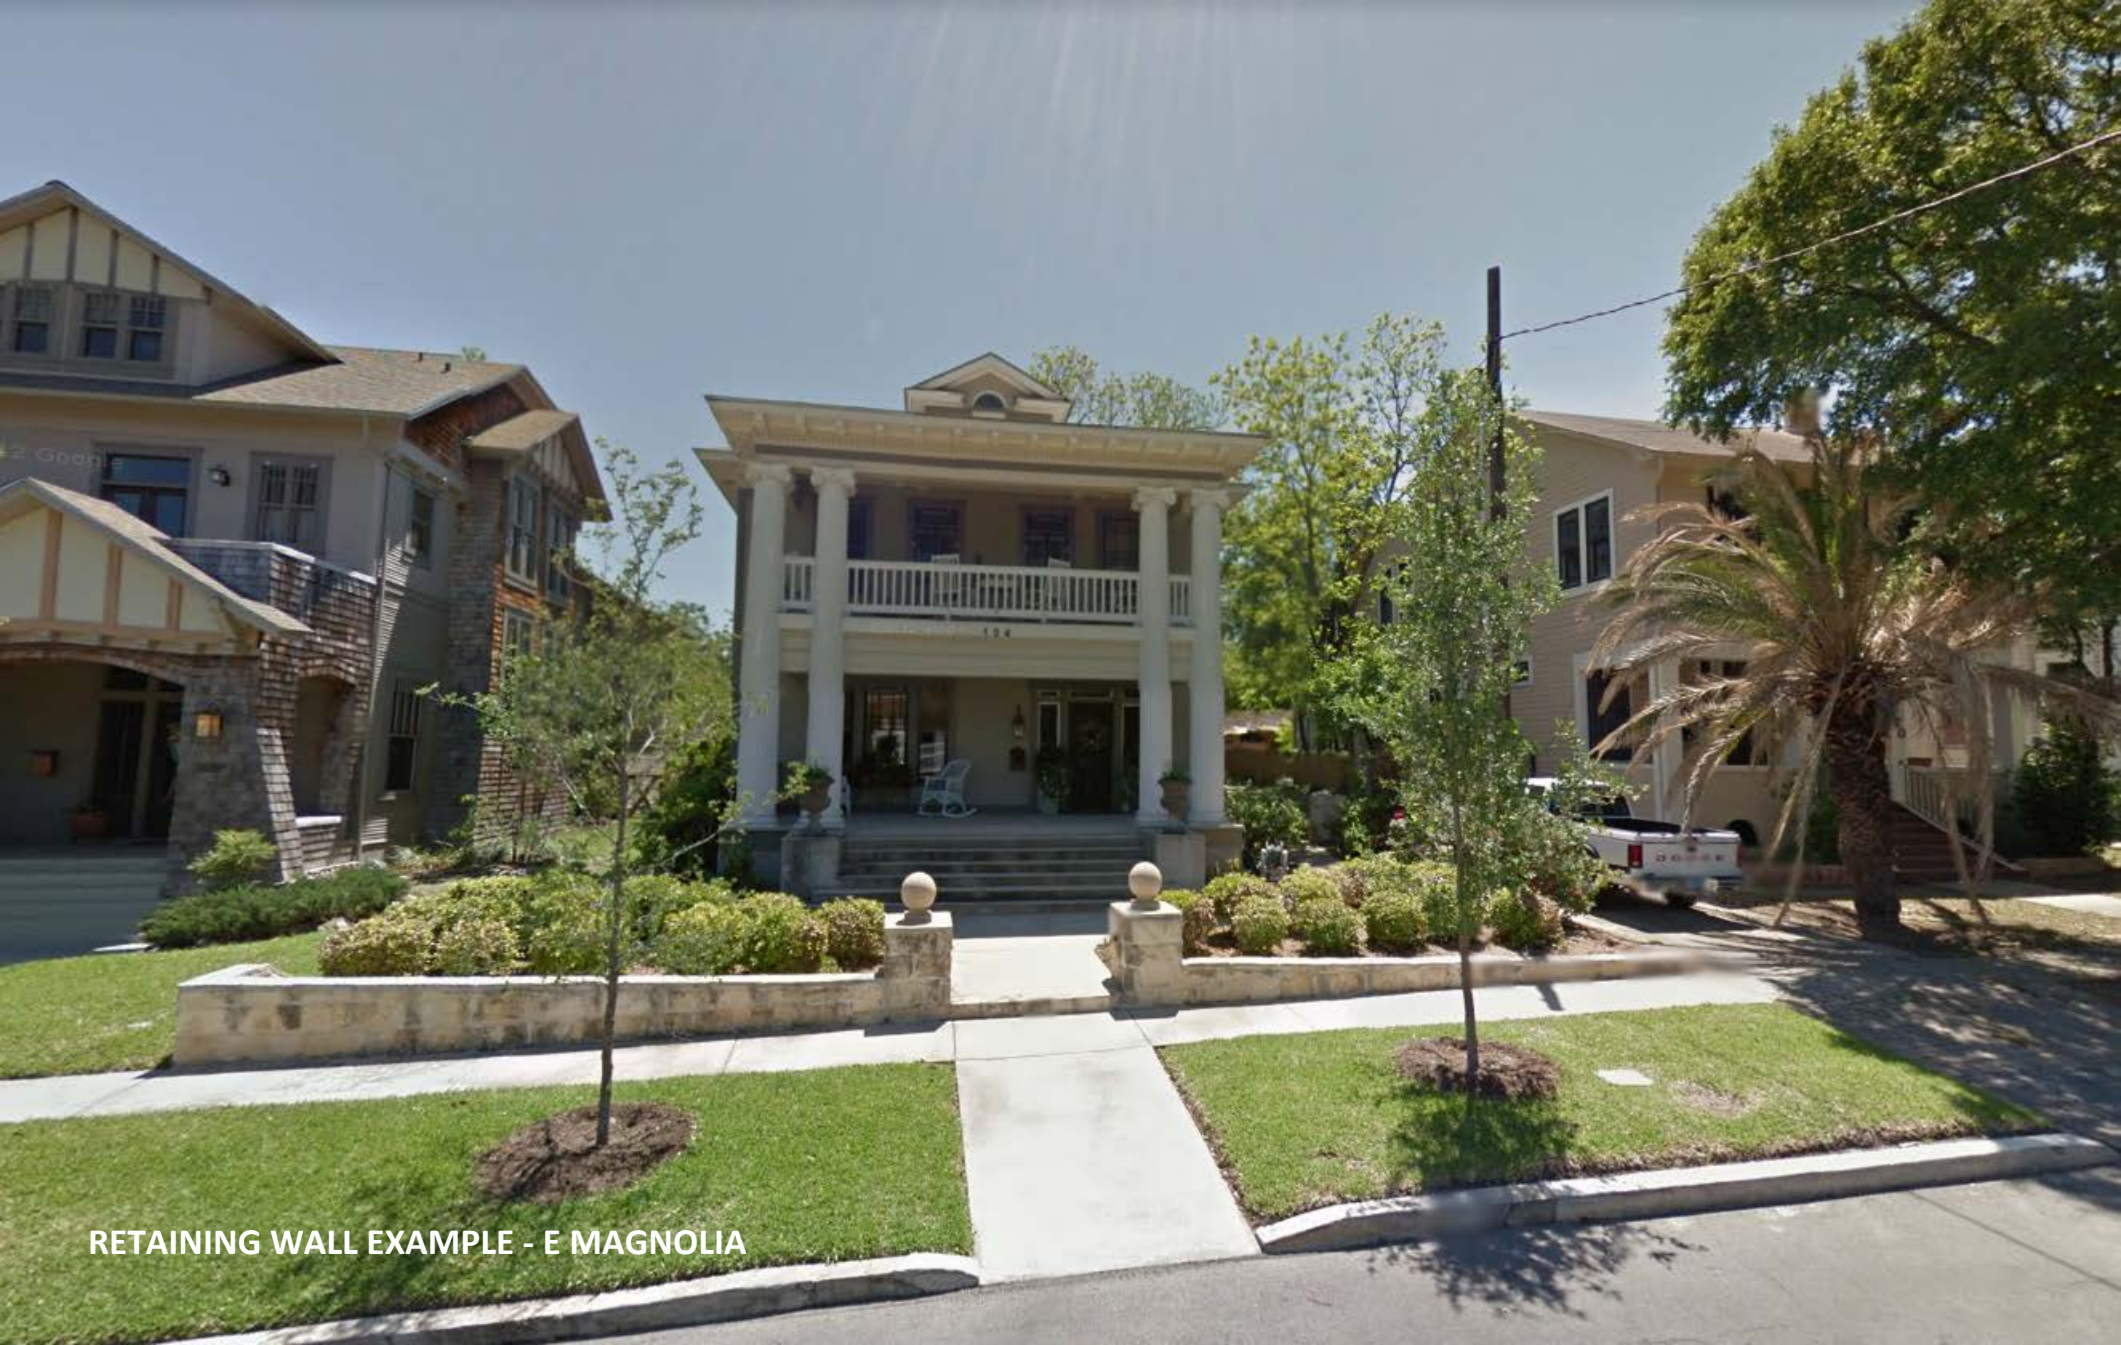
RETAINING WALL EXAMPLE - E MAGNOLIA

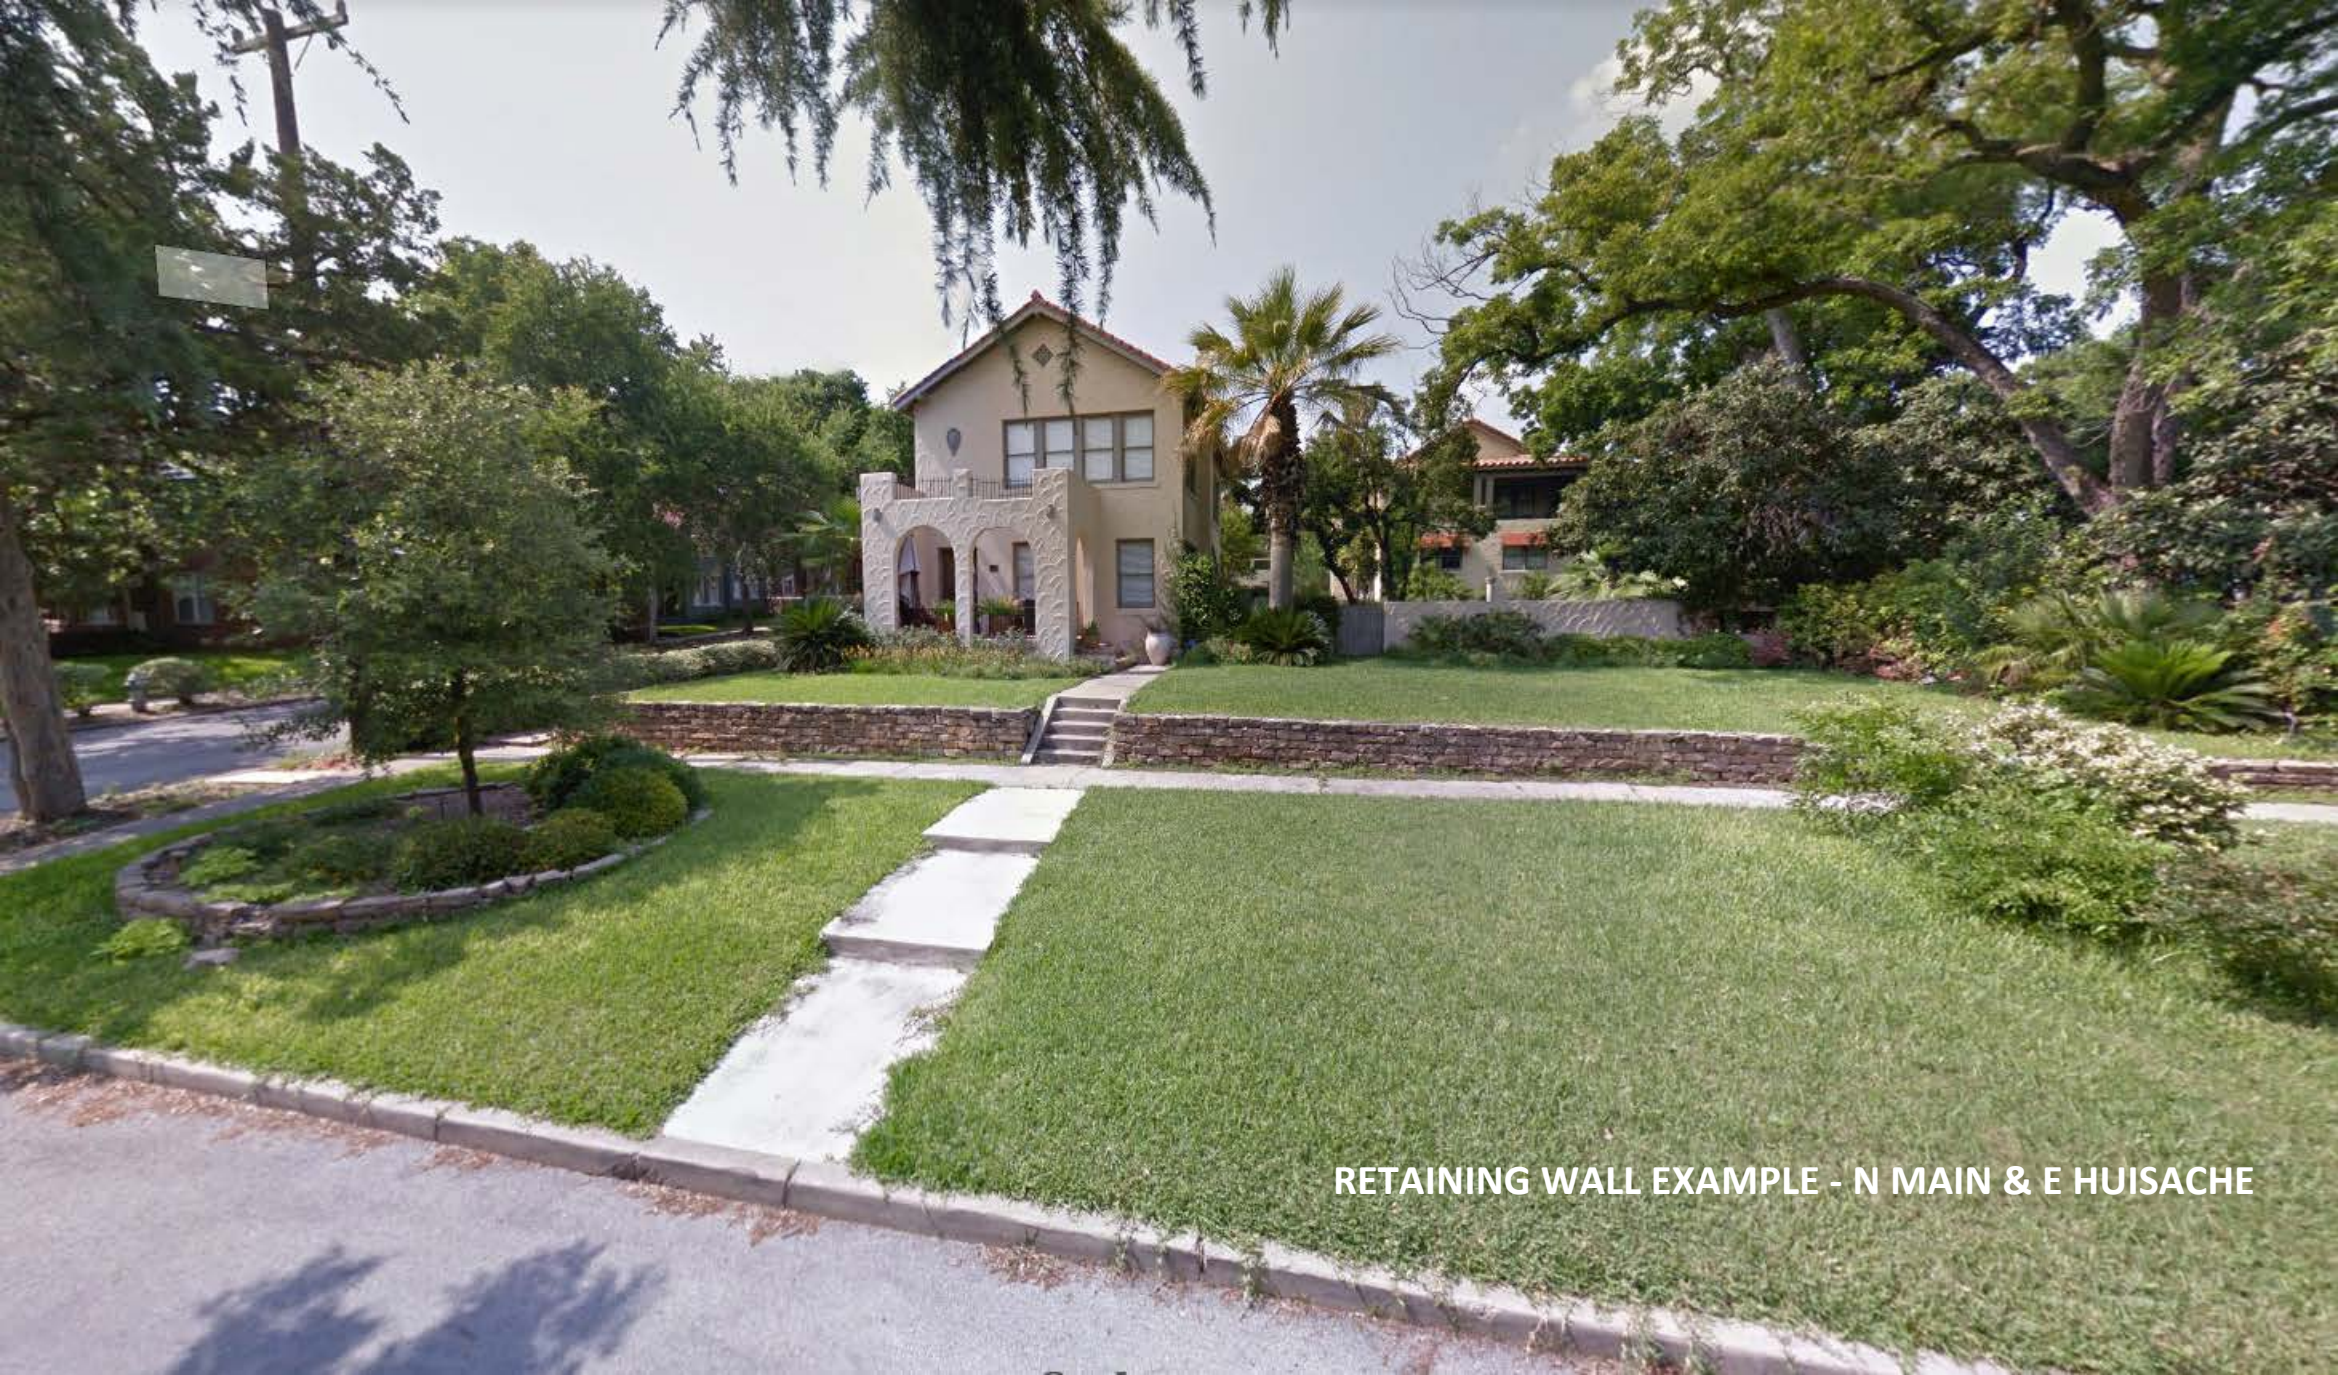
RETAINING WALL EXAMPLE - N MAIN & E HUISACHE
