HISTORIC AND DESIGN REVIEW COMMISSION

HDRC CASE NO: 2018-325
ADDRESS: 538 QUITMAN ST
LEGAL DESCRIPTION: NCB 993 BLK 3 LOT E 35.3 FT OF N 100FT OF 2 & W 14.7 FT OF N 100 OF 3
ZONING: R-6 H
CITY COUNCIL DIST.: 2
DISTRICT: Government Hill Historic District
APPLICANT: Justin Abt
OWNER: Justin Abt
TYPE OF WORK: Exterior modifications
APPLICATION RECEIVED: June 28, 2018
60-DAY REVIEW: August 27, 2018
REQUEST:

The applicant is requesting a Certificate of Appropriateness for approval to wrap four existing stucco front porch columns with cedar. The wrapping will feature simple paneled detailing.

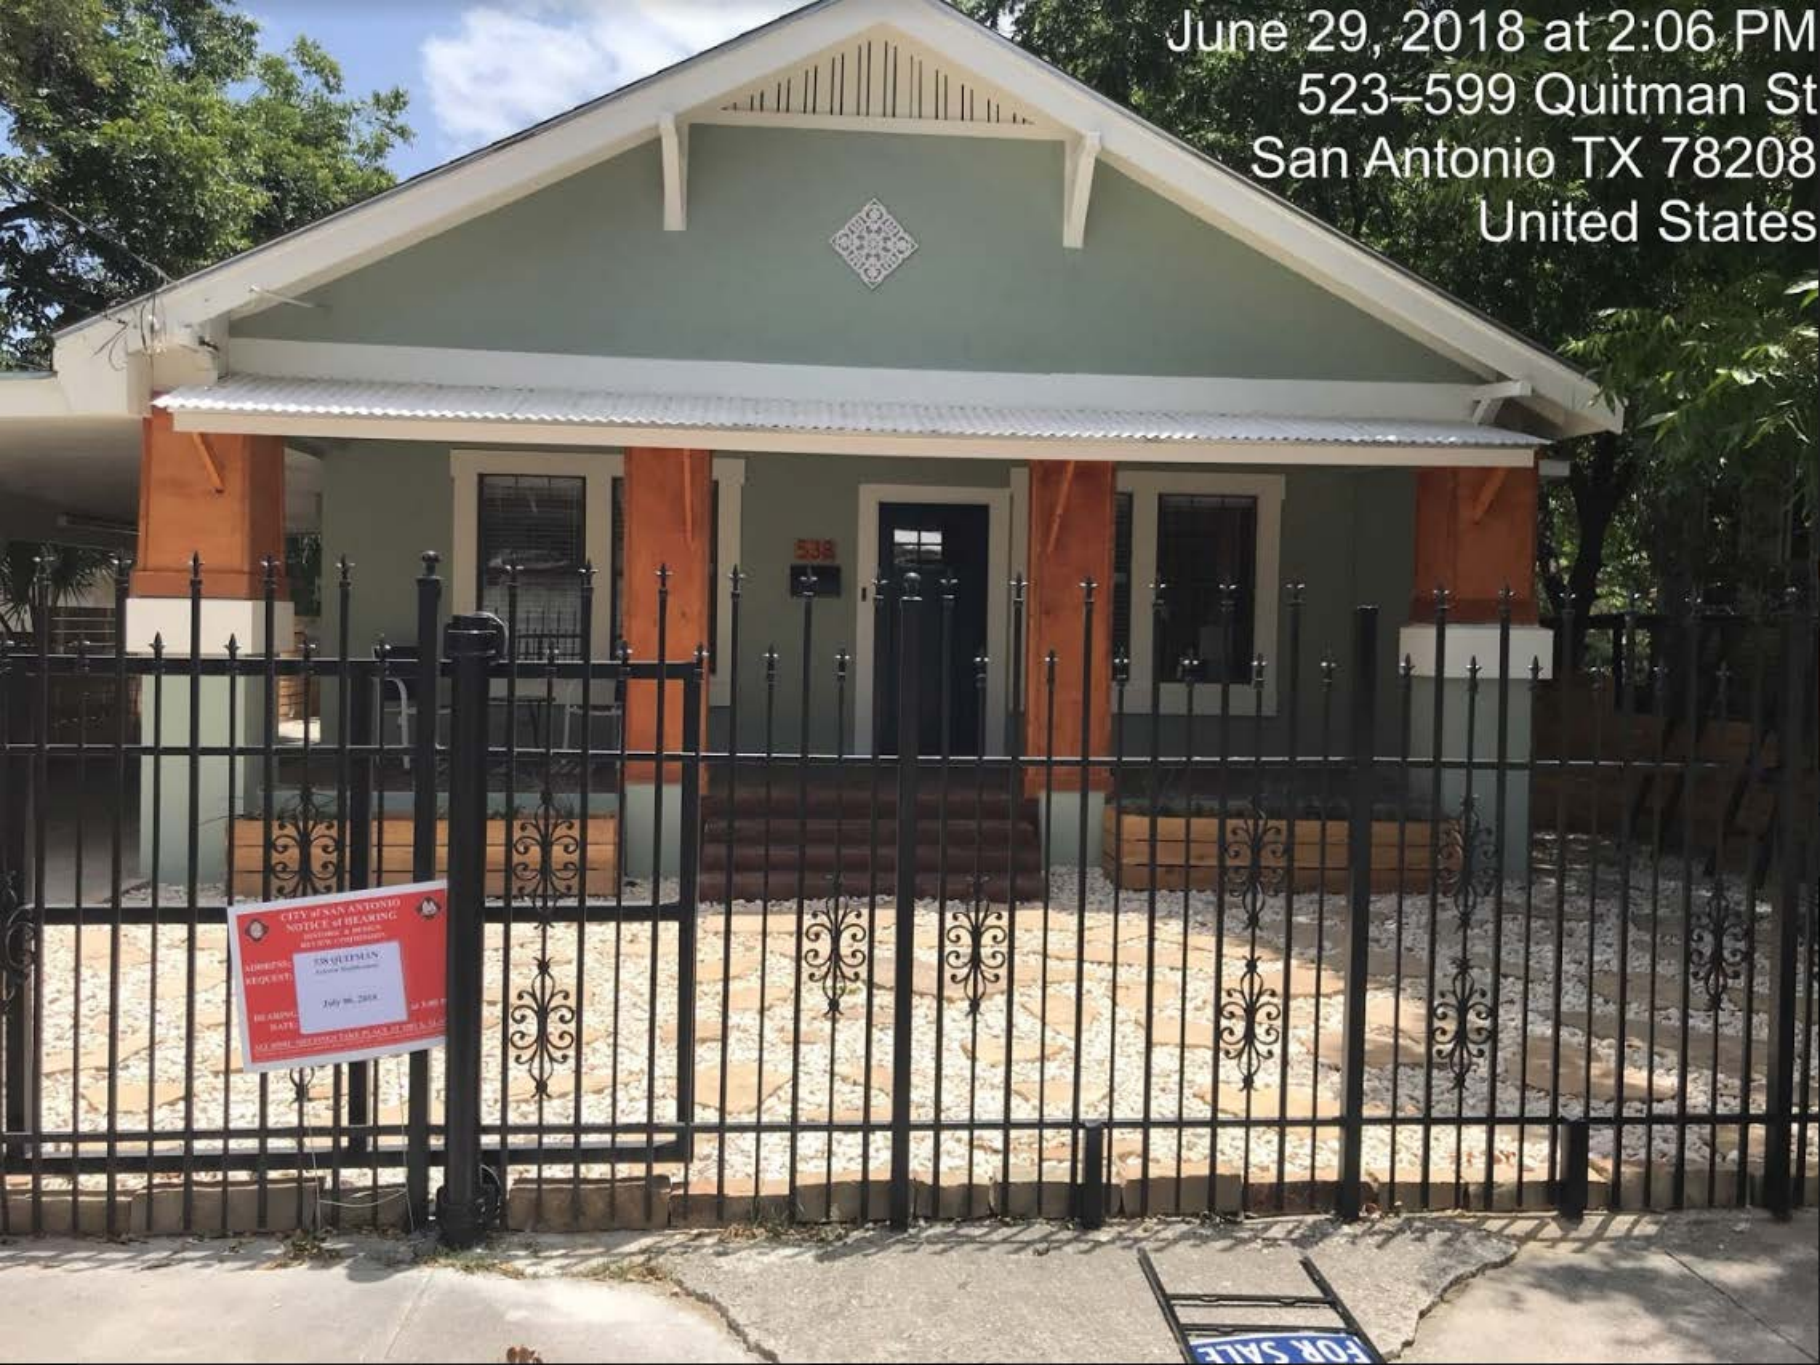
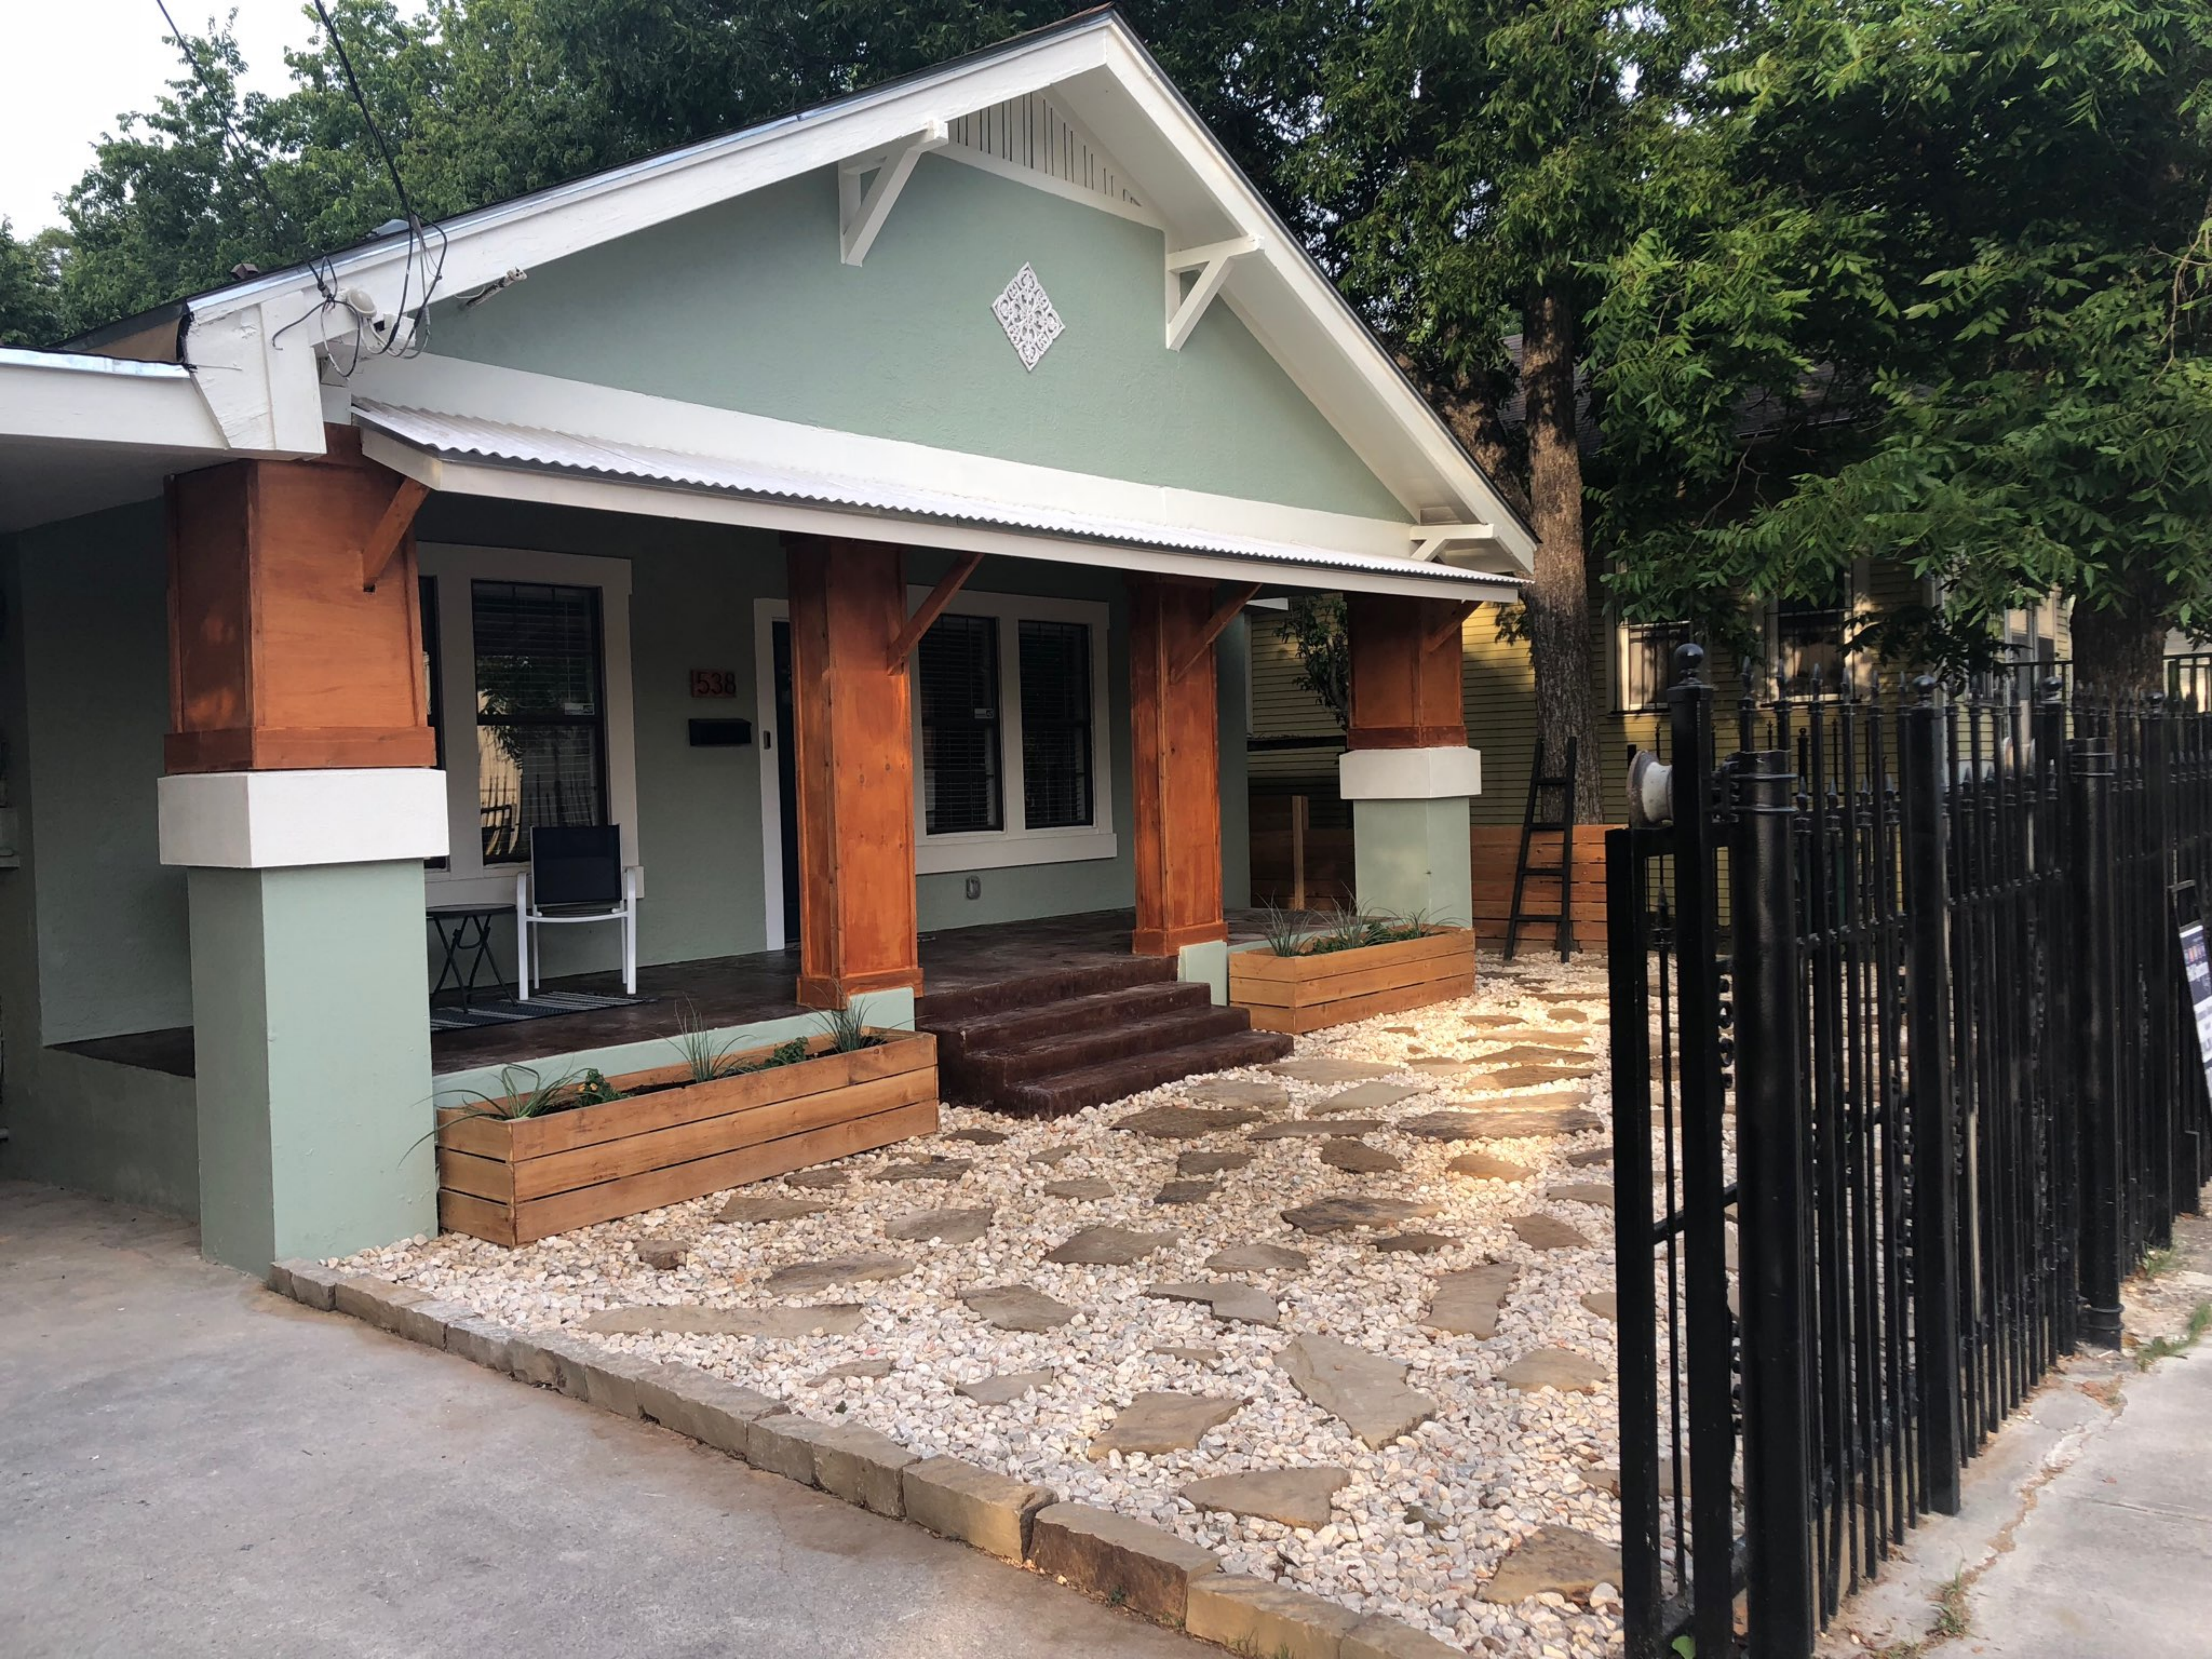
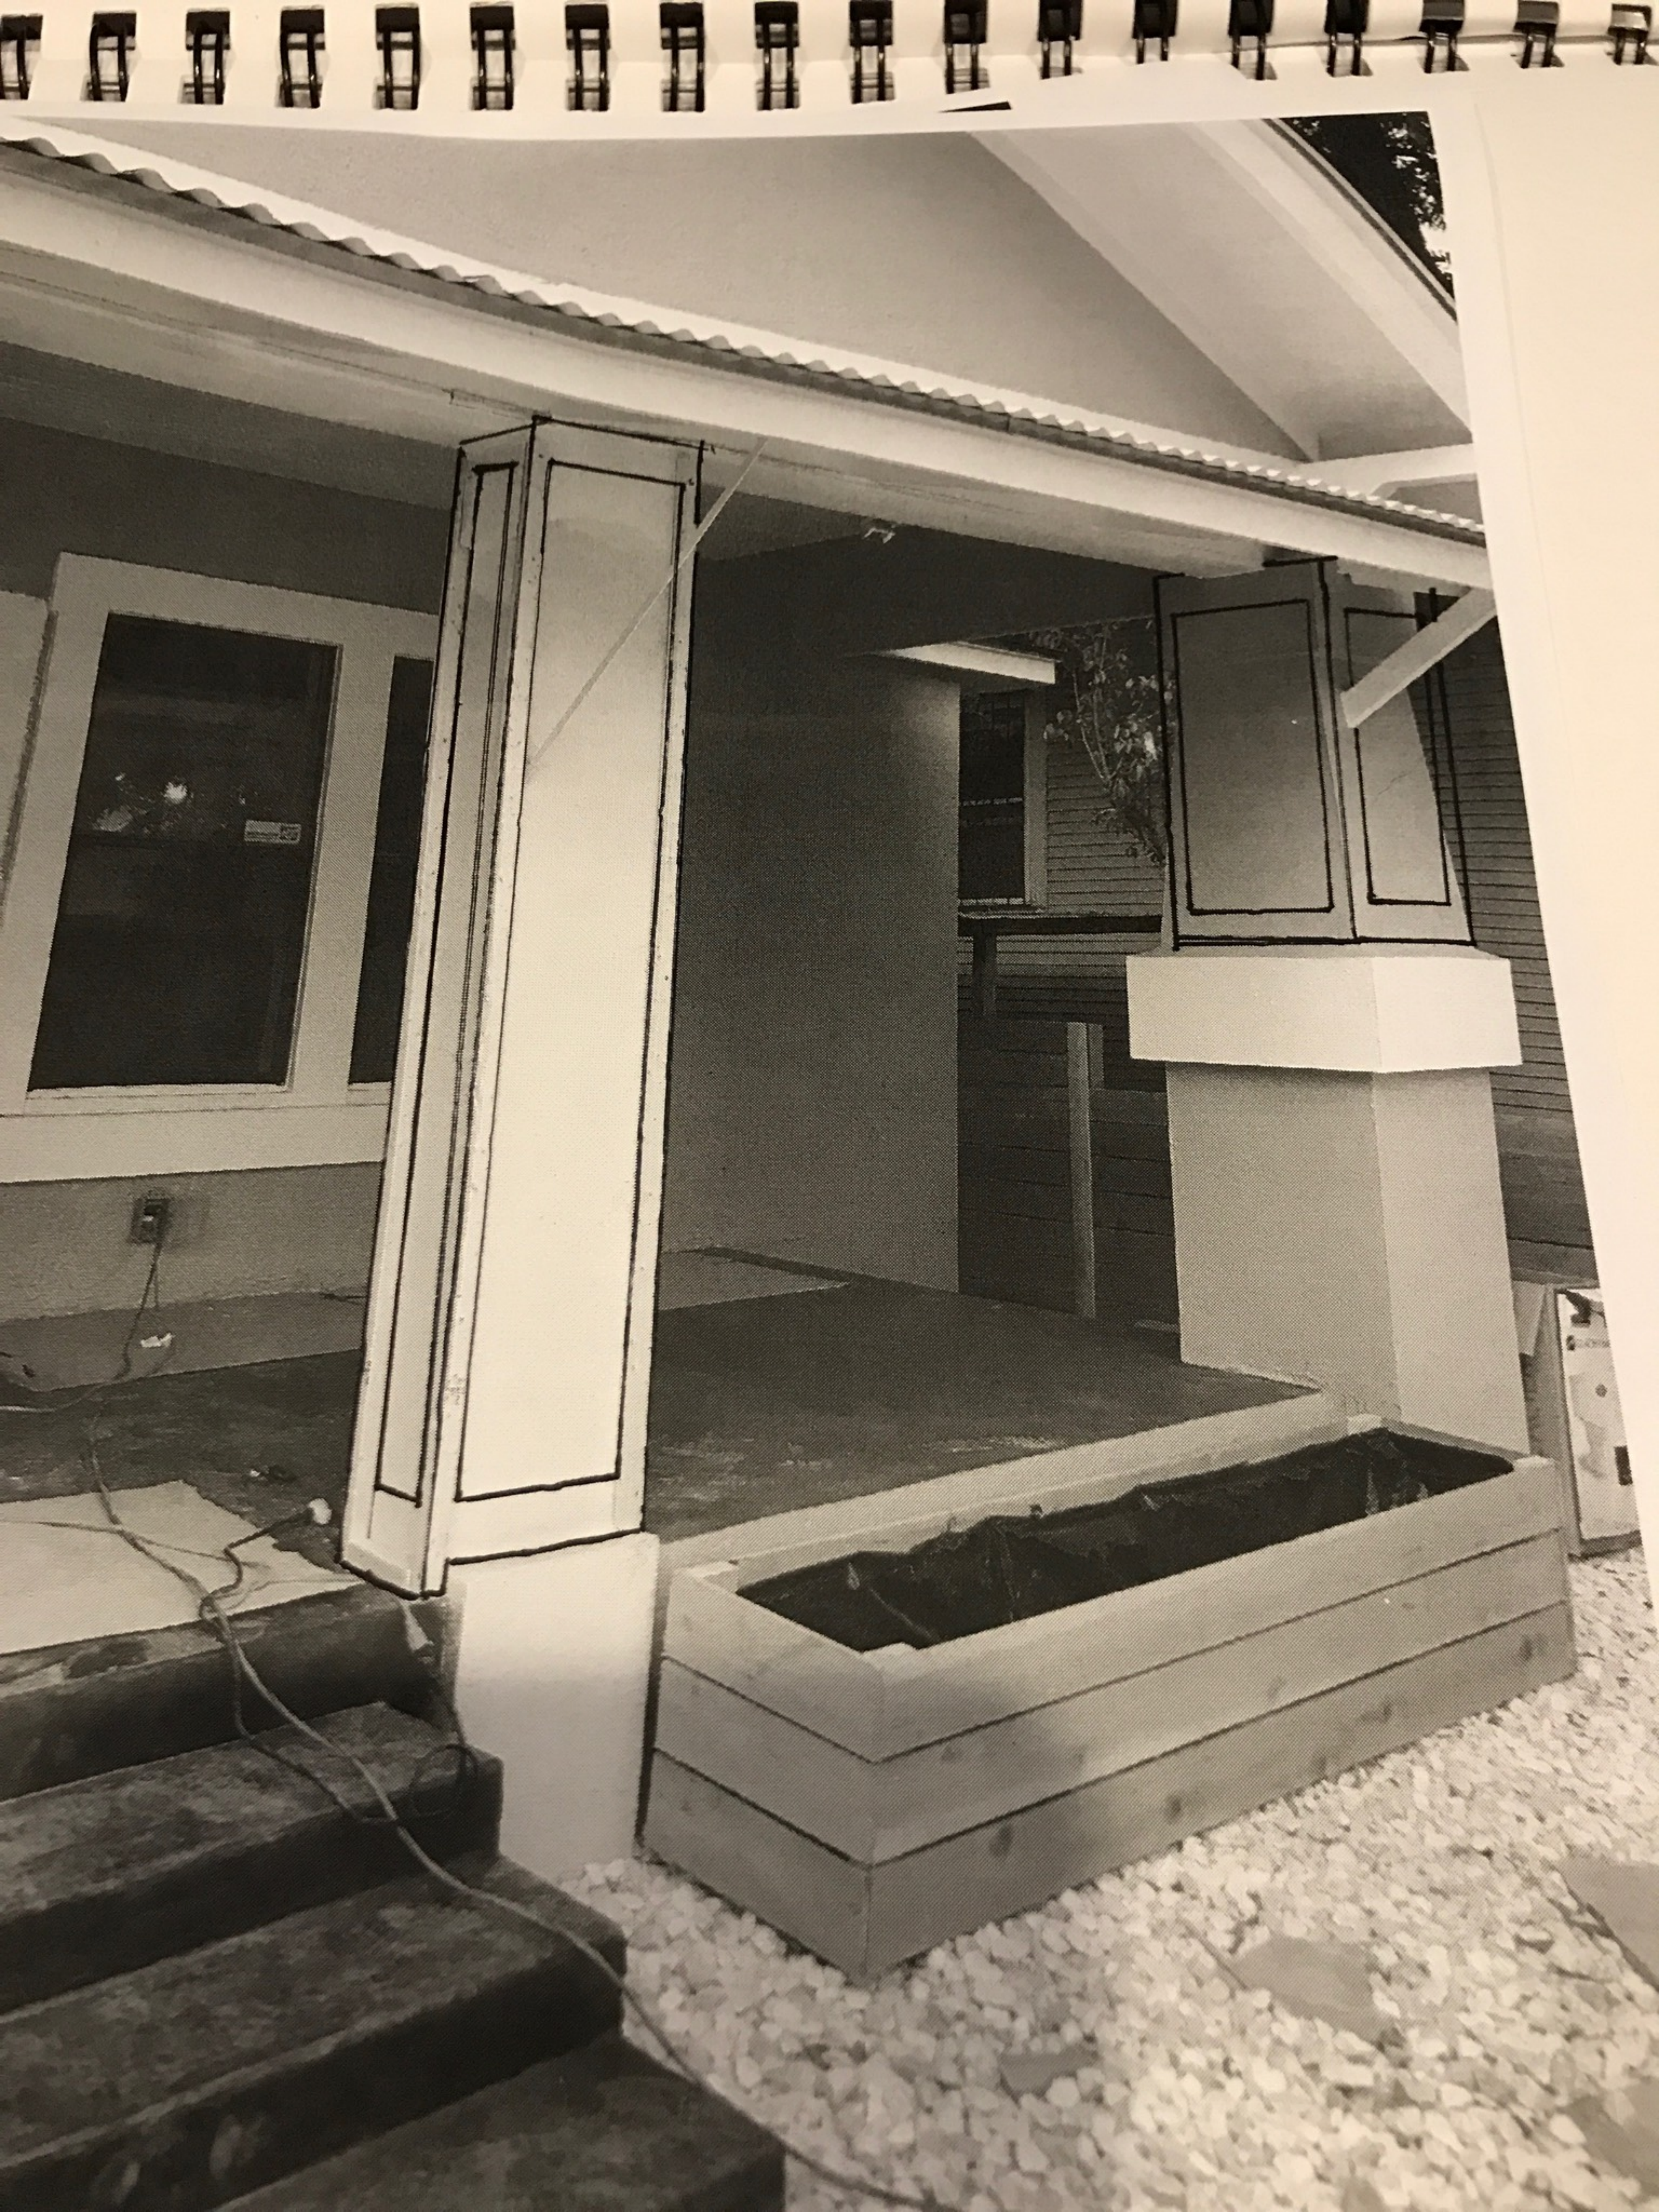
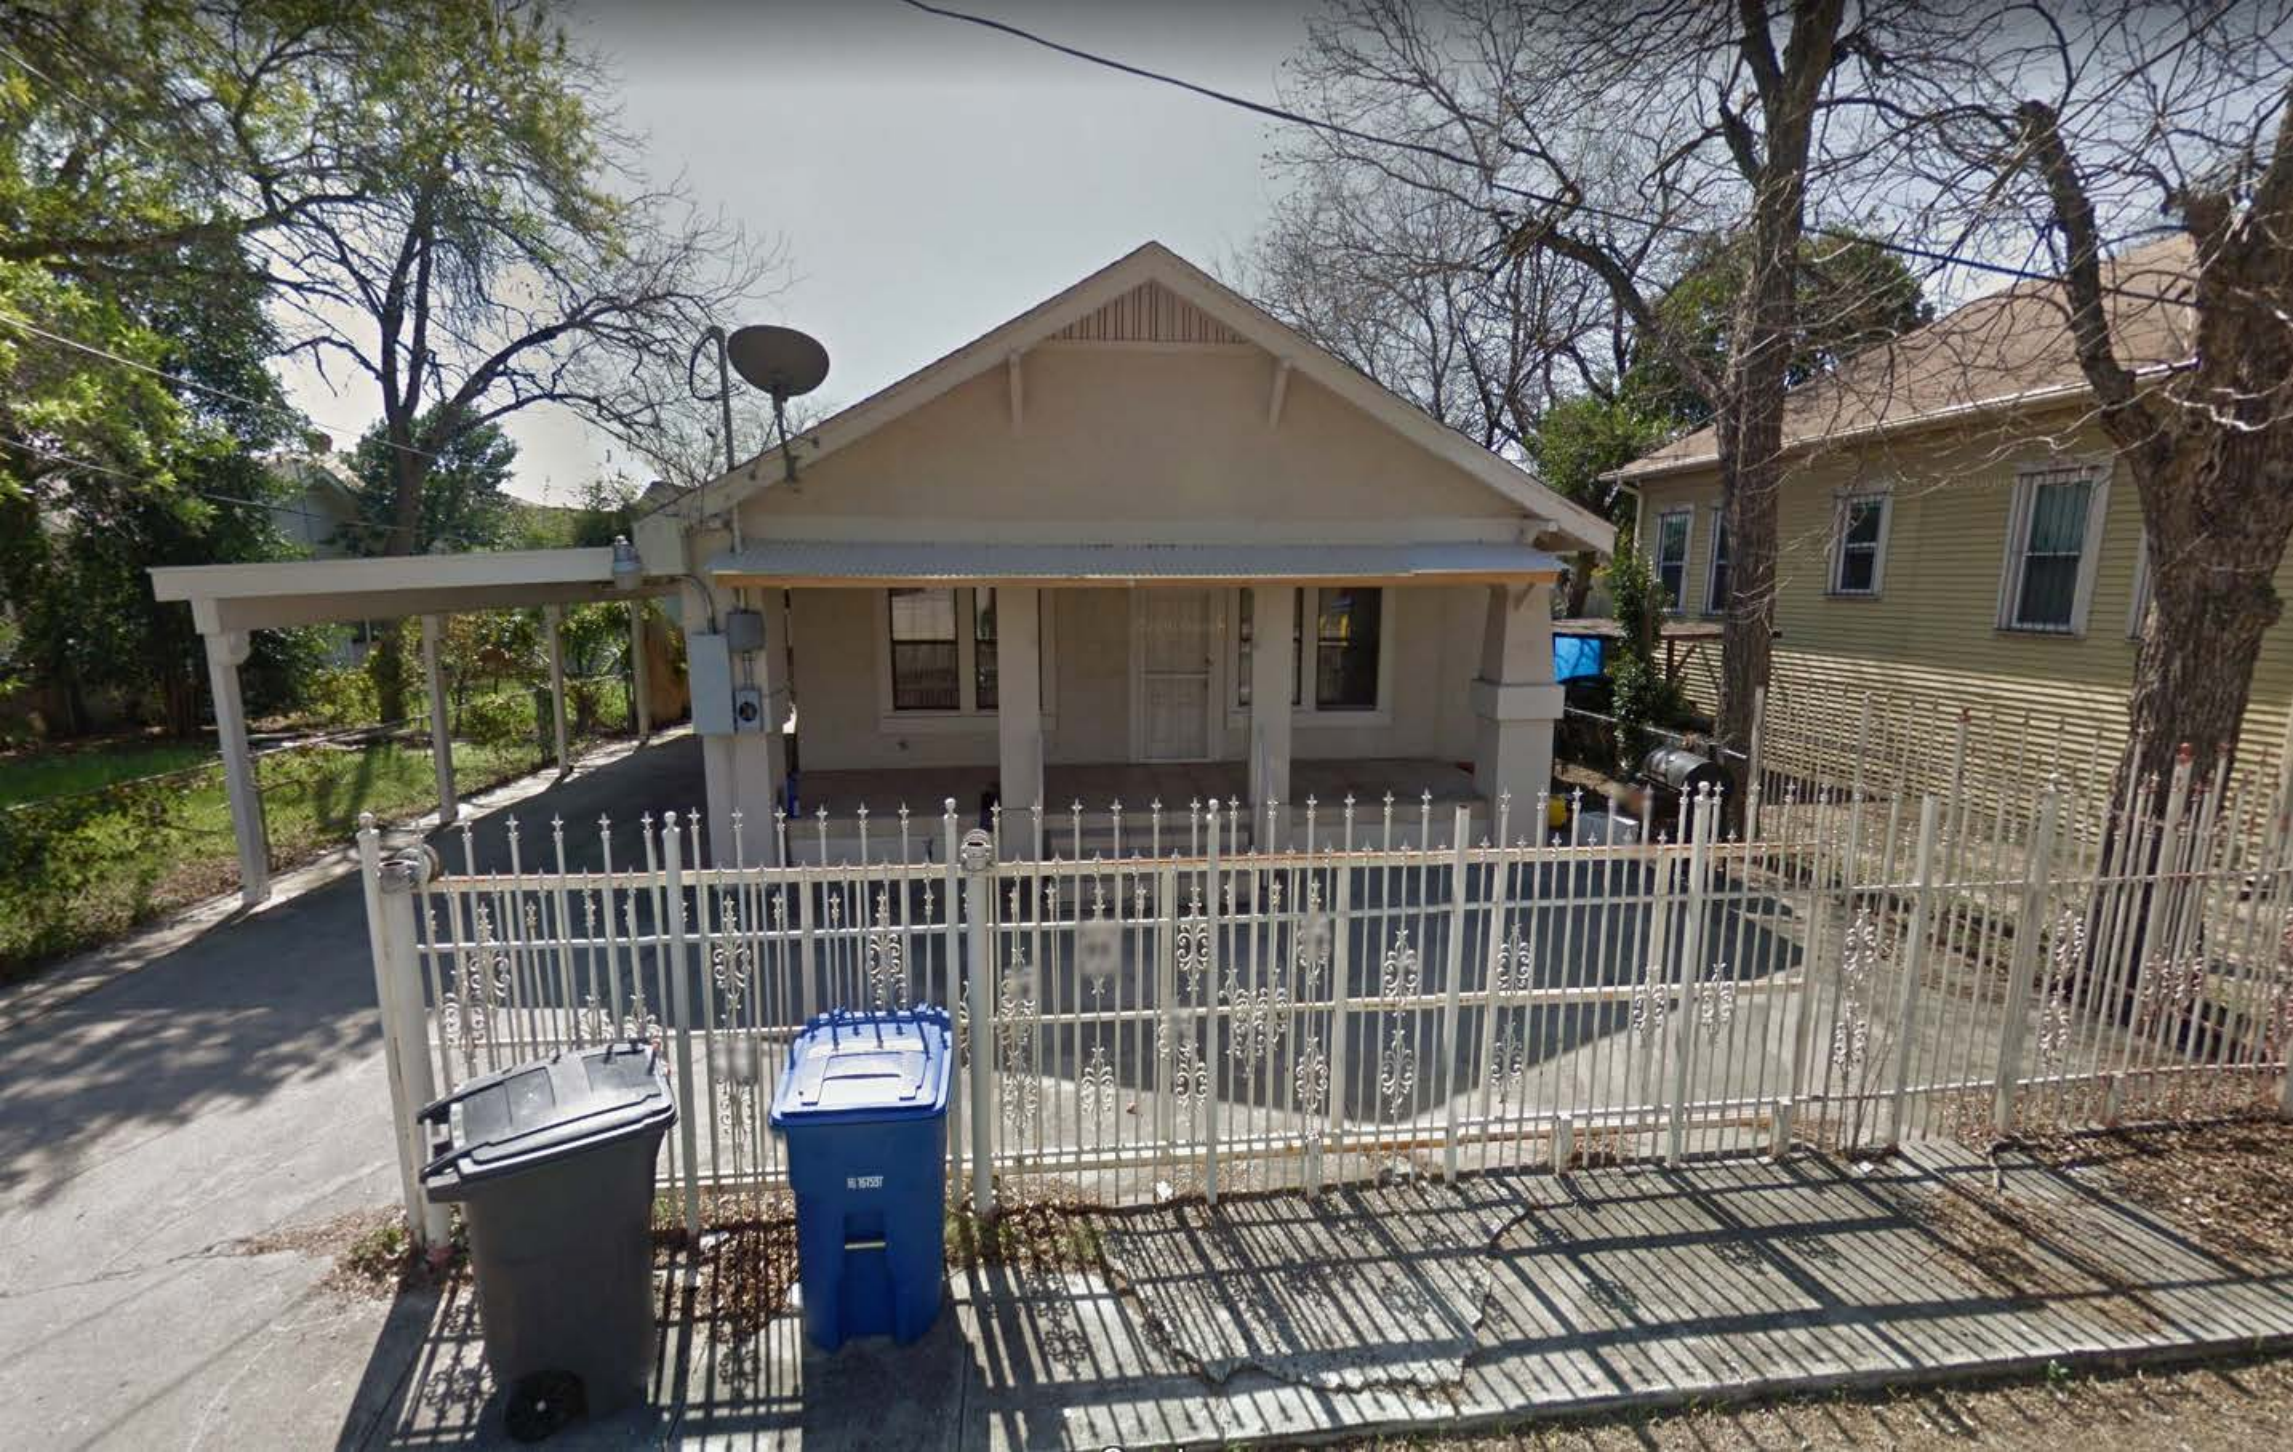
June 29, 2018 at 2:06 PM
523-599 Quitman St
San Antonio TX 78208
United States

- b. PORCH COLUMNS – The applicant has proposed to wrap the existing stucco-clad porch columns with thin sheets of wood coated with a cedar stain. The wrapping will feature a simple paneled detailing. The existing stucco-clad columns will be retained beneath. According to the Historic Design Guidelines, added or reconstructed porch elements should be compatible in scale, massing, and detail while materials should match in color, texture, dimensions, and finish. If no architectural evidence of added elements exist, the design should be based on the architectural style of the building and historic patterns. While staff finds that panel detailing generally appropriate for the Craftsman architecture of the structure, staff finds that the material, color, thickness, and detailing inconsistent with the Guidelines.

The work was completed prior to receiving a Certificate of Appropriateness. Post-work application fees have not been paid.

Staff does not recommend approval of the porch column modifications based on findings a through b. Staff recommends that the applicant consider alternatives that are more consistent with the original design and materials and of the house. Appropriate changes may be eligible for administrative approval.
