HISTORIC AND DESIGN REVIEW COMMISSION

March 20, 2019

HDRC CASE NO: 2019-043
ADDRESS: 224 E CAROLINA ST
LEGAL DESCRIPTION: NCB 2956 BLK LOT B
ZONING: RM-4, H
CITY COUNCIL DIST.: 1
DISTRICT: Lavaca Historic District
APPLICANT: Peter Matthew Price
OWNER: Peter Matthew Price
TYPE OF WORK: Amend previous approval for porch and addition; Tax Certification
APPLICATION RECEIVED: January 10, 2019
60-DAY REVIEW: March 09, 2019
REQUEST:

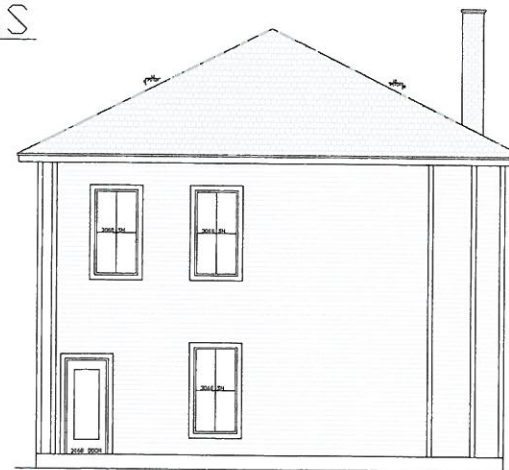
REAR ELEVATION

- d. ADDITION – The applicant is requesting to replace the existing rear portion of the house which featured an inset side elevation and 5 wood sashed windows and a rear door with a larger rear addition that is flush to the side elevations of the primary structure and includes a rear door, a set of double-doors, 1 sashed window, and 1 square picture window. Staff finds that the rear portion was constructed during the period of significance of the property as depicted in the 1911 Sanborn map and should be preserved in-place including its windows. Staff finds that the proposed modification inconsistent with the following Guidelines:

- i. Complies with reconstruction design from the 2016 HDRC approval to feature full-height classical columns.
- ii. Restore the rear portion to its original configuration after submitting plans to staff – or resubmit a plan for a rear addition that includes appropriate fenestration and inset side wall planes.

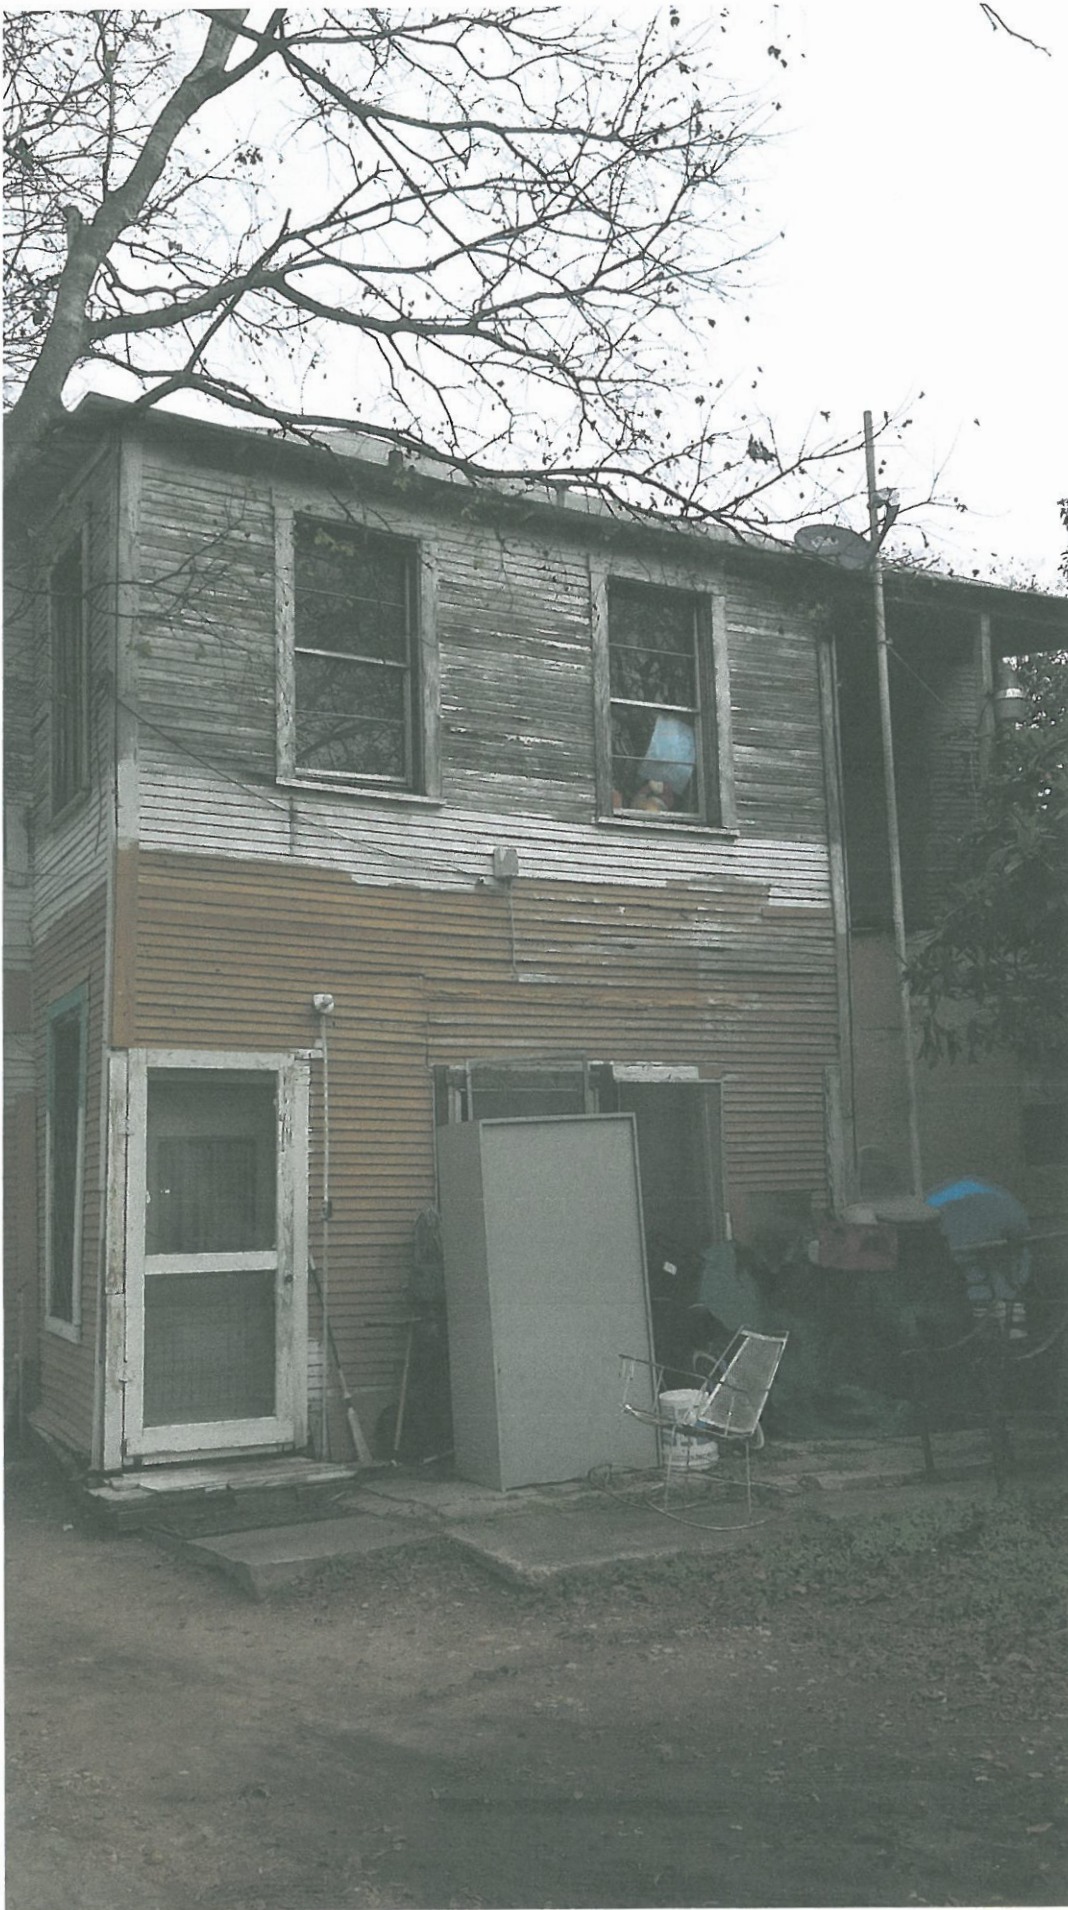
REMOVED REAR PORTION, FIRST APPEARS ON 1911 SANBORN MAP
