**HISTORIC AND DESIGN REVIEW COMMISSION**  
**February 20, 2019**

**HDRC CASE NO:** 2019-045  
**ADDRESS:** 843 RIGSBY AVE  
**LEGAL DESCRIPTION:** NCB 3306 BLK 38 LOT 24 W 30 FT OF 25  
**ZONING:** R-4  
**CITY COUNCIL DIST.:** 3  
**APPLICANT:** Jesse Martinez, on behalf of owner Marie A. Miller  
**OWNER:** Marie A. Miller  
**TYPE OF WORK:** Historic Landmark Designation

## Statement of Significance

**Property Address:** 843 Rigsby Ave

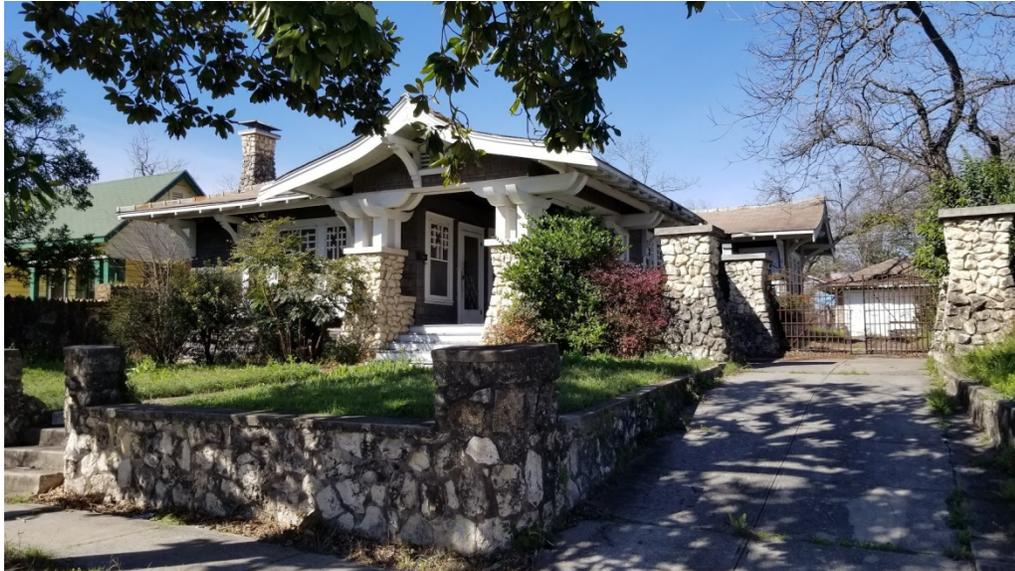
South (primary)  
facade

The south and primary façade's dominant feature is the front-gabled porch with stone pedestals and decorative wood columns and capitals. There are five steps with white painted risers and weathered wood runners leading to the painted wood porch deck, which has a low stone wall topped in concrete along the east edge with a break in the low wall for a short staircase to the driveway. The porch ceiling is lacquered beadboard with a small metal (possibly copper) Arts and Crafts-style pendant light at center. There is a vent in the peak of the flared gable, with a brace on either side of the vent. The gable has the same ribbon-course pattern as the rest of the house. There are three ganged wood windows with decorative screens to the left of the porch with a wood planter box running the length of the windows. The north wall of the patio has French doors with wood screen doors. The west wall of the patio has the original wood front door with a wood screen door flanked by one-over-one wood windows with decorative wood screens. Protruding from roughly the southwest corner of the roof is one of two hourglass-shaped stone chimneys, visible from the right-of-way. This front chimney has concrete capital and a square metal vent.

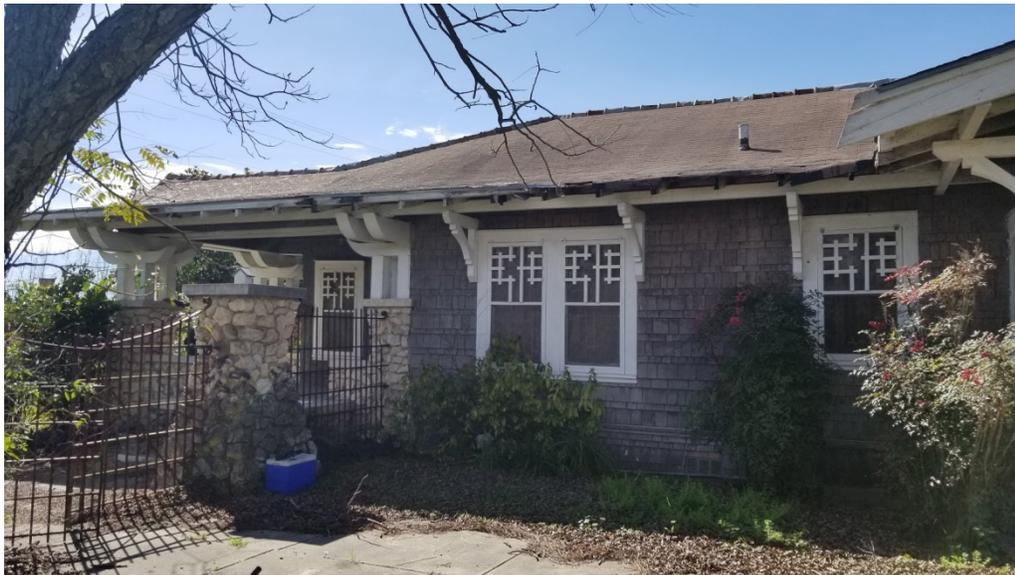
South half of east  
facade

On the east façade, from south end to north, are a pair of ganged one-over-one wood windows with decorative wood screens followed by a single one-over-one wood window with decorative wood screen. This side of the house has a small gabled wing; the south elevation of the wing has a wood door and wood screen door on the left and a one-over-one wood window with decorative wood screen on the right. The gable end has three ganged one-over-one wood windows with decorative wood screens with braces at each side of the elevation and braces on either side of a vent at the peak of the gable.

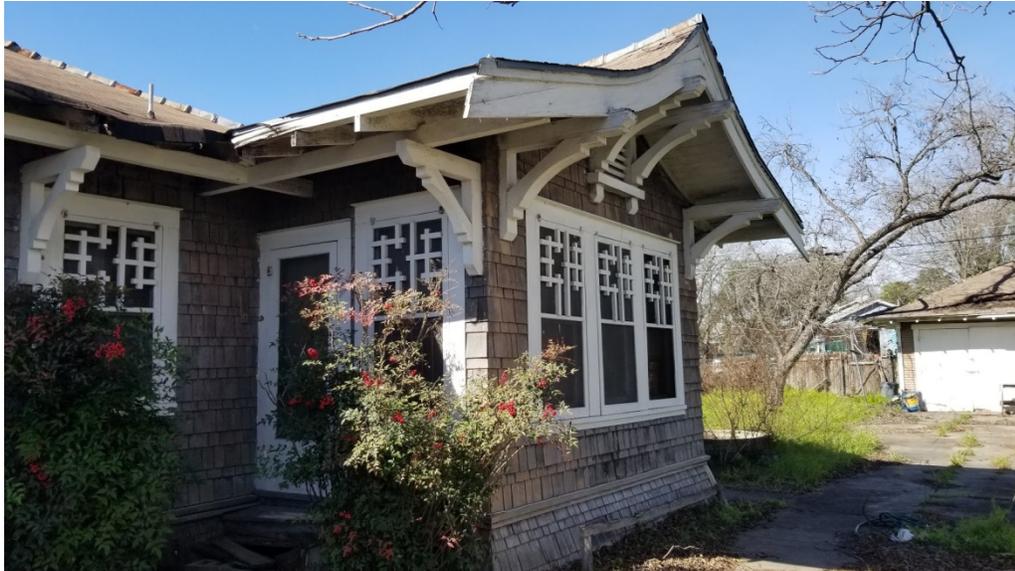
North half of east  
facade

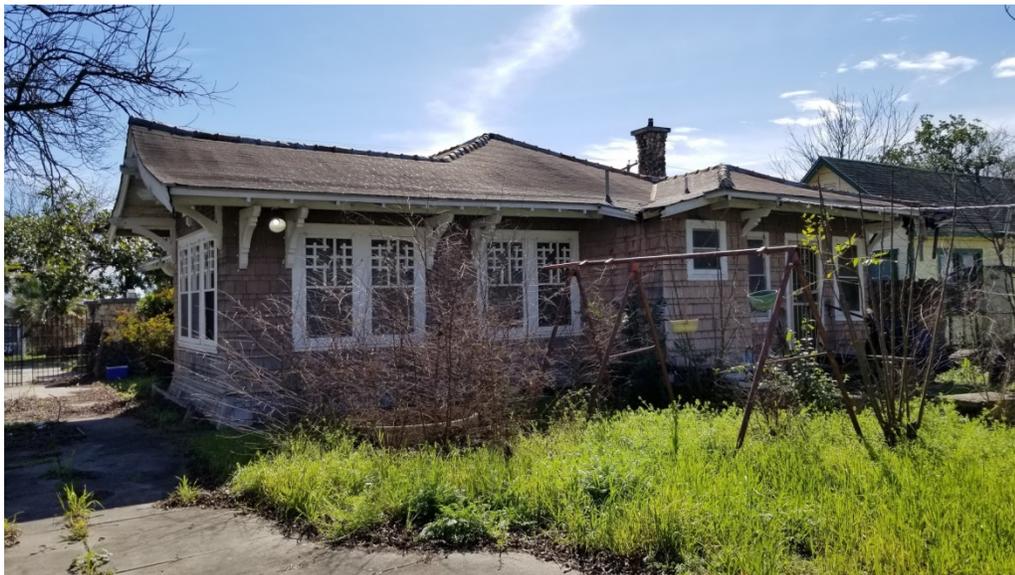
North facade

The north (rear) elevation, from east to west, has two pairs of ganged one-over-one wood windows on the first plane. A room breaks from this elevation, with a small one-over-one wood window and undecorated wood screen centered on the projection. The elevation steps back again and has what appears to be a more modern door with a decorative metal screen door flanked by one-over-one wood windows with undecorated

wood screens. From the projection to the west edge of the façade, the roofline remains the same despite changes in the elevation, creating a covered stoop at this rear entrance. There is a brick patio separated from the house by a concrete sidewalk and three steps up to the back door; the sidewalk connects to the driveway.

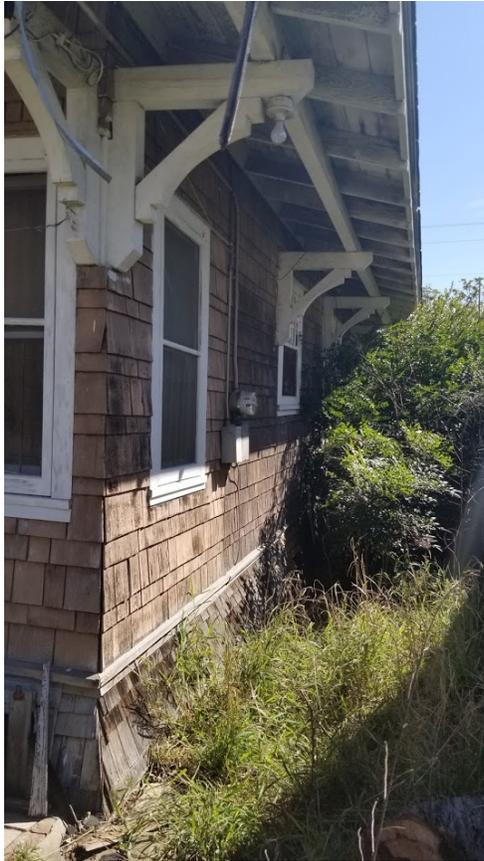
West facade

The west elevation was difficult to access and document due to some overgrown landscaping near the southwest corner of the house. From left to right, the elevation has a single one-over-one wood window with undecorated wood window screen, then a smaller one-over-one wood window with wood window screen. The trim of a third window is just visible beyond the third brace; no other details are visible. Roughly five feet from this elevation is a stone wall four- to five-feet tall with jagged rocks at the top instead of a smooth cap. The stone differs from that used on the primary structure's pedestals and wall along the right-of-way: stones are set with the largest face visible. This stone wall runs the length of the west façade.

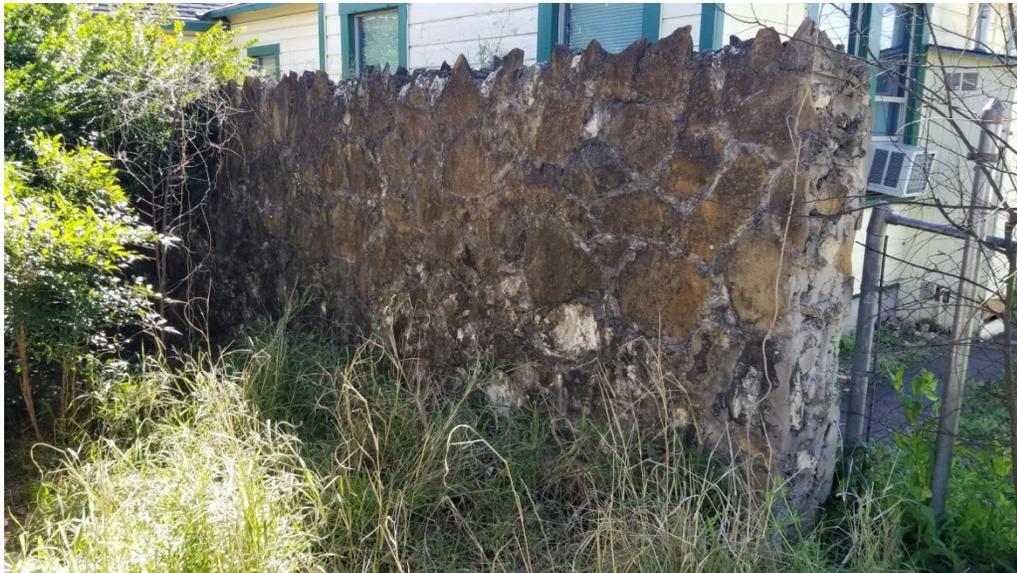
Stone wall along west  
edge of parcel

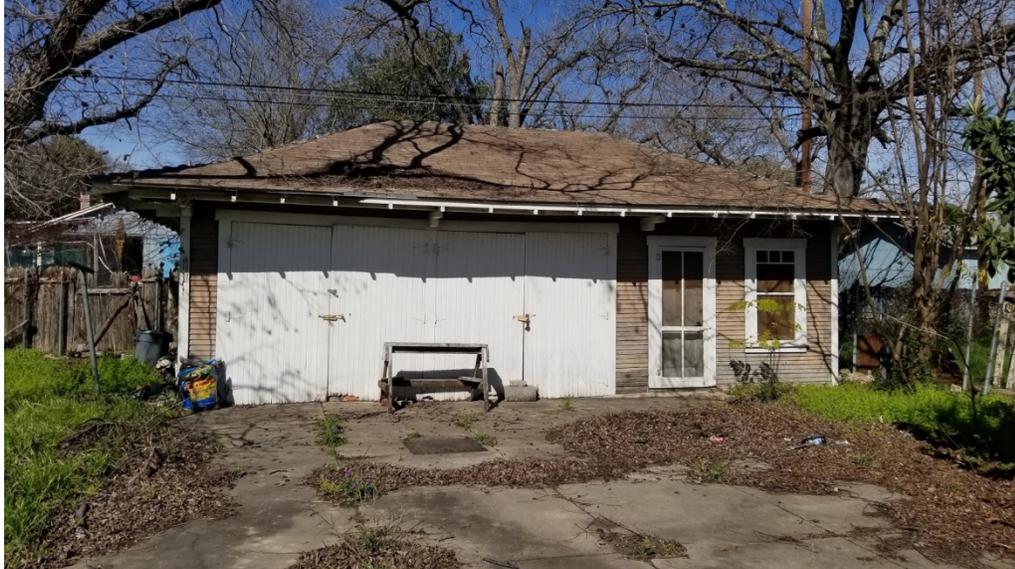
Rear garage

North of the house in the northeast corner of the parcel is a detached garage with a flared roof and the same metal barrel ridge caps and asphalt shingles as the primary structure. The hipped roof has exposed rafters, shallow braces under wide eaves, and clapboard siding instead of the shingles found on the primary structure. The south façade of the garage has a pair of ganged swinging garage doors followed by a single wood door and two-over-two wood door screen. The door is followed by a single one-over-one wood window with a four-over-one wood window screen.

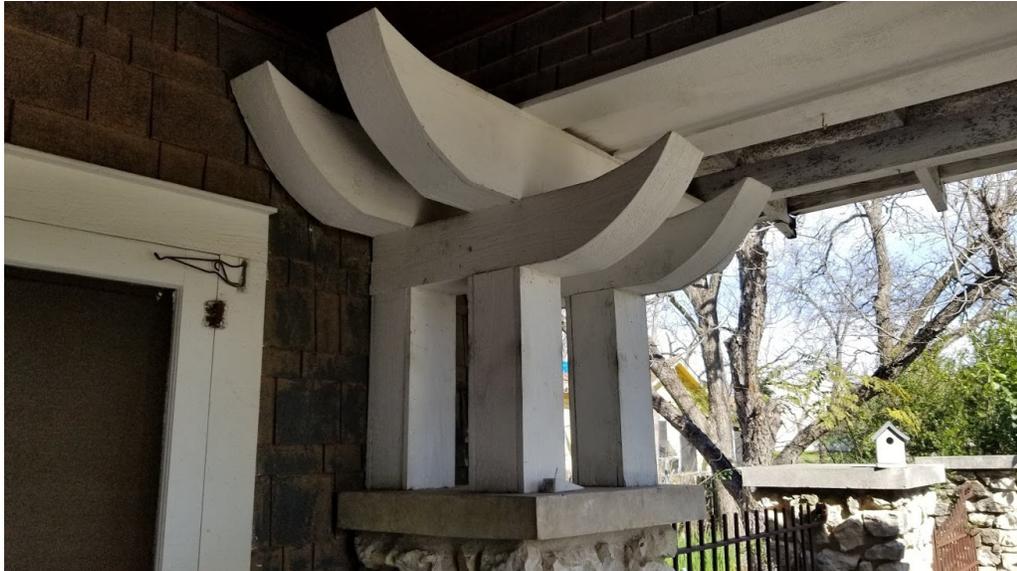
A closer view of the porch columns and beams. Construction method is readable in the joinery.

Rough stone pedestals for the porch and carport and the stone chimneys are hourglass-shaped and topped with concrete capitals. Porch pedestals are topped with four square columns and beveled, stacked beams. The seams are visible in the beveled beams, allowing staff to see how they were constructed to create the tails at beam ends. The house retains all of its original one-over-one wood windows and patterned wood screens, and all but one of its original wood doors and wood door screens, as well as its original footprint; there are no additions to the primary structure. The current owner has added interior burglar bars to most of the windows; they appear to be set between the window and screen when present.

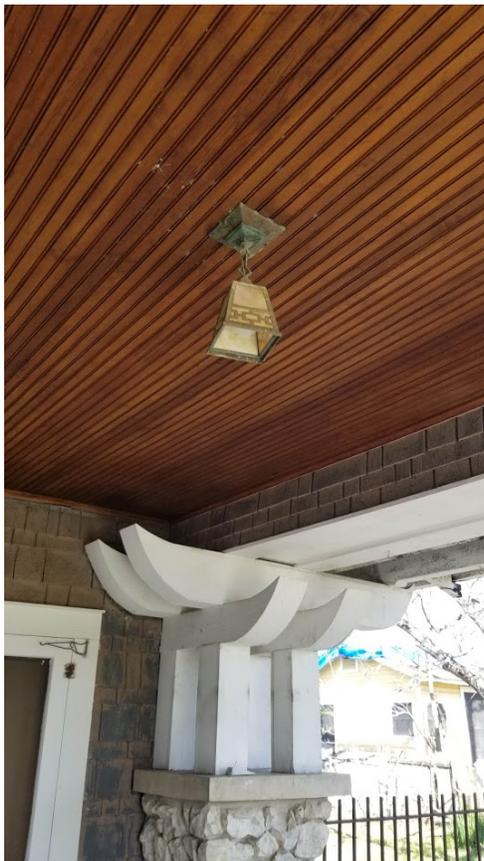
Porch ceiling and metal pendant light

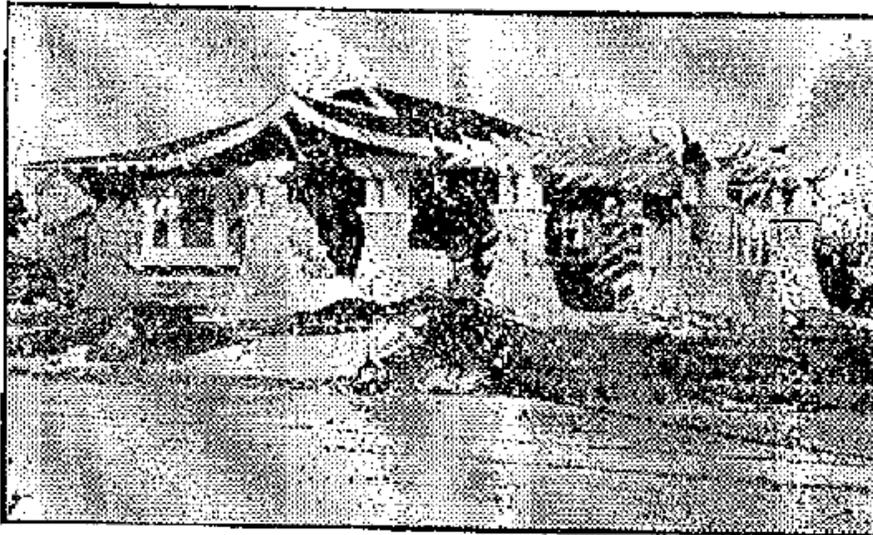
*New Bungalow—Highland Park*

San Antonio *Light*, June 4, 1922, featuring a photo of the structure at 843 Rigsby Ave. Note the pergola-style carport, since removed.

843 Rigsby Ave first appears in a June 4, 1922, advertisement for Highland Park, “the addition with character.” The ad touts the individuality of the neighborhood and chose this high-style and unique home to drive that point home.<sup>1</sup> In the 1924 city directory, the address is listed as home of Dennis “Denny” and Rose McNerney. The couple first rented the home, and then purchased it from Jules and Amie (alternately reported as Annie) Hill in February 1926. The McNerneys owned 843 Rigsby Ave until c. 1946. They rented it for about a year before selling it to John F. and Helen A. Milhan. Mr. Milhan died in 1961, followed by Mrs. Milhan in 1963. The current owner’s aunt, Annabelle L. Fisher (alternately Fischer), purchased the home from L. J. Milhan c. 1963, after Fisher, her sister Lilly Miller, and Lilly’s daughter Marie (the current owner) were displaced from their previous home at 1107 Hoefgen Ave by the expansion of Highway 37. The structure at 843 Rigsby Ave has remained in their family since.<sup>2</sup>
