HISTORIC AND DESIGN REVIEW COMMISSION

HDRC CASE NO: 2019-352
ADDRESS: 1021 N PALMETTO
LEGAL DESCRIPTION: NCB 1369 BLK 6 LOT N 46 FT OF 8 & 9 ARB A-1
ZONING: R-4,H
CITY COUNCIL DIST.: 2
DISTRICT: Dignowity Hill Historic District
APPLICANT: James Benfield/BENFILED REAL ESTATE LLC & G6 HOMES LLC
OWNER: James Benfield/BENFILED REAL ESTATE LLC & G6 HOMES LLC
TYPE OF WORK: Amendment to previously approved siding specifications
APPLICATION RECEIVED: May 16, 2019
60-DAY REVIEW: July 15, 2019
CASE MANAGER: Stephanie Phillips
REQUEST:

The applicant is requesting a Certificate of Appropriateness for an amendment to allow for the use of faux wood Hardie siding in lieu of the previously approved smooth Hardie siding on the new construction located at 1021 N Palmetto.

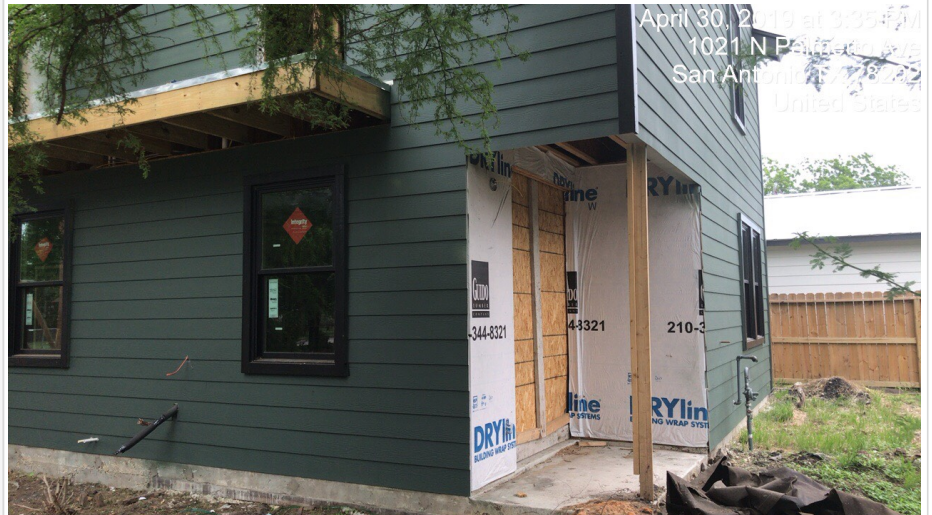
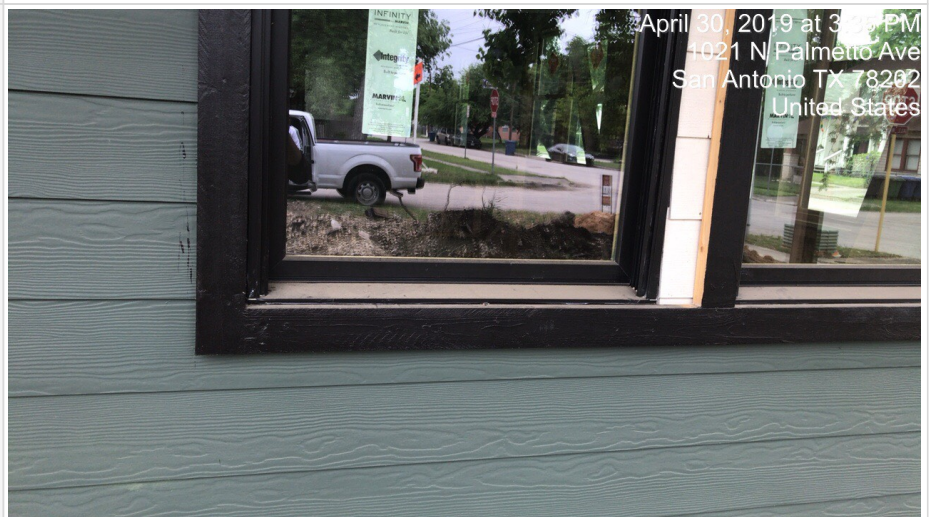
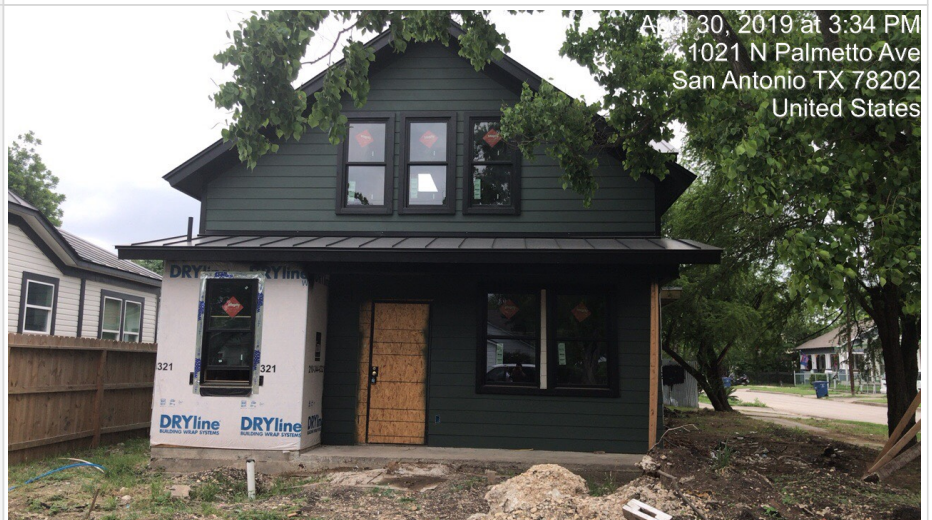
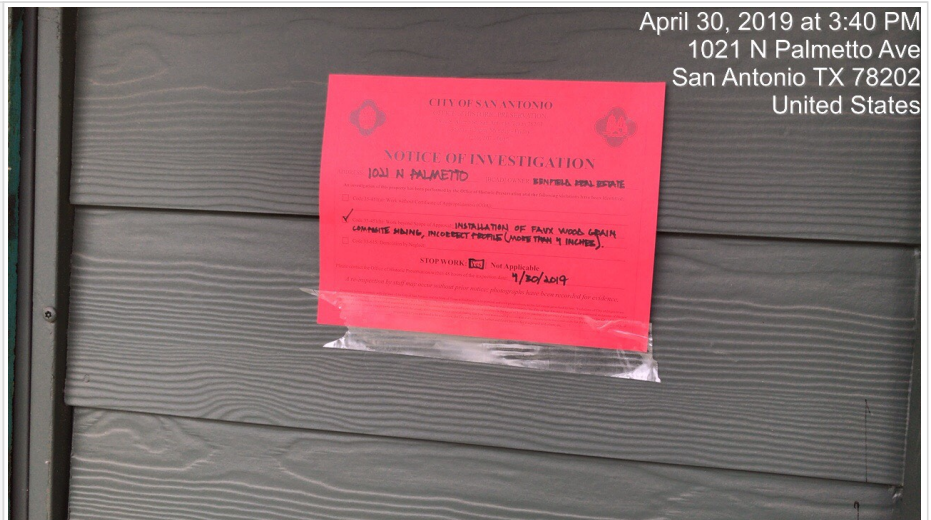
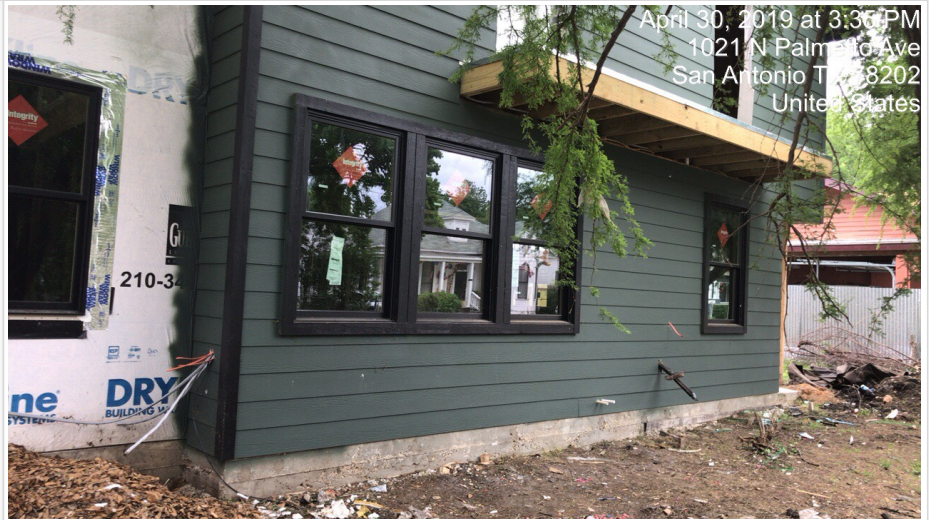
On April 30, 2019, a Notice of Investigation was posted on the property by OHP staff due to the use of faux grain Hardie siding, which was inconsistent with the final approval for new construction granted by the HDRC on March 21, 2018. Photographs from the site investigation are included in the exhibits.

Date	04/30/2019
Time	03:39 PM (-5 GMT)
Context	citizen report
Present Staff	Huy Pham, Edward Hall
Present Individuals	None
Types of Work Observed	New Construction
Amount of Work Completed	50%
Description of work	Installation of siding material inconsistent with approval.

Violation Type	Beyond scope of Certificate of Appropriateness (Code 35-451h)
OHP Action	Posted "Notice of Investigation"
Will post-work application fee apply?	No
