# HISTORIC AND DESIGN REVIEW COMMISSION

**HDRC CASE NO:** 2020-027  
**ADDRESS:** 1425 S FLORES ST  
**LEGAL DESCRIPTION:** NCB 1009 BLK LOT 40B  
**ZONING:** IDZ, H, RIO-7  
**CITY COUNCIL DIST.:** 1  
**LANDMARK:** Fest Block  
**APPLICANT:** Kris Feldmann/Creoarc, LLC  
**OWNER:** Jacob Harris/HB PROPERTIES I LLC  
**TYPE OF WORK:** Storefront restoration, cleaning  
**APPLICATION RECEIVED:** January 17, 2020  
**60-DAY REVIEW:** March 17, 2020  
**CASE MANAGER:** Edward Hall

# Fest Block

HDRC SUBMITTAL | 2020.1.17

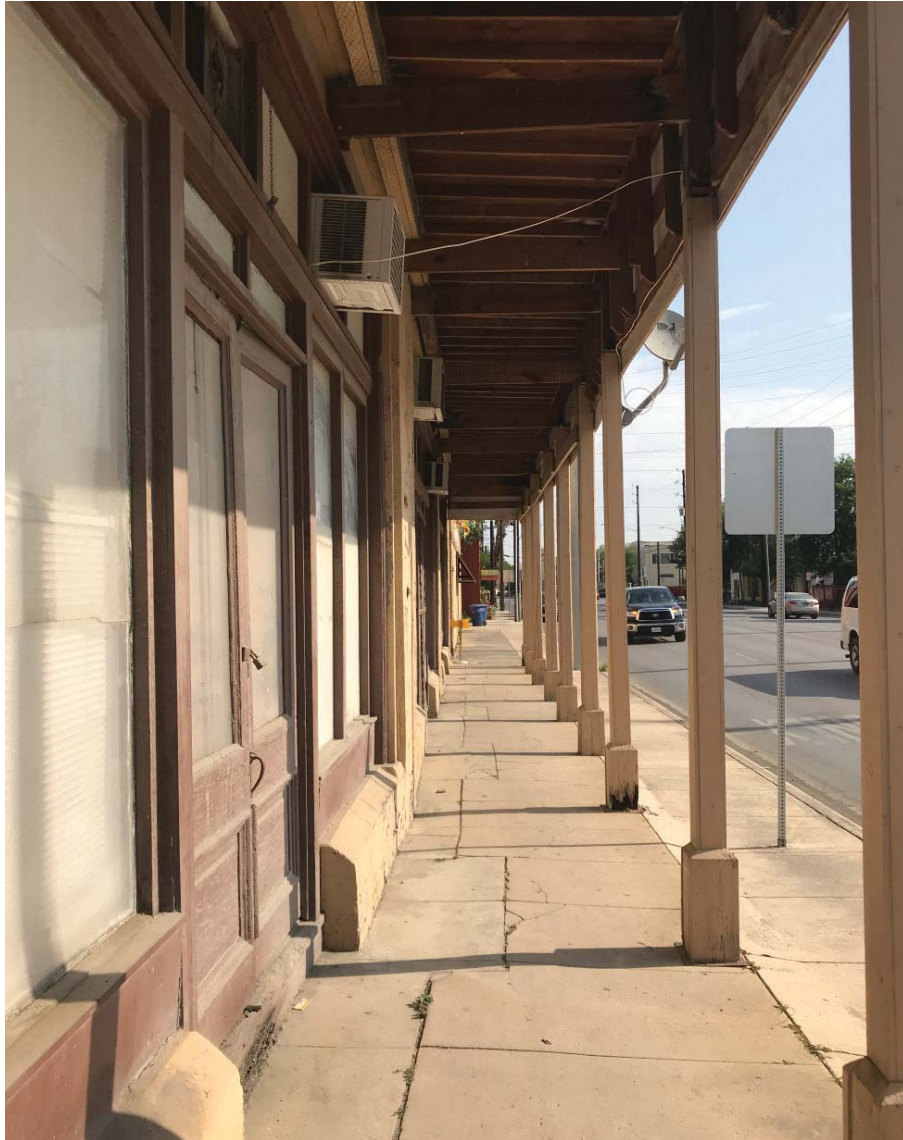
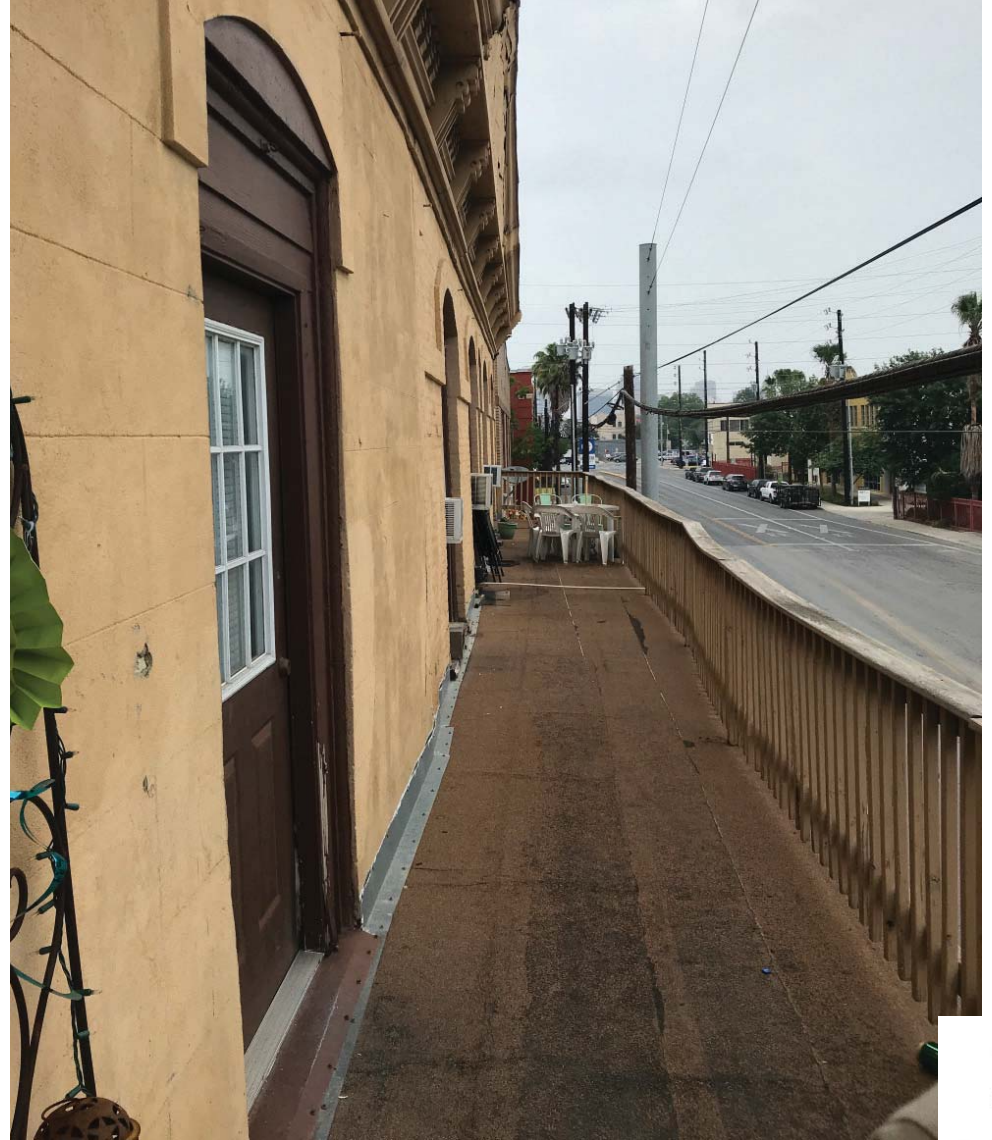
**HARRIS BAY**

**EXISTING EXTERIOR CONDITIONS - SOUTH (CEVALLOS ST.)**

**① DETERIORATING SINGLE PANE WOOD FRAMED WINDOWS - TO BE REPLACED (REF. WINDOW SPEC EXHIBIT)**

**② ORIGINAL OPENINGS TO REMAIN. DETERIORATING NON-ORIGINAL WINDOWS AND DOORS TO BE REPLACED**

**③ EXISTING ROOF TO BE ASSESSED AND REPAIRED/REPLACED AS NEEDED. CORNICE TO REMAIN AND TO BE REPAIRED.**

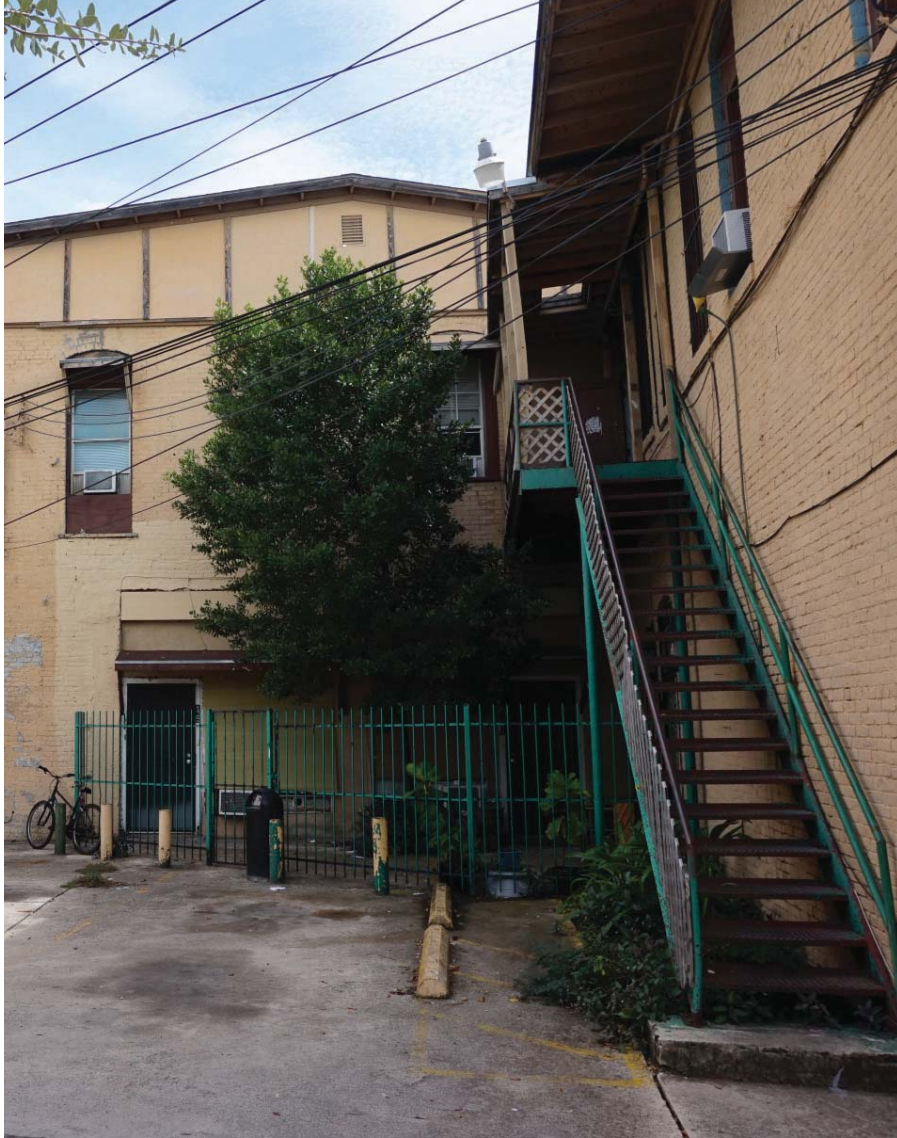
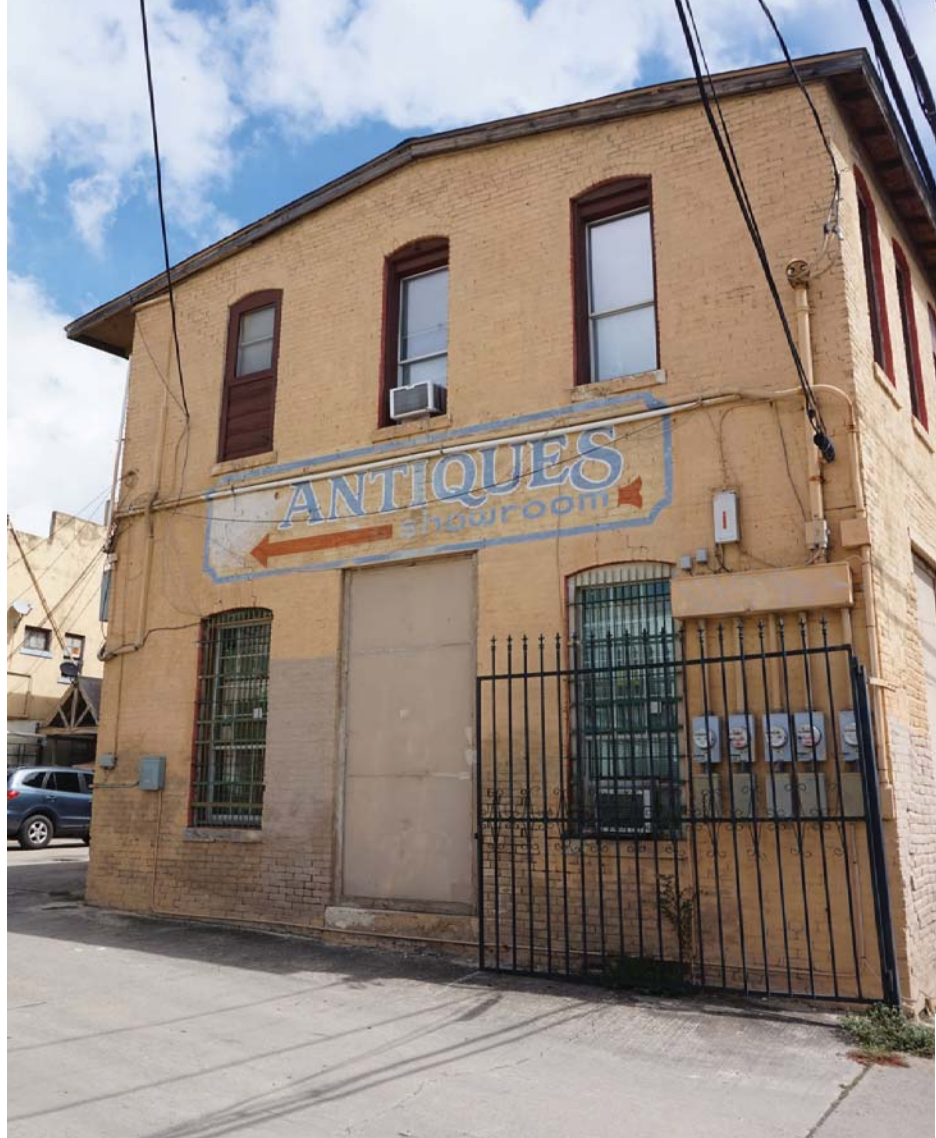
**HARRIS BAY**

- ① DETERIORATING SINGLE PANE WOOD FRAMED WINDOWS - TO BE REPLACED (REF. WINDOW SPEC EXHIBIT)
- ② CLEAN ORIGINAL BRICK FACADE AND REPAIR AS NEEDED
- ③ EXISTING ROOF TO BE ASSESSED AND REPAIRED/REPLACED AS NEEDED.
- ④ EXISTING STAIR TO REMAIN.
- ⑤ EXISTING METAL FENCE TO BE REMOVED

EXISTING EXTERIOR CONDITIONS - WEST (PARKING LOT)

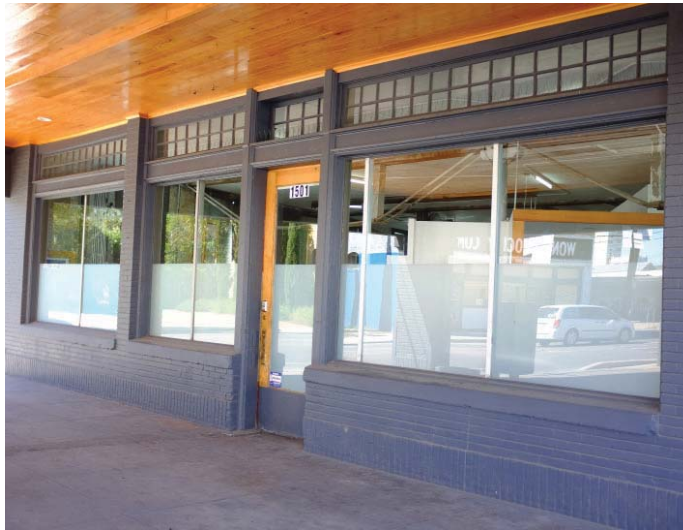
**G** EXHIBIT G  
NON-HISTORIC ALUMINUM  
STOREFRONT W/ FROSTED FILM  
ON EXISTING STOREFRONT  
OPENING

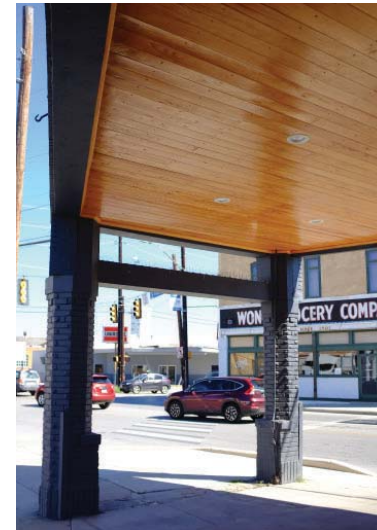
**H** EXHIBIT H  
NON-HISTORIC TREATMENT OF  
EXTERIOR PORCH SOFFIT

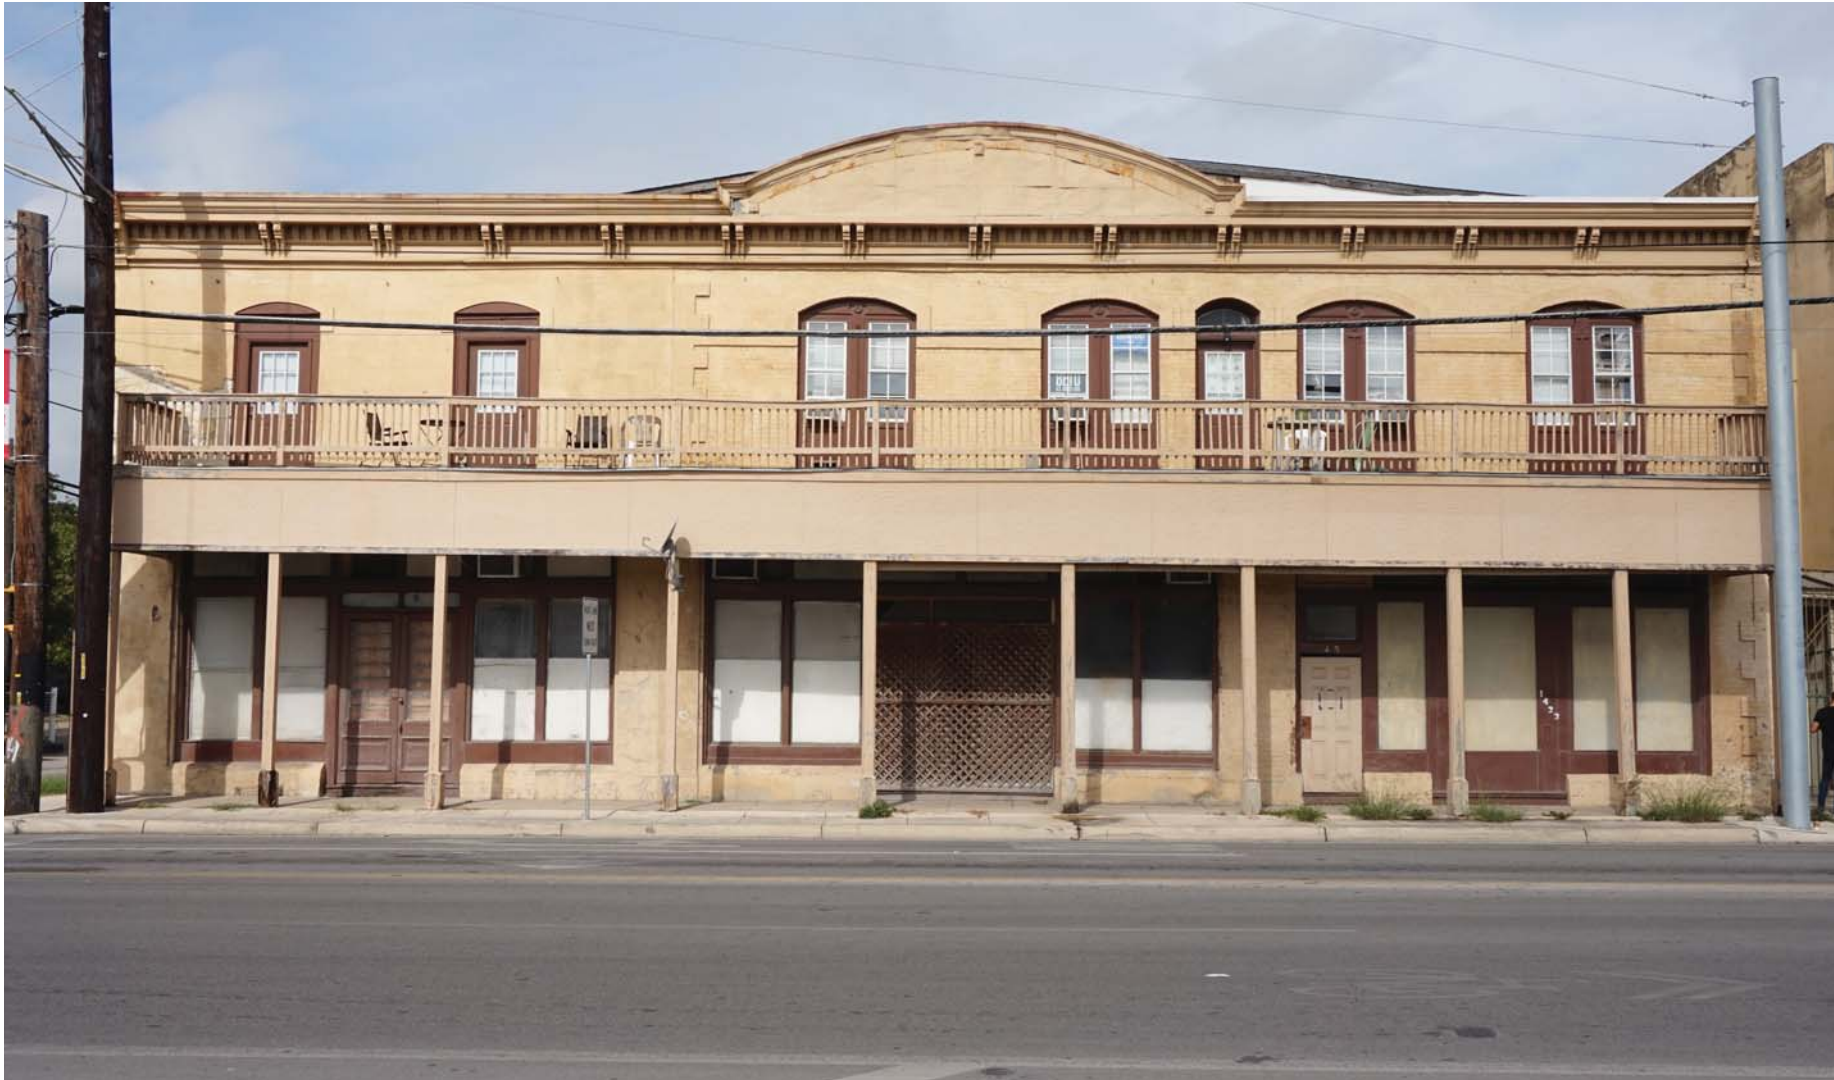
**HARRIS BAY**

**FROM THE PHOTOGRAPH, ITS DIFFICULT TO DETERMINE THE EXACT SIZE AND TYPE OF WINDOW THAT WAS INSTALLED AT THE TIME.**

EXISTING EXTERIOR CONDITION - EAST (STREET ELEVATION)

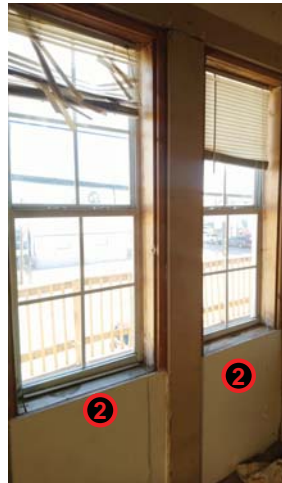
**② EXISTING NON-ORIGINAL WINDOW. VIEW FROM INSIDE. NON-ORIGINAL WINDOWS FRAMED INSIDE ORIGINAL OPENING**

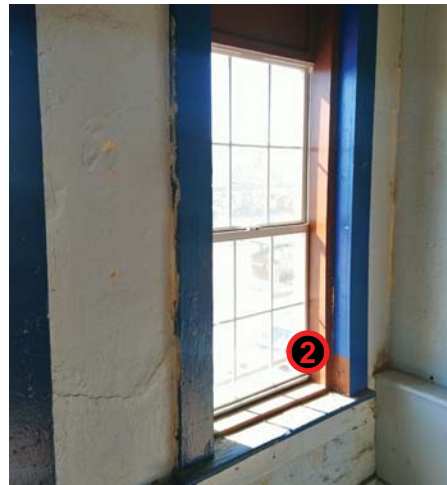
**② EXISTING NON-ORIGINAL WINDOW. VIEW FROM INSIDE. NON-ORIGINAL WINDOWS FRAMED INSIDE ORIGINAL OPENING**

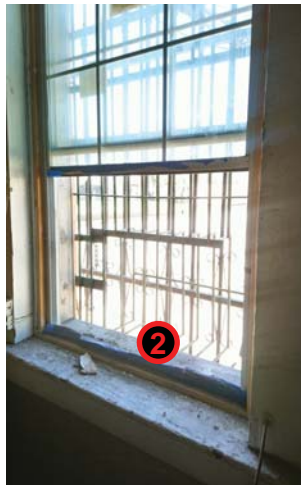
**2** EXISTING NON-ORIGINAL WINDOW. VIEW FROM INSIDE. NON-ORIGINAL WINDOWS FRAMED INSIDE ORIGINAL OPENING

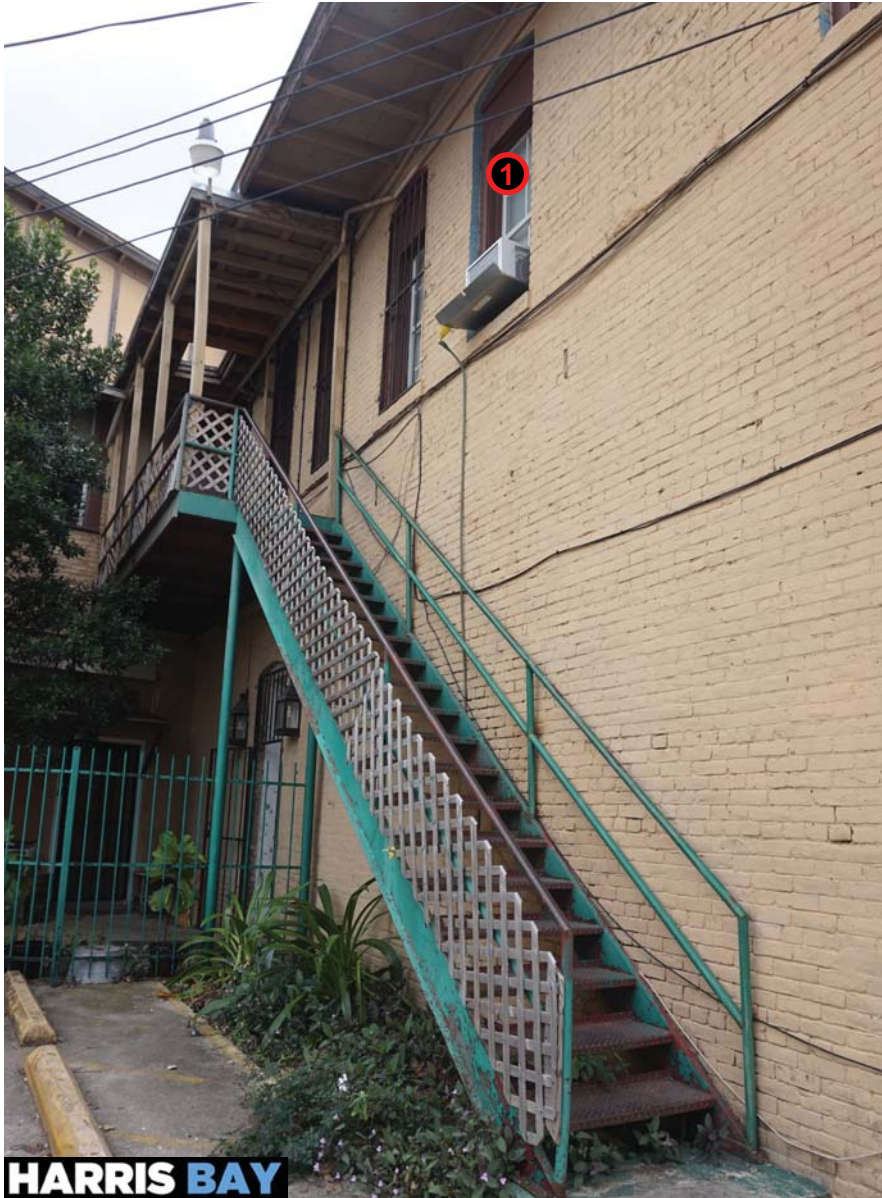
**EXISTING EXTERIOR CONDITIONS - SOUTH (CEVALLOS ST.)**

- 1** EXISTING NON-ORIGINAL WINDOW. NON-ORIGINAL WINDOWS ARE INSTALLED THROUGHOUT THE ENTIRE BUILDING

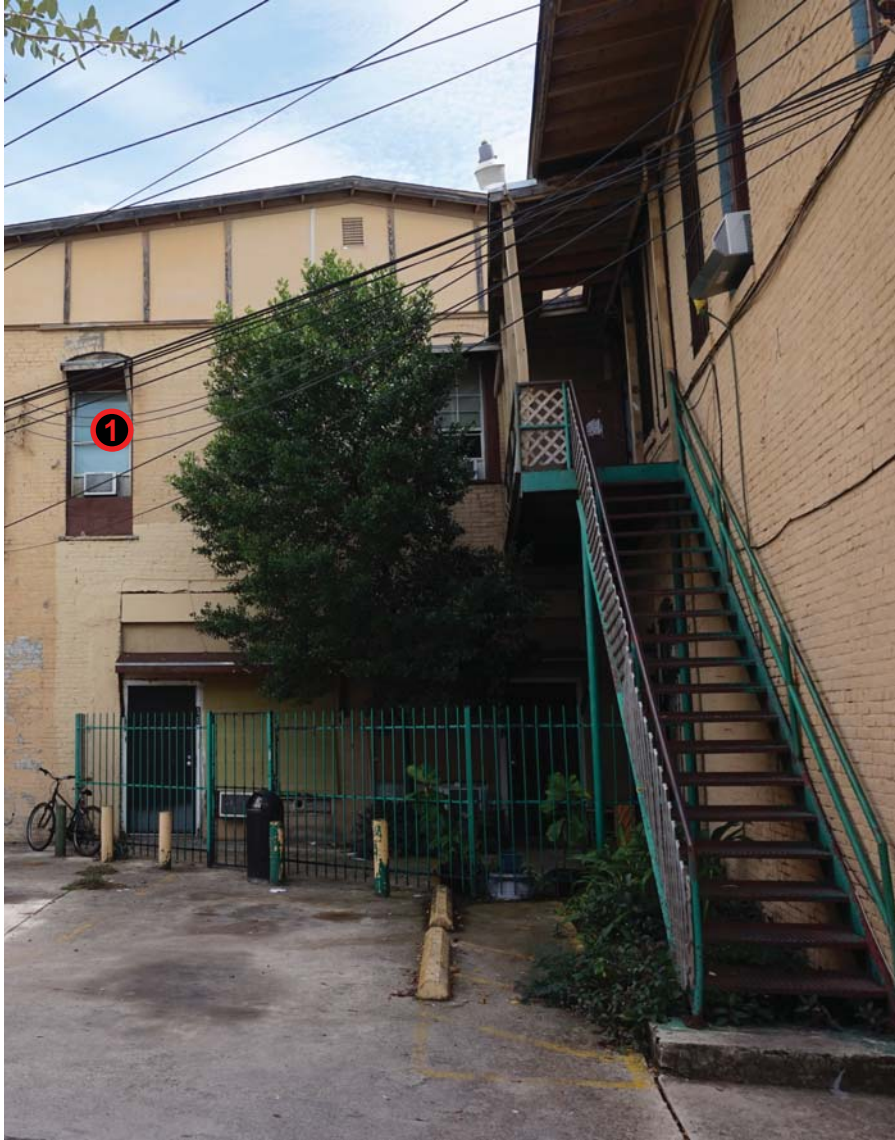
**EXISTING EXTERIOR CONDITIONS - WEST (PARKING LOT)**

**1** EXISTING NON-ORIGINAL WINDOW.  
NON-ORIGINAL WINDOWS ARE INSTALLED  
THROUGHOUT THE ENTIRE BUILDING

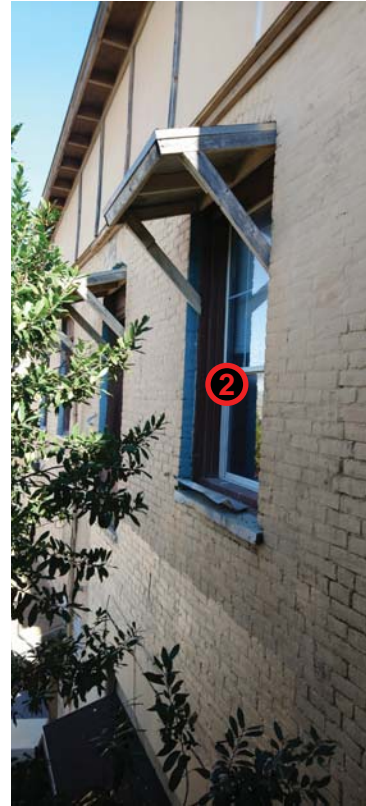
**2** EXISTING NON-ORIGINAL  
WINDOW.  
VIEW FROM INSIDE.  
NON-ORIGINAL WINDOWS  
FRAMED INSIDE ORIGINAL  
OPENING

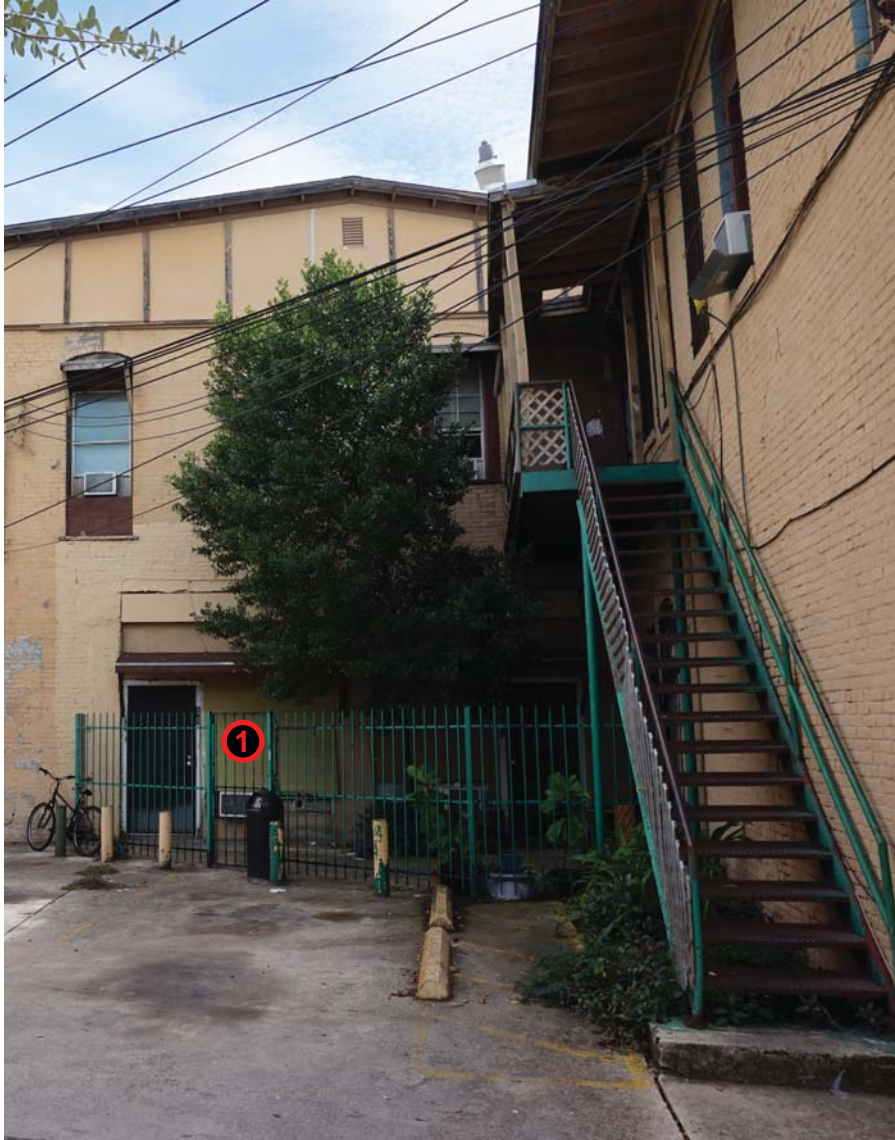
**EXISTING EXTERIOR CONDITIONS - WEST (PARKING LOT)**

**1** EXISTING NON-ORIGINAL WINDOW.  
NON-ORIGINAL WINDOWS ARE INSTALLED  
THROUGHOUT THE ENTIRE BUILDING
