# HISTORIC AND DESIGN REVIEW COMMISSION

May 01, 2020

**HDRC CASE NO:** 2020-122  
**ADDRESS:** 533 E CARSON  
**LEGAL DESCRIPTION:** NCB 993 BLK 3 LOT S 96.91 FT 7 (ARB 7C)  
**ZONING:** MF-33, H  
**CITY COUNCIL DIST.:** 2  
**DISTRICT:** Government Hill Historic District  
**APPLICANT:** Mary Jo Vargas/VARGAS MARY JOSEPHINE  
**OWNER:** Mary Jo Vargas/VARGAS MARY JOSEPHINE  
**TYPE OF WORK:** Siding and window replacement  
**APPLICATION RECEIVED:** March 04, 2020  
**60-DAY REVIEW:** May 03, 2020  
**CASE MANAGER:** Huy Pham

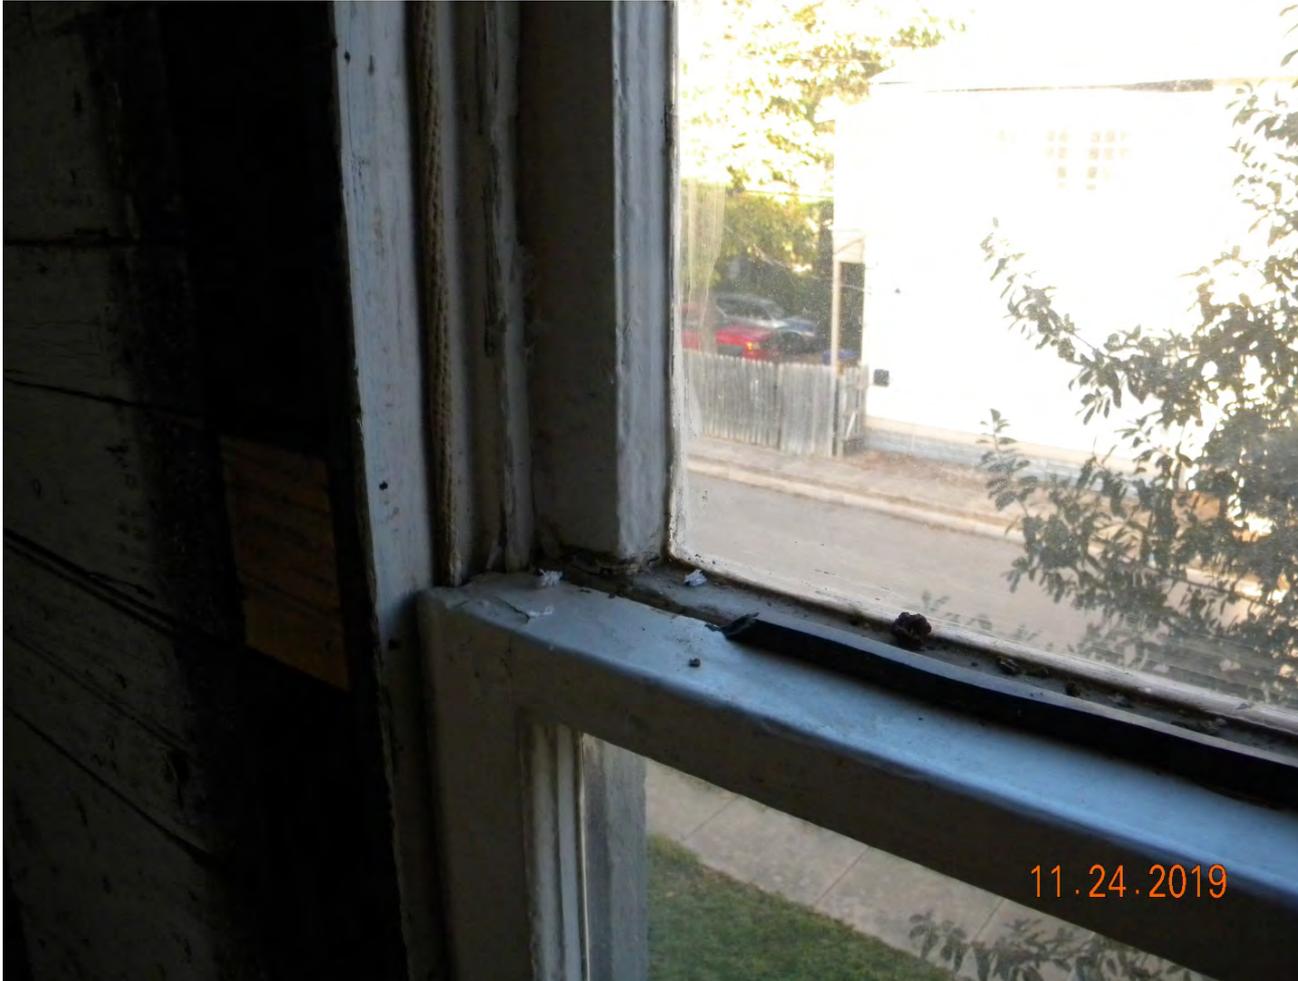
# Unit III, Bedroom 1, Window H

Use of foam  
between  
windows to  
reduce air  
drafts.

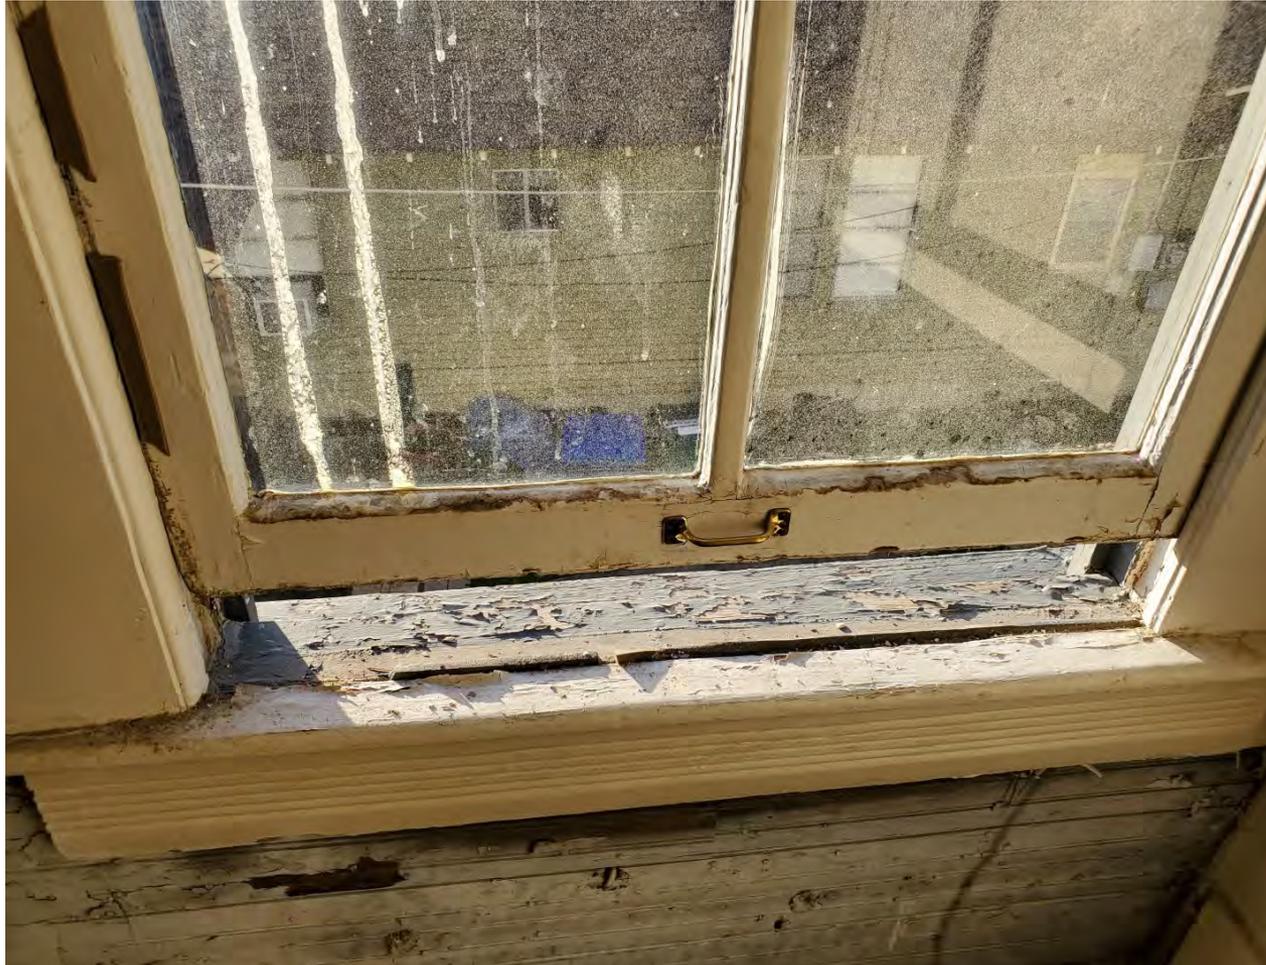
# Unit III, Living Room Window K

Closer inspection of window shows flaking and use of foam strips to reduce air drafts.

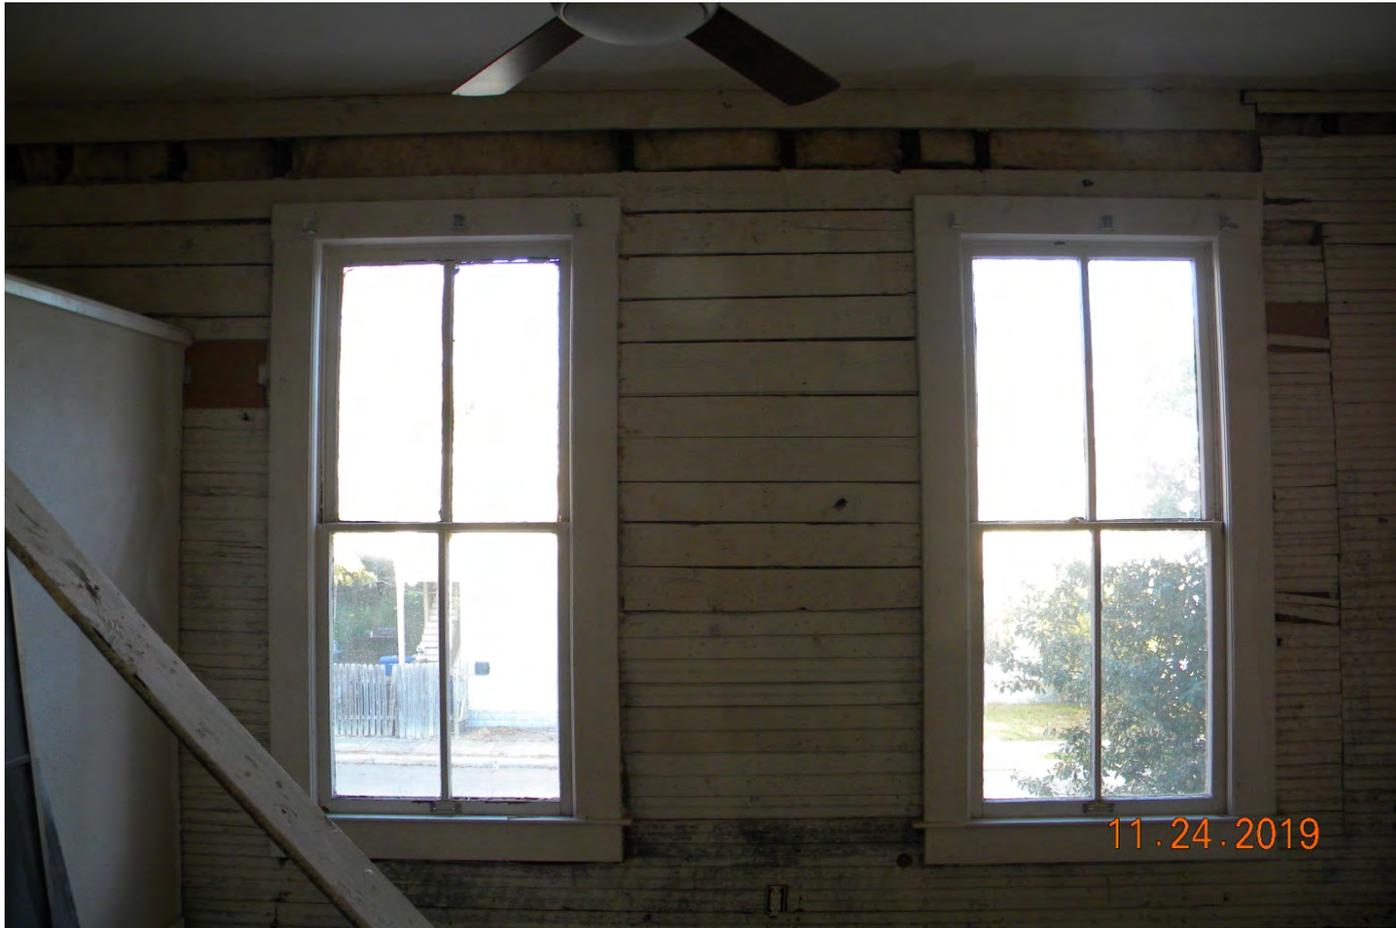
# Unit IV, Living Room Windows

- Unit IV
  - Living Room
    - Window L - Requires lead paint remediation and repair
    - Window M - Requires lead paint remediation and repair

Windows from right to left are L and M

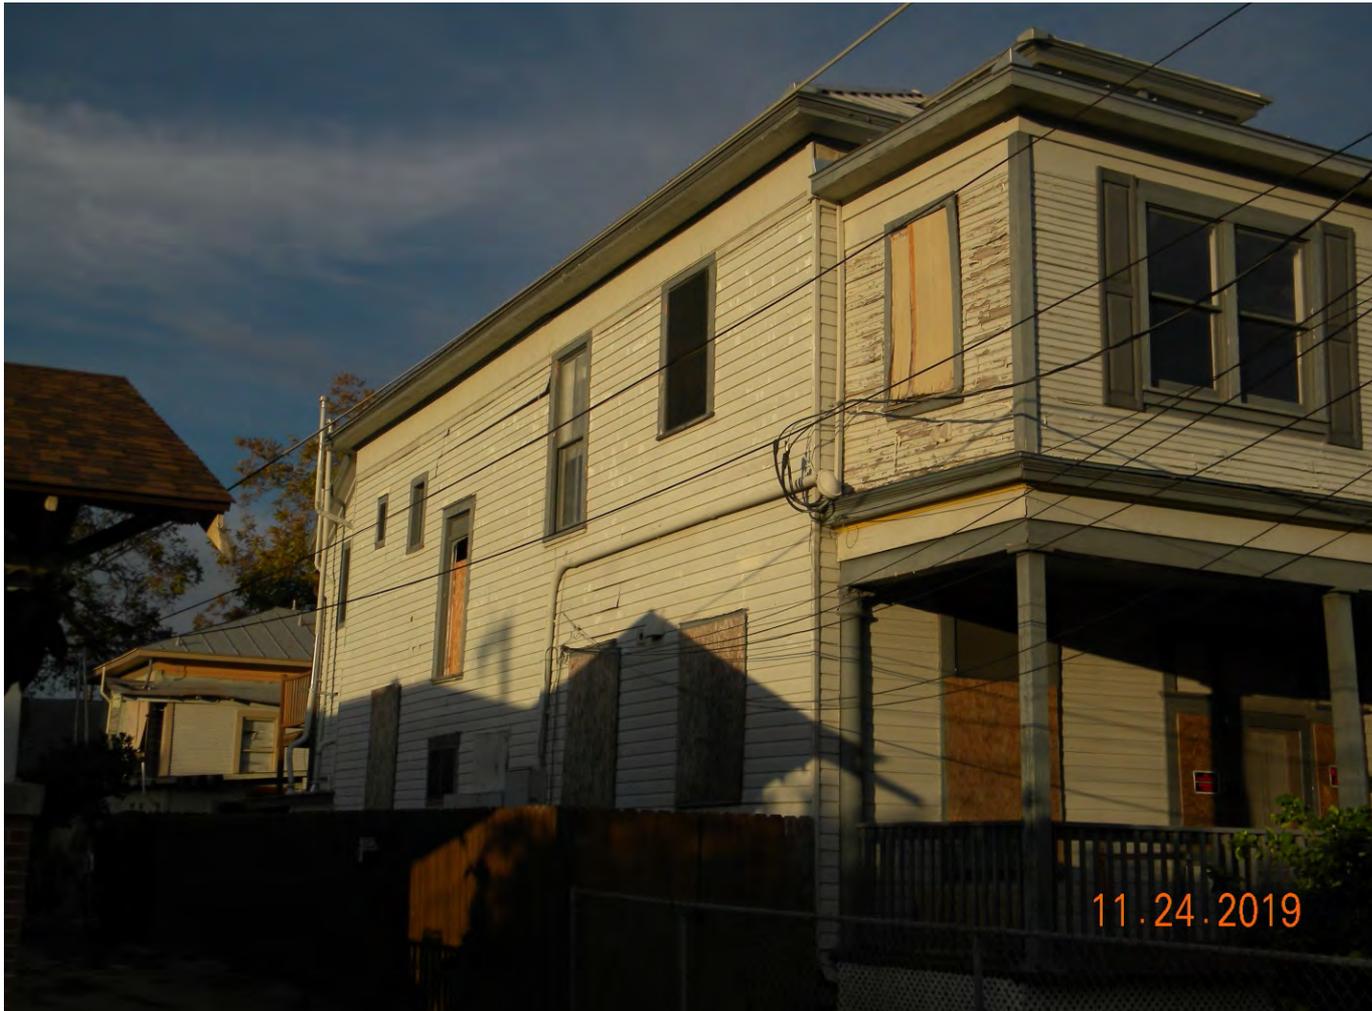
# Exterior, West Side of Property

The west side of the property has aluminum siding except for the enclosed upstairs portion of the porch, which is finished in waterfall siding.

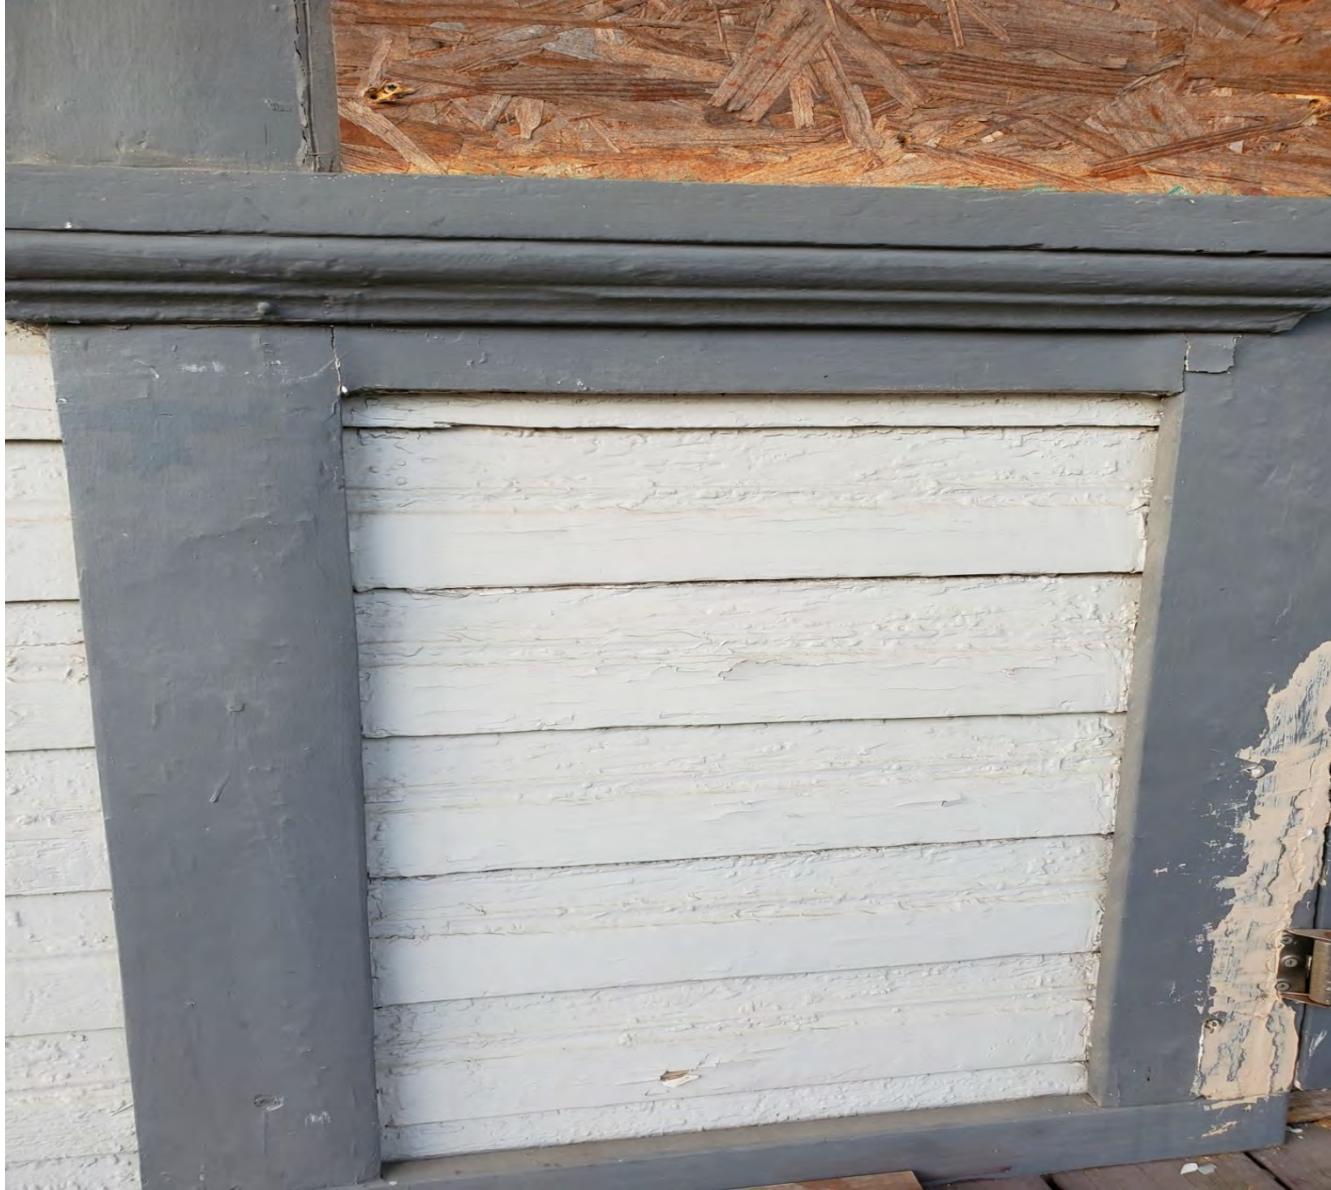
# Picture of Original Siding

Left sided  
of the  
front door.

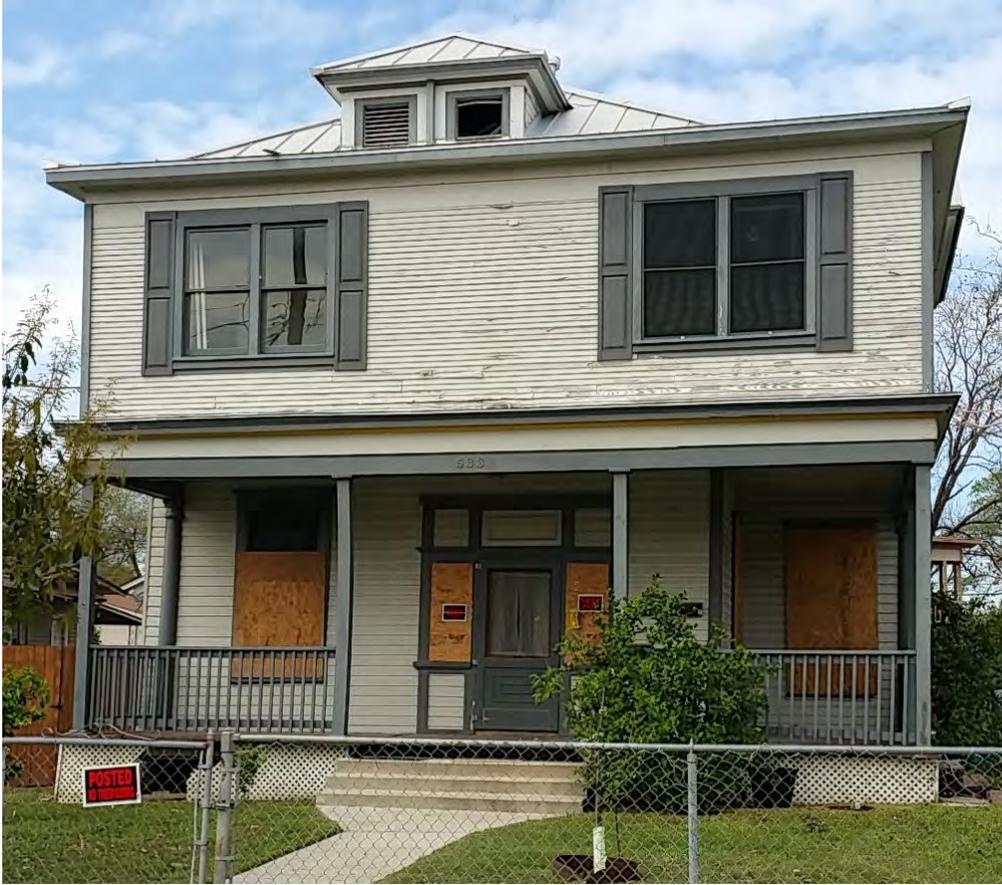
Front of property with waterfall siding, enclosed upper porch, no columns-capitals or bases on porch.

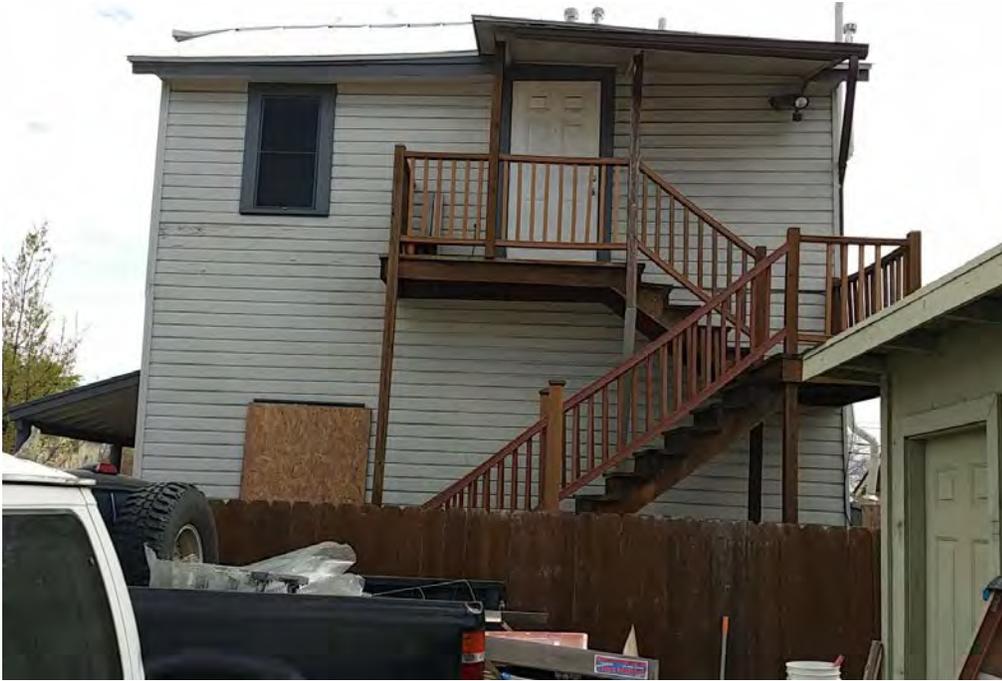
Back side of property with 105 wood siding installed in 2009. Has not weather very well.

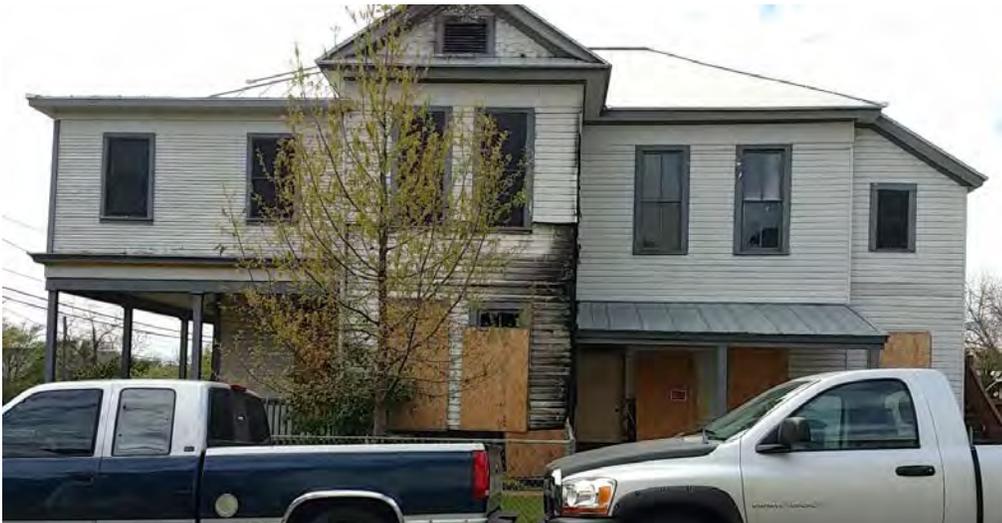
Below, east side of property with waterfall siding on the top left side and the rest aluminum siding.

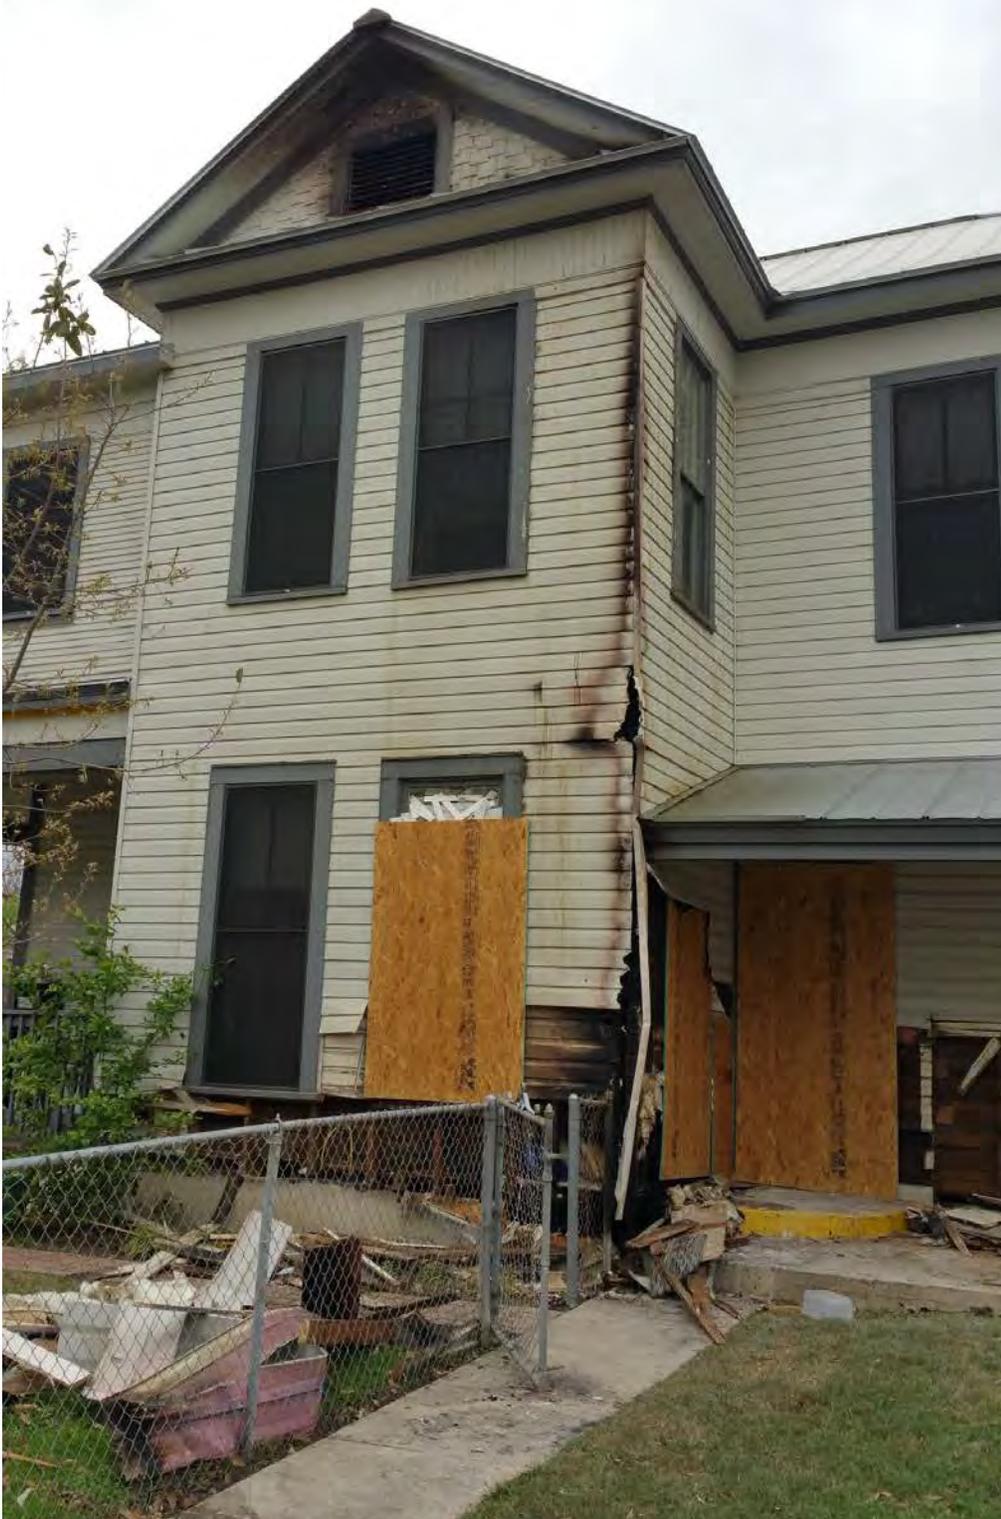
Aluminum siding on the left with 105 wood siding on the right, picture is of the Northeast back corner of the property.

Damage to aluminum siding does not appear to be extensive. Fire went through attic and out of gable.

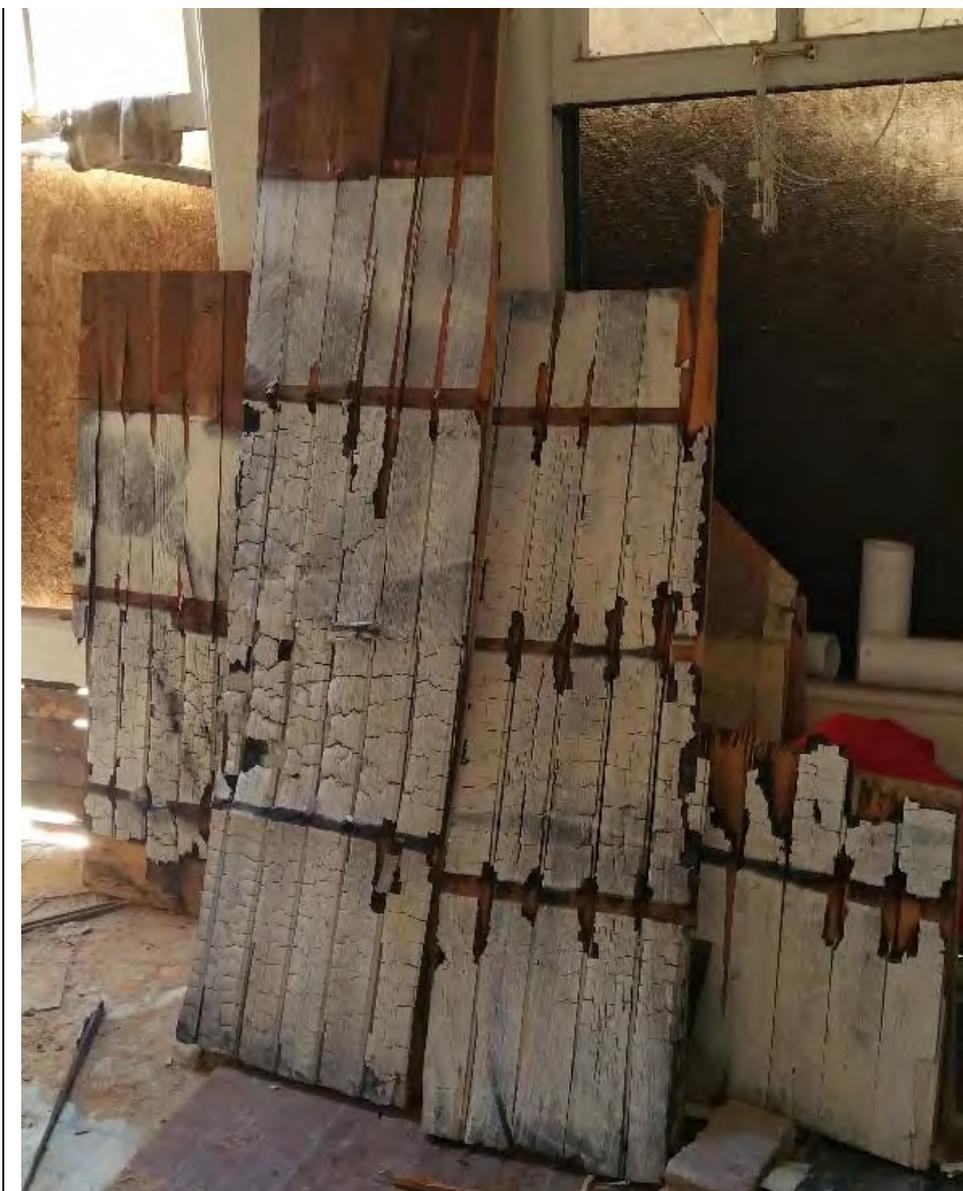
Fire damaged wall cavities that were removed.

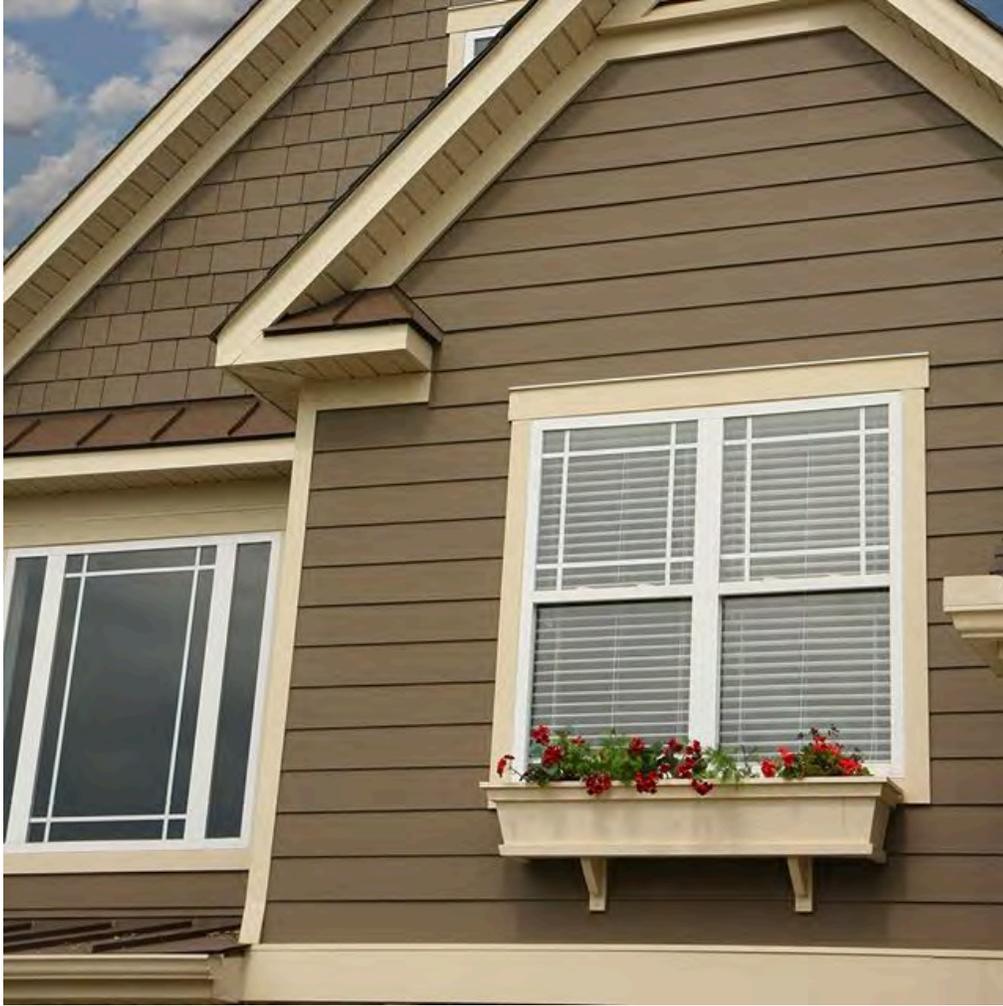
Hail damage in 2013

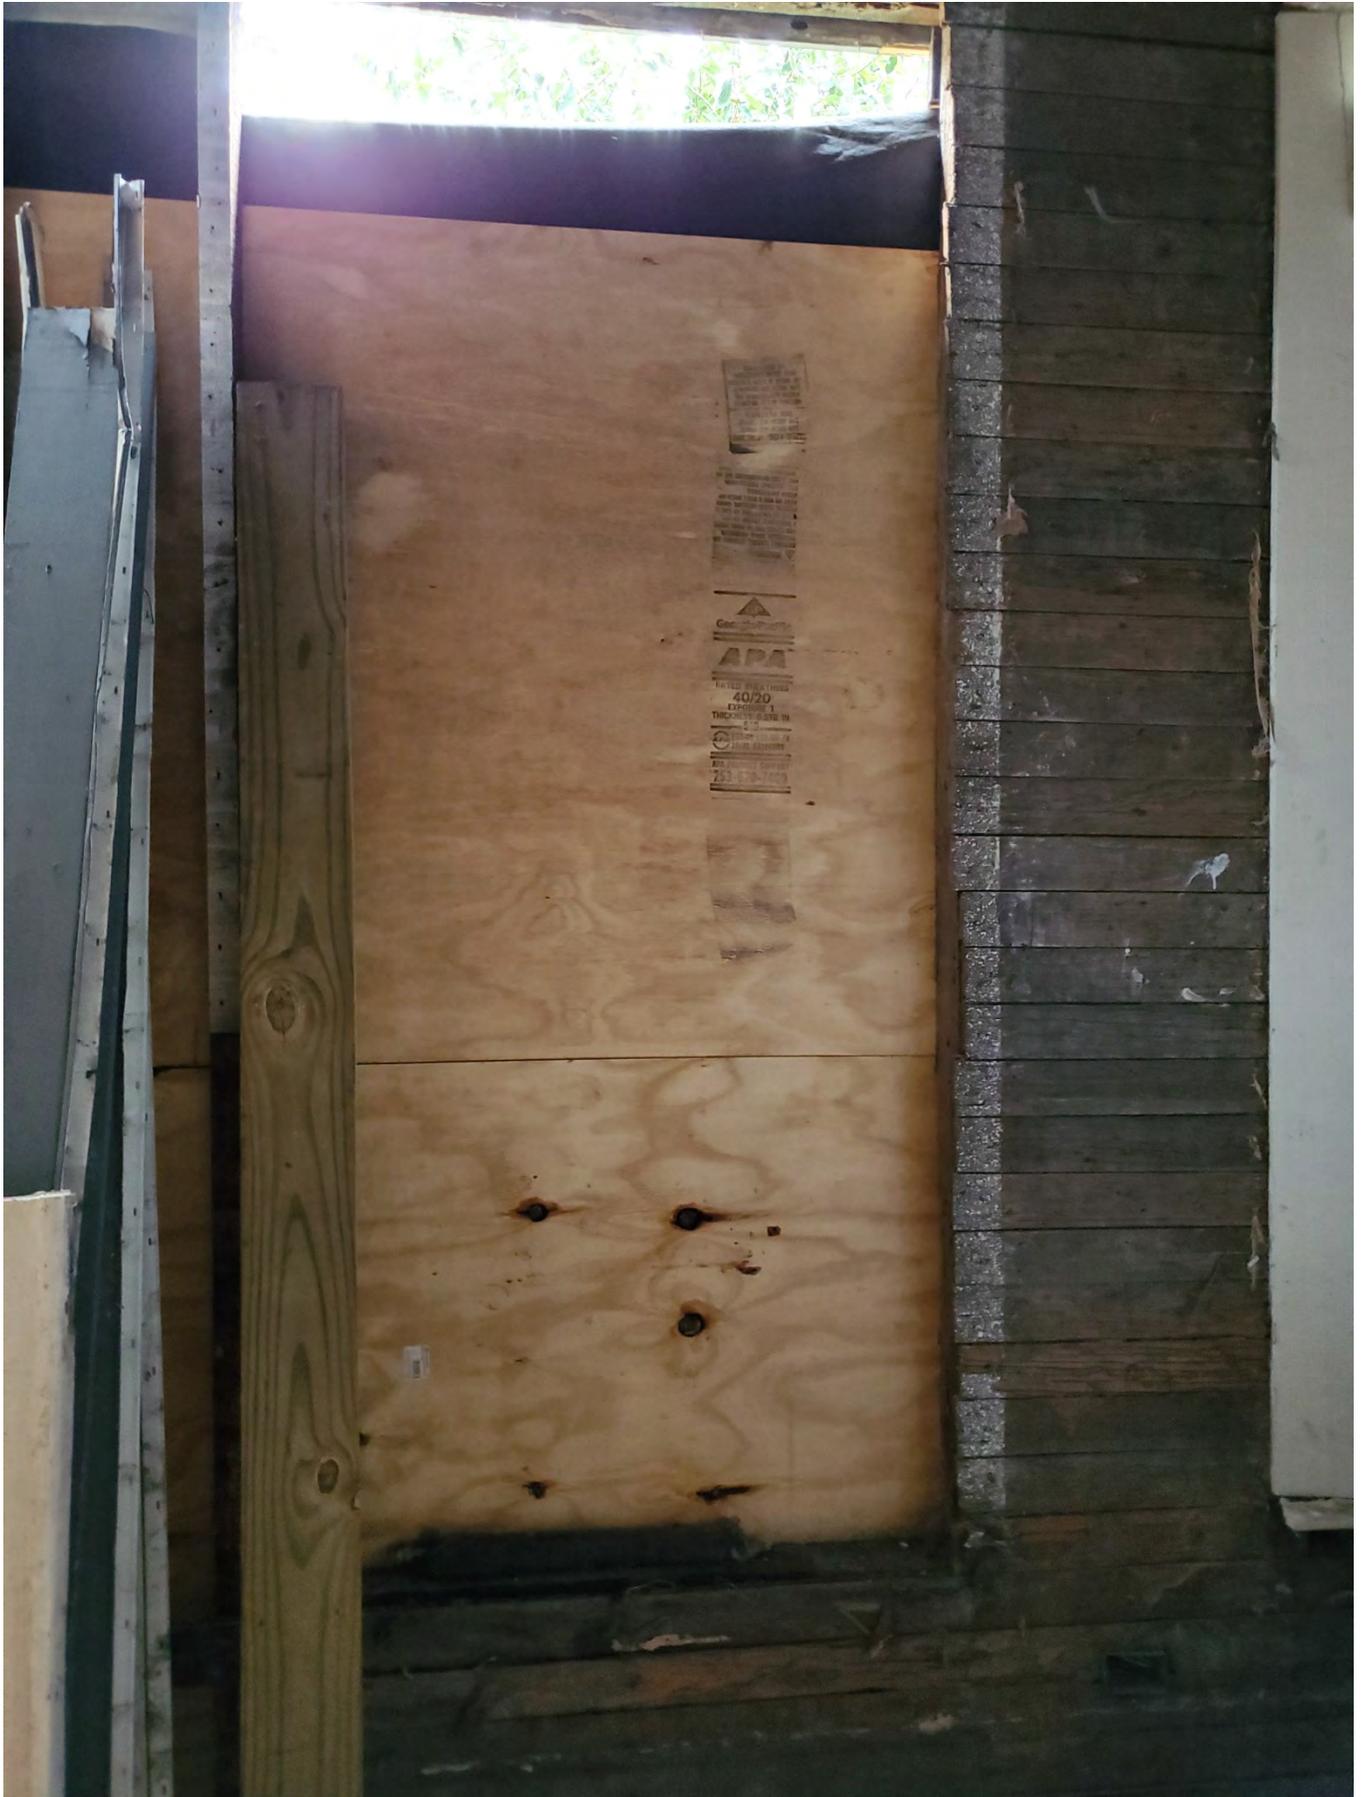
This section consists of window pictures and the original wood siding.

1. The first picture is where the 4 panel 3'X7" wood window was destroyed in the fire.
2. Pictures of other windows show water damage from fire suppression activities. Remediation is needed to remove lead based paint that is flacking off. The estimated cost of remediation is \$15,600. This does not include needed repairs and painting the windows. An additional estimated cost of XXXXX

3. Pictures of the exterior portion of the windows.
4. The last three pictures are of the original wood siding on the front porch area. This area represents approximately 7% of the total property.

Remediation of these windows is of great importance for the health and safety of the tenants. There was a 2 ½ year old child that lived in Unit 3 from October 2010 through July 2016 (6 years) and a 6 year old child that lived in Unit 1 from January 2014 to March 2017 (3 years).
