# HISTORIC AND DESIGN REVIEW COMMISSION

July 06, 2018

**HDRC CASE NO:** 2018-254  
**ADDRESS:** 205 OSTROM  
**LEGAL DESCRIPTION:** NCB 6938 BLK LOT 1&2  
**ZONING:** R-4 CD, H, RIO-1  
**CITY COUNCIL DIST.:** 1  
**DISTRICT:** River Road Historic District  
**APPLICANT:** Tobias Stapleton  
**OWNER:** Tobias Stapleton  
**TYPE OF WORK:** Rehabilitation, construction of a rear addition and a two story accessory structure  
**APPLICATION RECEIVED:** June 15, 2018  
**60-DAY REVIEW:** August 14, 2018  
**REQUEST:**

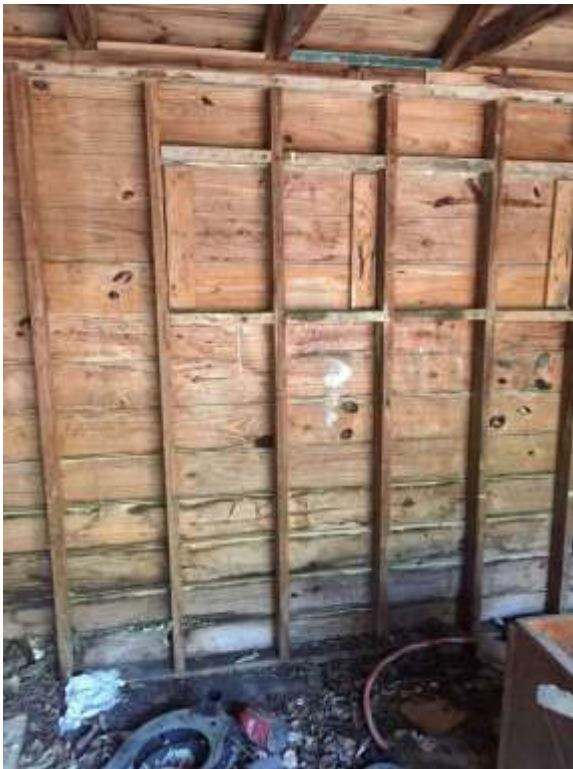
Figure 6: View of wooden wall structure showing vertical studs and horizontal planks.
