HISTORIC AND DESIGN REVIEW COMMISSION

May 01, 2020

HDRC CASE NO: 2020-122
ADDRESS: 533 E CARSON
LEGAL DESCRIPTION: NCB 993 BLK 3 LOT S 96.91 FT 7 (ARB 7C)
ZONING: MF-33, H
CITY COUNCIL DIST.: 2
DISTRICT: Government Hill Historic District
APPLICANT: Mary Jo Vargas/VARGAS MARY JOSEPHINE
OWNER: Mary Jo Vargas/VARGAS MARY JOSEPHINE
TYPE OF WORK: Siding and window replacement
APPLICATION RECEIVED: March 04, 2020
60-DAY REVIEW: May 03, 2020
CASE MANAGER: Huy Pham

533 E Carson

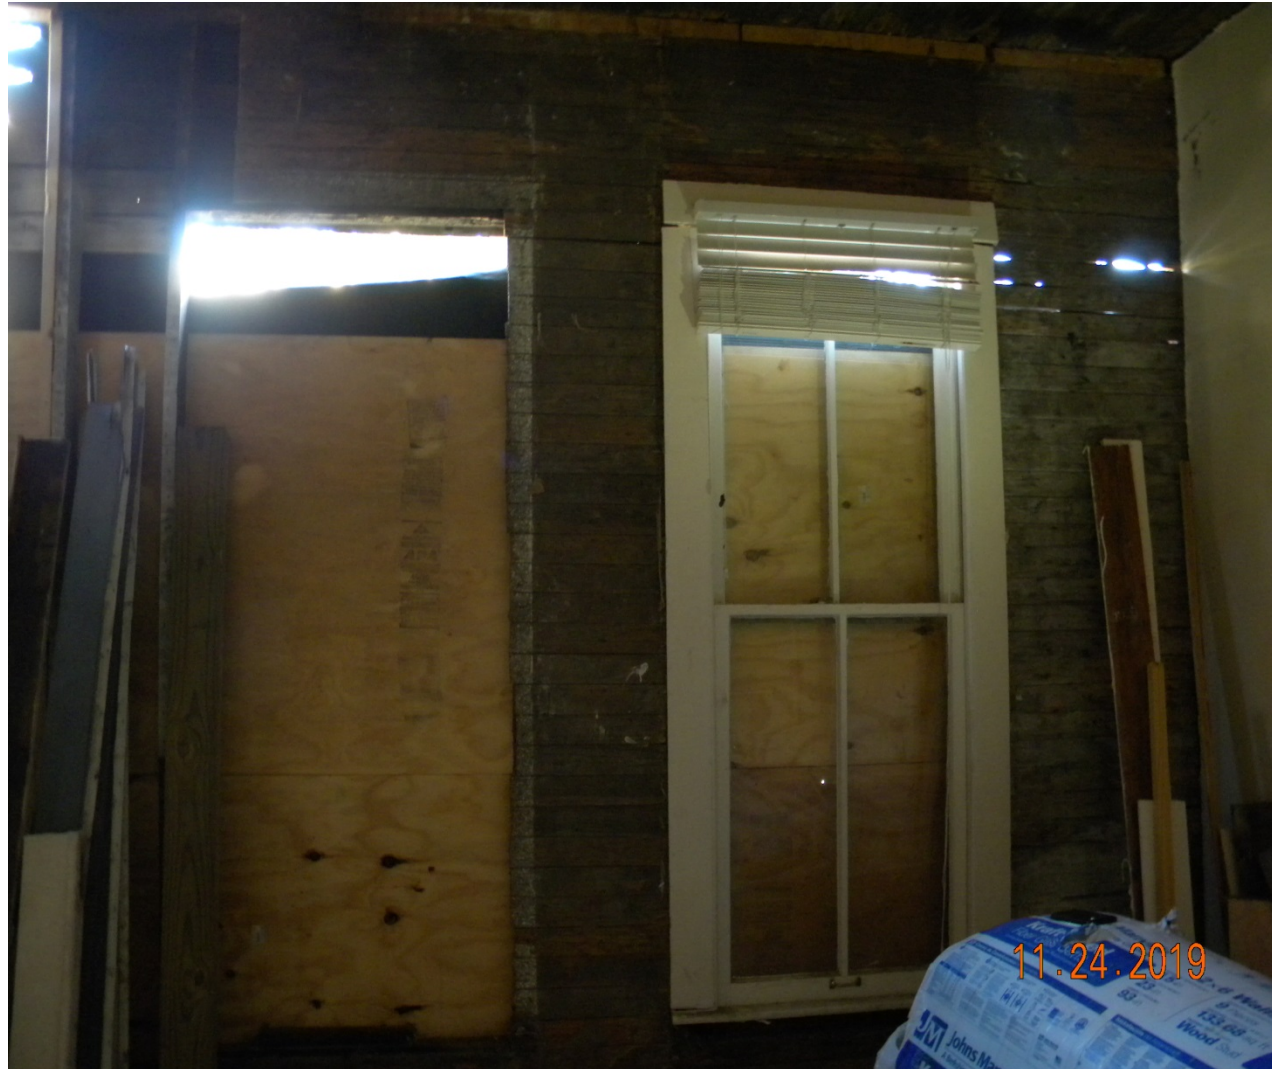
Unit I, Bedroom 1, Windows

Windows D
and E of
Unit I,
Bedroom 1

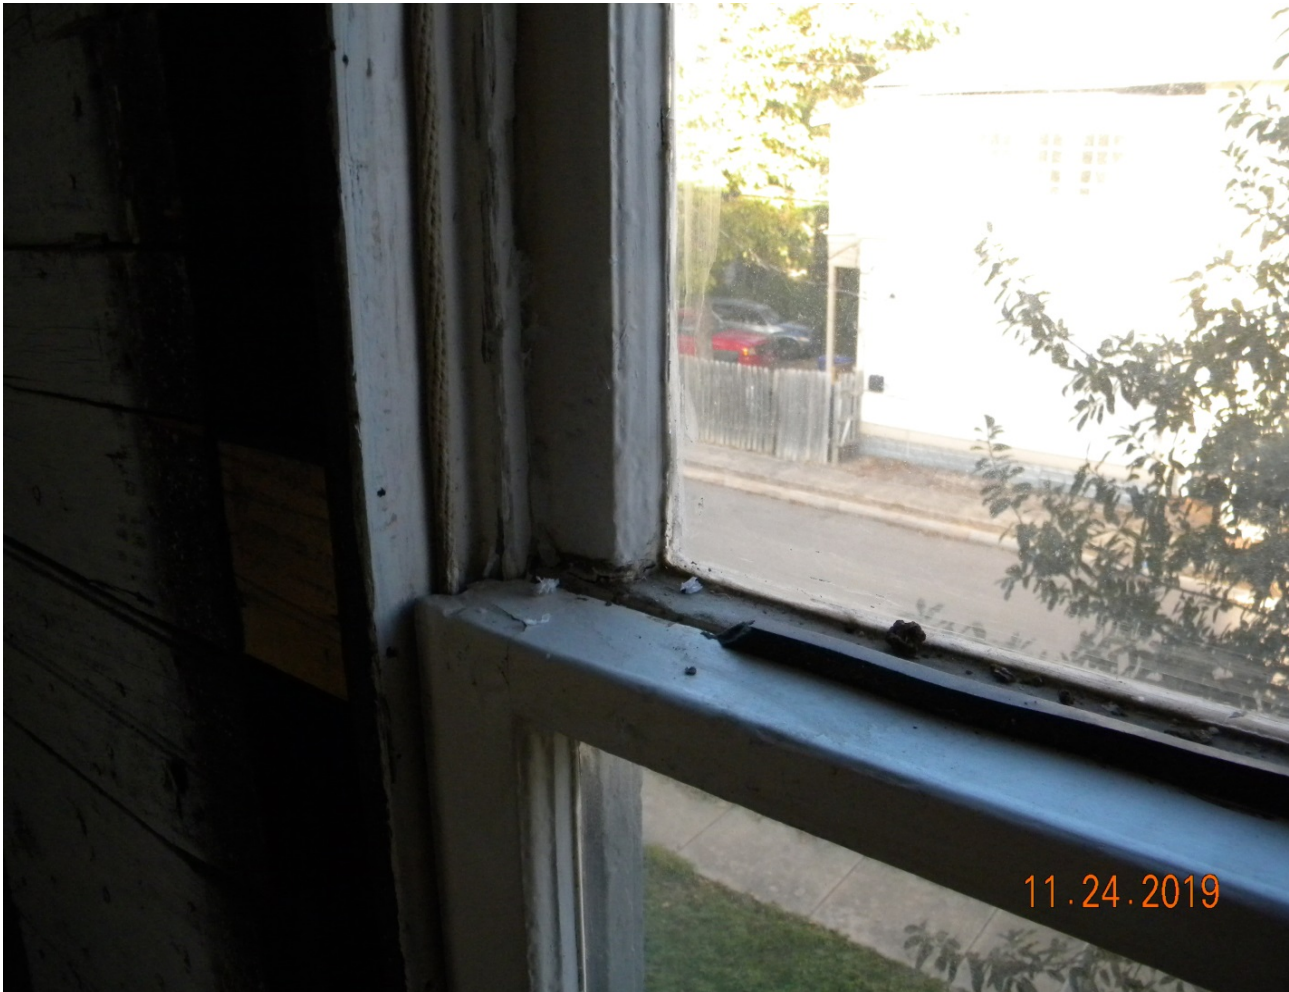
Unit III, Bedroom 1, Window H

Use of foam
between
windows to
reduce air
drafts.

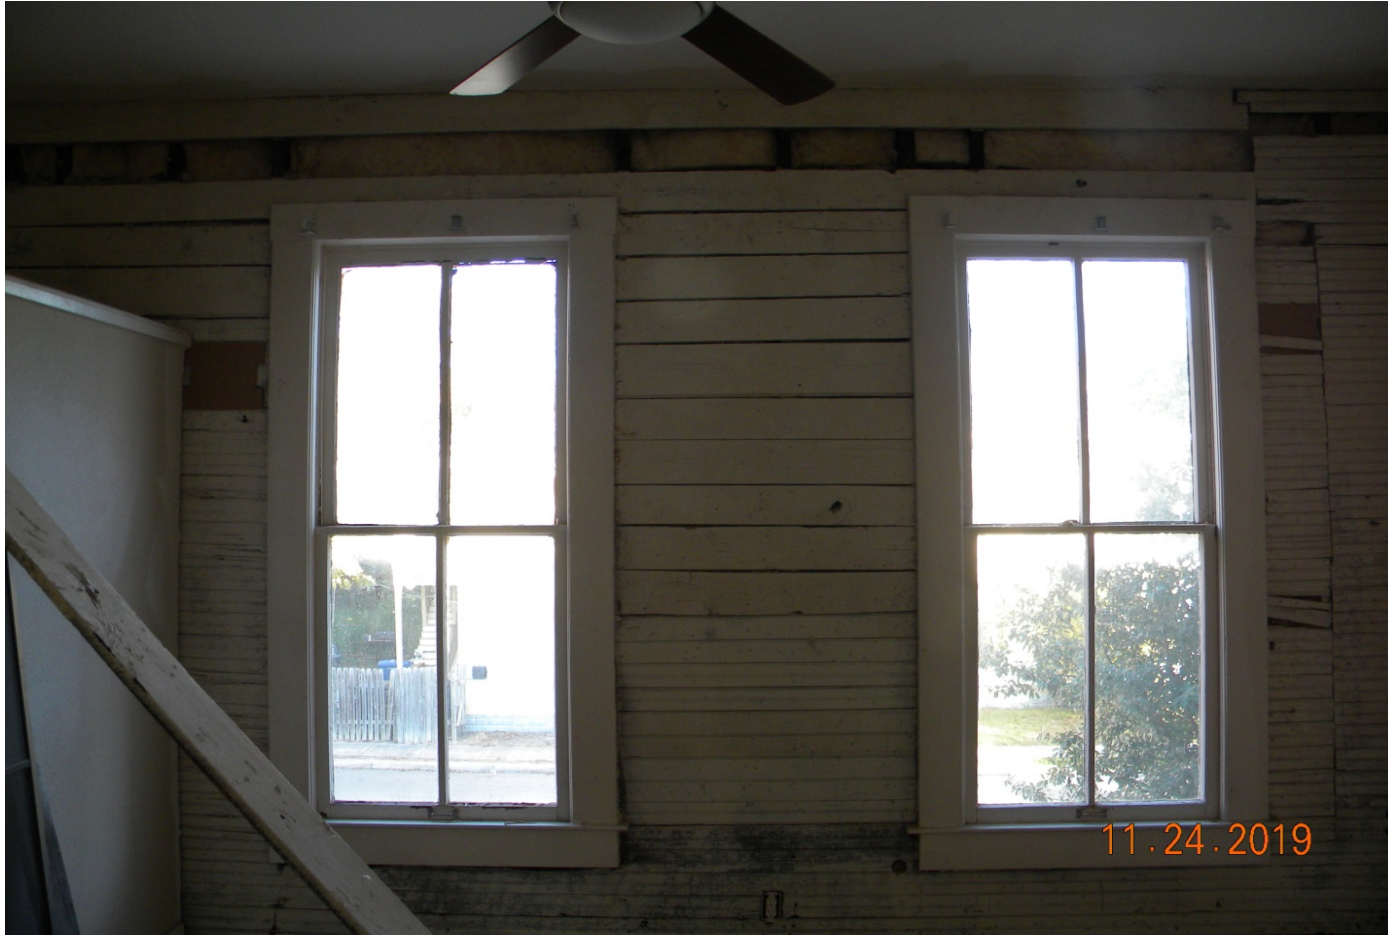
Unit IV, Living Room Windows

Windows from right to left are L and M

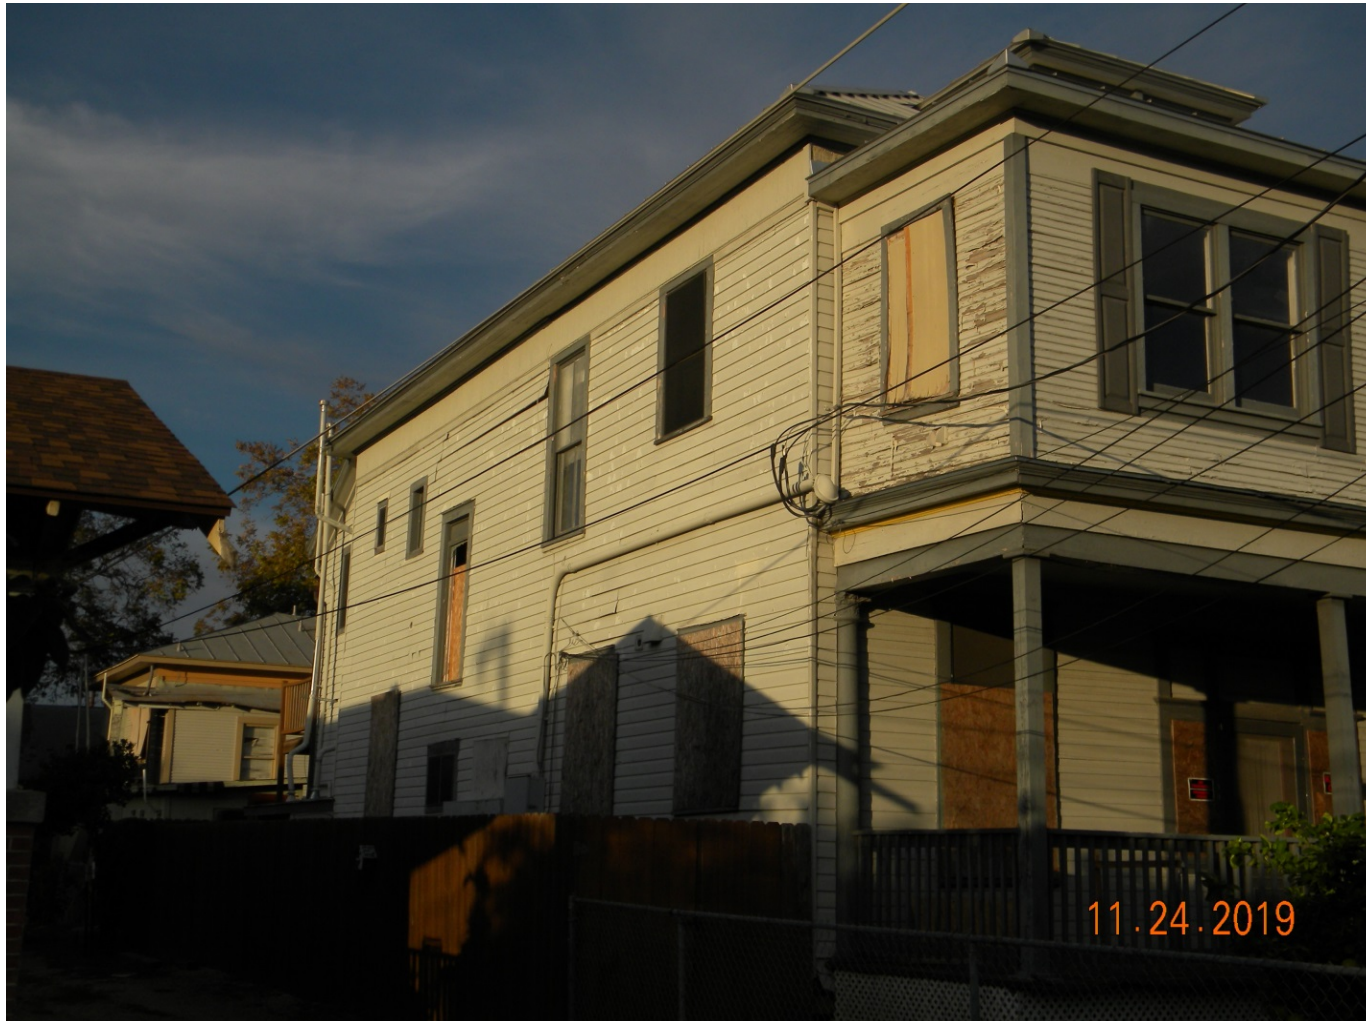
Exterior, West Side of Property

The west side of the property has aluminum siding except for the enclosed upstairs portion of the porch, which is finished in waterfall siding.

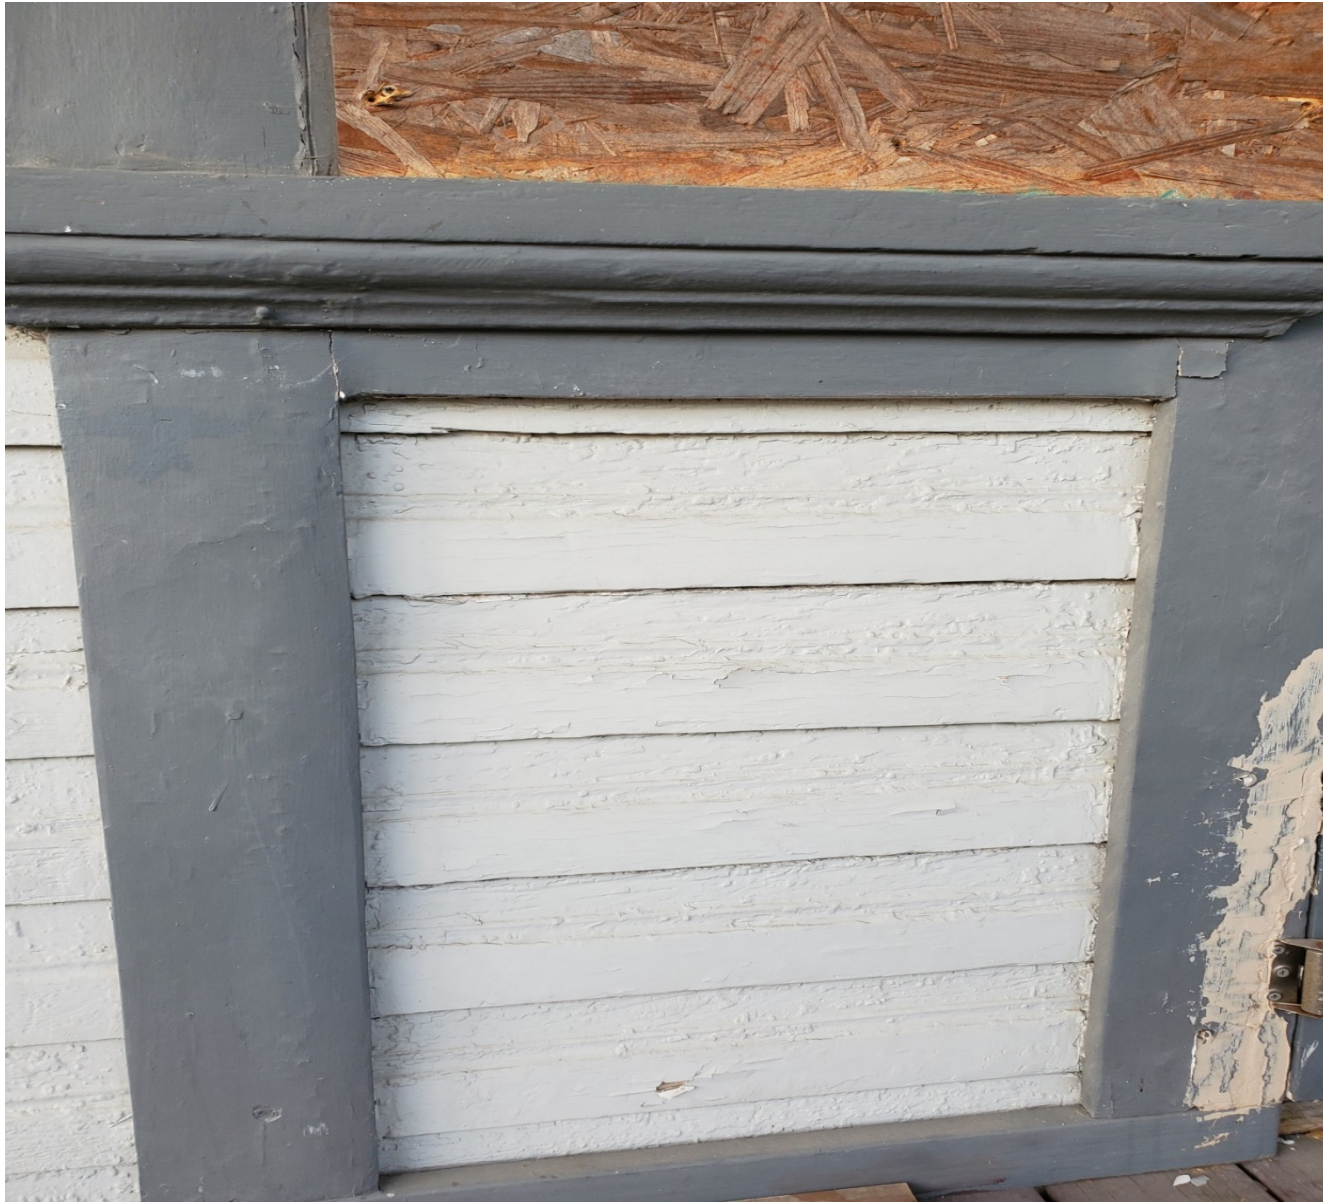
Picture of Original Siding

Left sided
of the
front door.

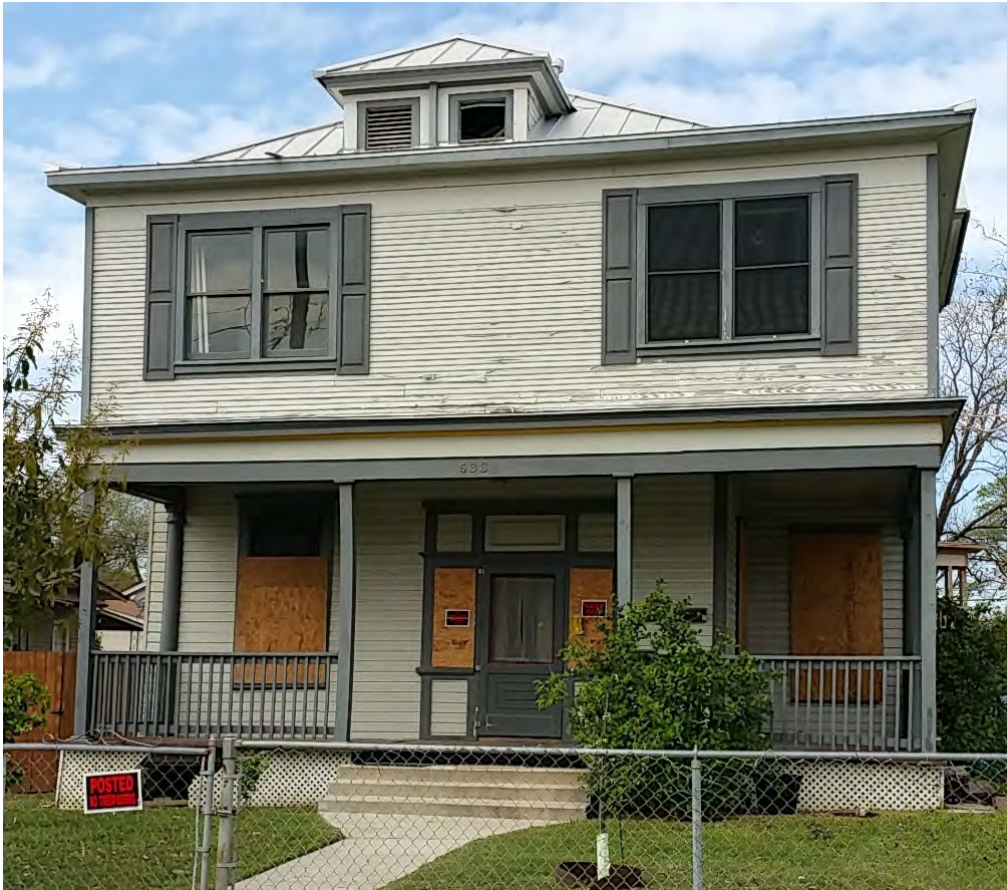
Front of property with waterfall siding, enclosed upper porch, no columns-capitals or bases on porch.

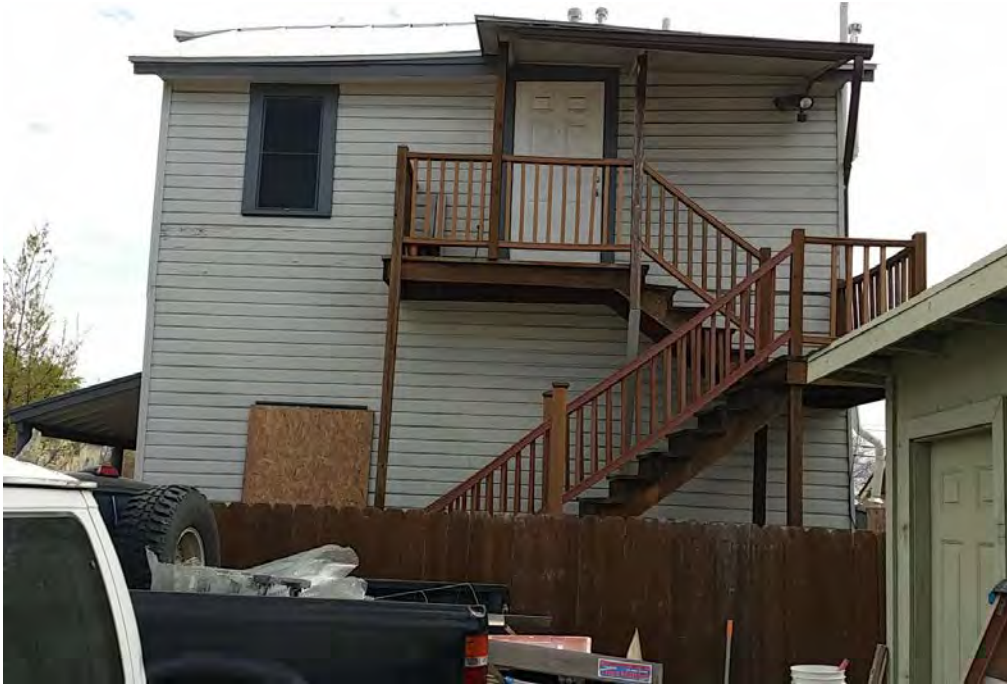
Back side of property with 105 wood siding installed in 2009. Has not weather very well.

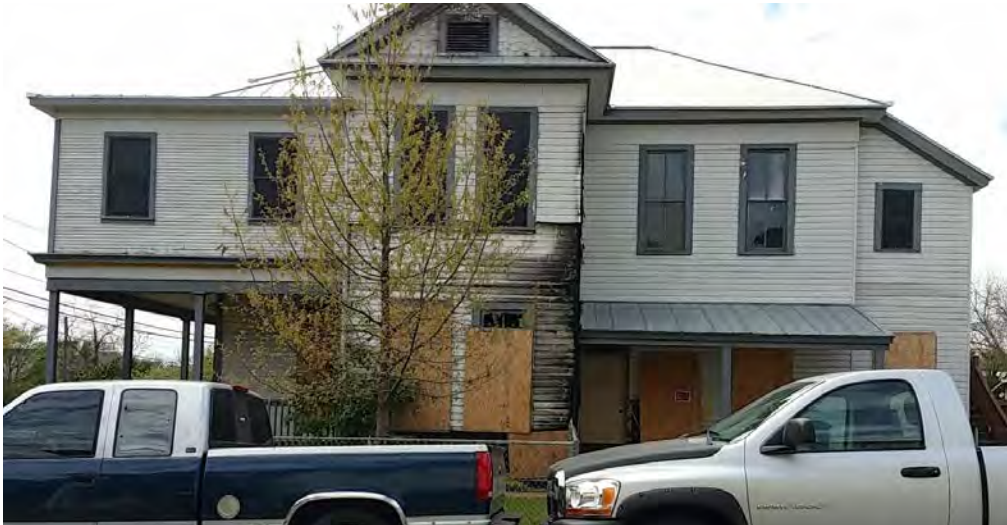
Below, east side of property with waterfall siding on the top left side and the rest aluminum siding.

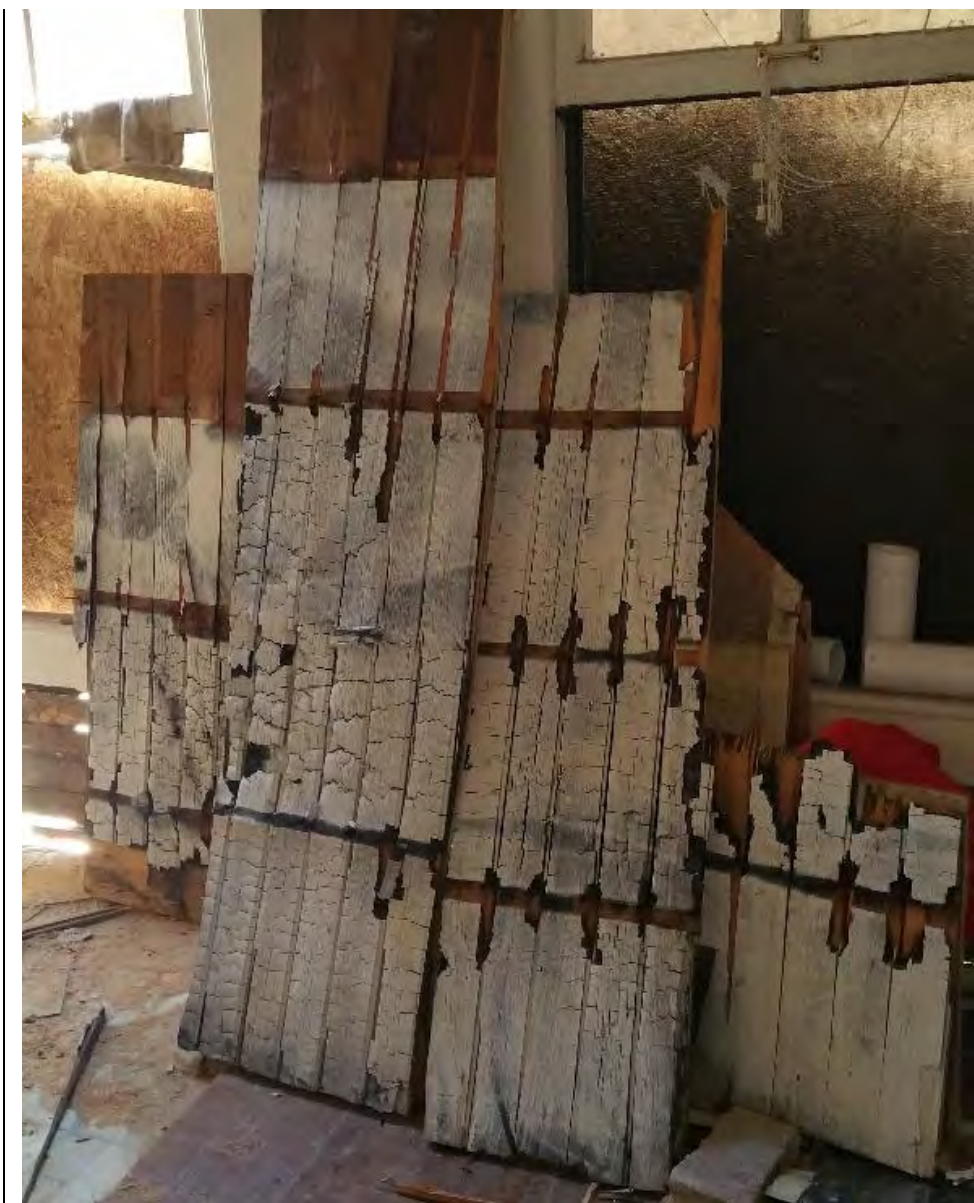
Fire damaged wall cavities that were removed.
